ASBESTOS SURVEY REPORT FOR WESSINGTON PRIMARY SCHOOL LANERCOST, WASHINGTON, TYNE AND WEAR, NE38 7QA.

Asbestos Register for

**Wessington Primary School, Washington,
NE38 7QA**

Date: 03 July 2025

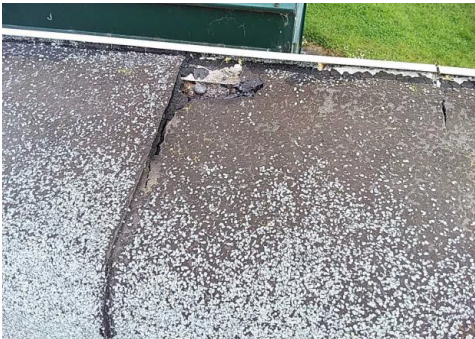
Item 65 Ref: 22-47238-6

The bitumen roof felt (Area 1/External) does not contain asbestos.

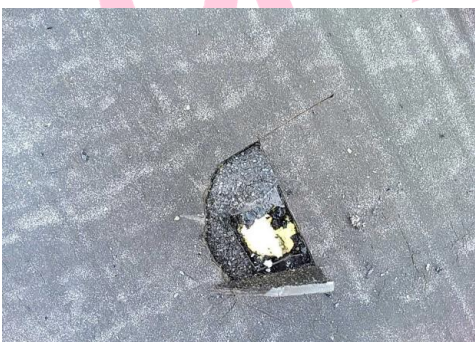
Item 66 Ref: 22-47238-7

The bitumen roof felt (Area 1/External) does not contain asbestos.

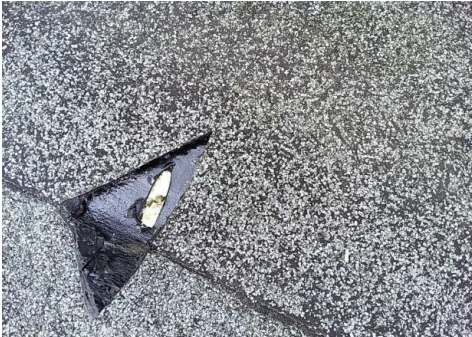
Item 67 Ref: 22-47238-8

The bitumen roof felt (Area 1/External) does not contain asbestos.

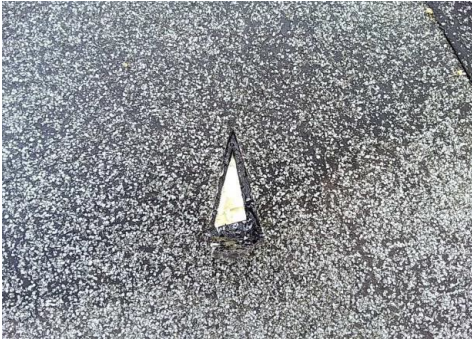
Item 68 Ref: 22-47238-9

The bitumen roof felt (Area 1/External) does not contain asbestos.

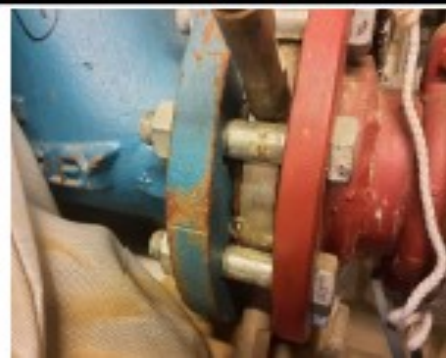
Item 73 Ref: RC000280

The Gaskets pipework far side of room (Keystage 1 Plant Room G/01) does not contain asbestos.
