ASBESTOS SURVEY REPORT FOR MARKET PLACE DEPOT, HOUGHTON LE SPRING,

Asbestos Register for Market Place Depot, Houghton le Spring

UPRN: - 344426

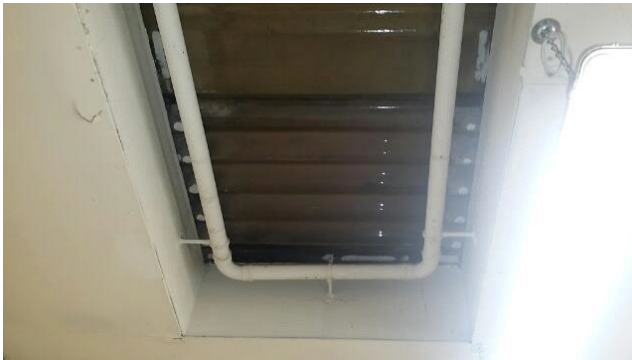
Item 1 Ref: Presumed

The skylight panels in the office (Rm 0/08) are presumed to contain asbestos.

Any changes in the appearance should be recorded and passed to Property Services.

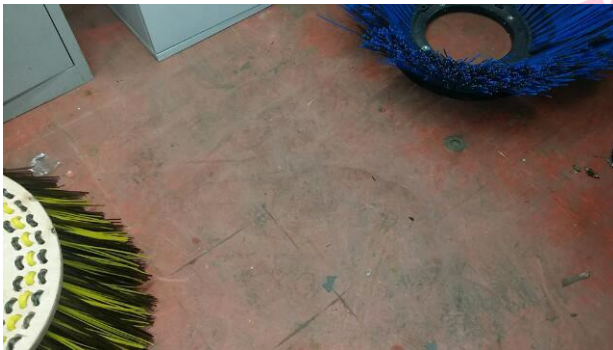
Item 2 Ref: 01

The floor tiles in the Store Room (Rm 0/09) do not contain asbestos.

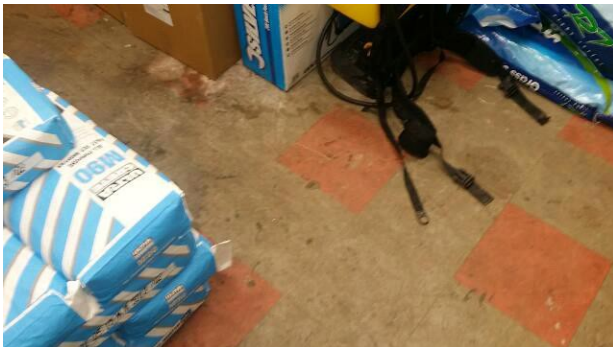
Item 3 Ref: 02

The floor tiles in the Store Room (Rm 0/10) do not contain asbestos.

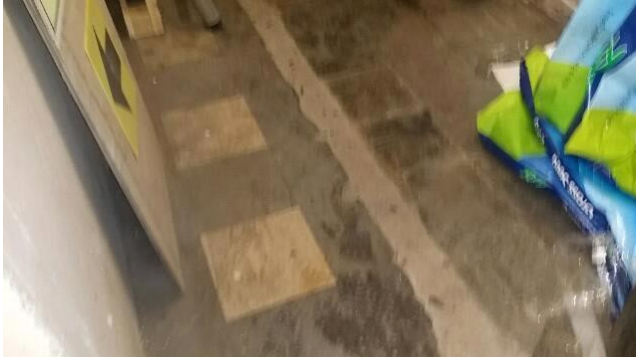
Item 4 Ref: 03

The floor tiles in the Entrance Hall (Rm 0/11) do not contain asbestos.

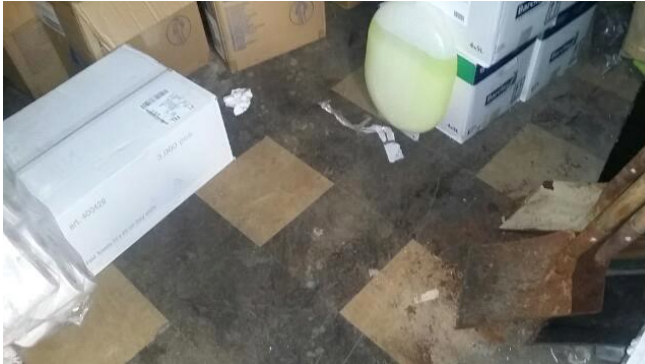
Item 5 Ref: As 03

The floor tiles in the Store room (Rm 0/12) do not contain asbestos.

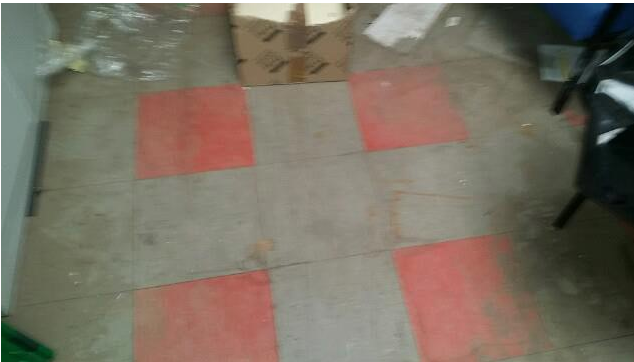
Item 7 Ref: As 02

The floor tiles in the Store Room (Rm 0/14) do not contain asbestos.

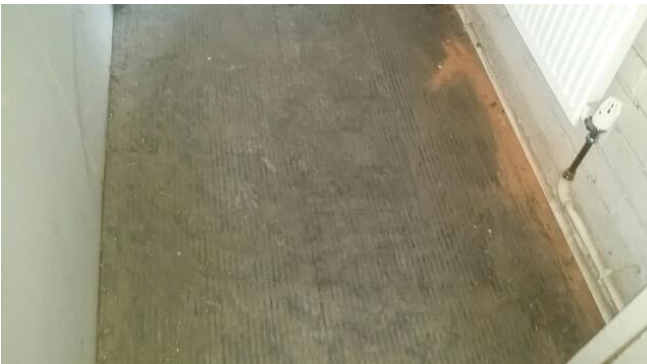
Item 9 Ref: As 03

The floor tiles in the Corridor (Rm 0/16) do not contain asbestos.

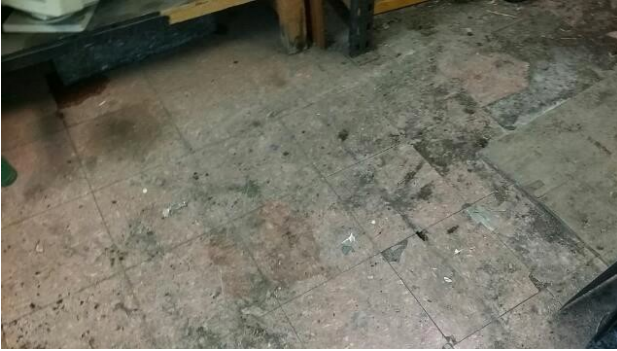
Item 10 Ref: 04

The floor tiles in the Store Room (Rm 0/19) do not contain asbestos.

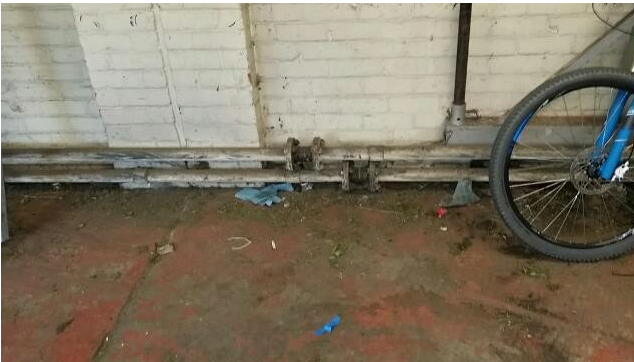
Item 11 Ref: Presumed

The gaskets in the Warehouse (Rm 0/20) are presumed to contain asbestos.

Any changes in the appearance should be recorded and passed to Property Services.

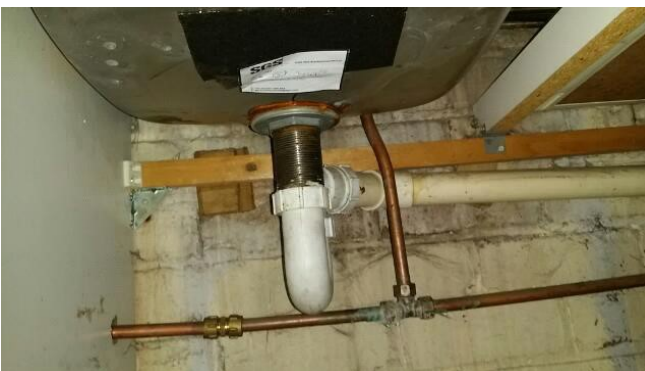
Item 12 Ref: 05

The sink pad in Kitchen (Rm 0/23) does not contain asbestos.

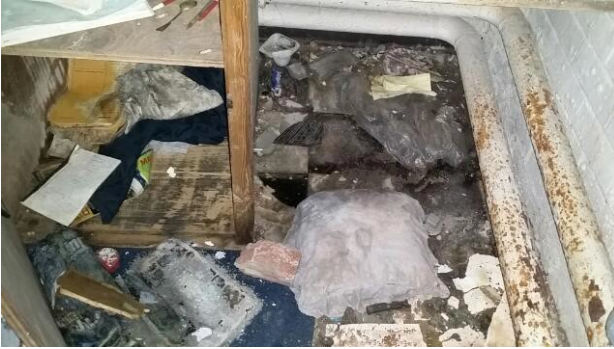
Item 13 Ref: 06

The floor tiles in the Store Room (Rm 0/26) contain asbestos.

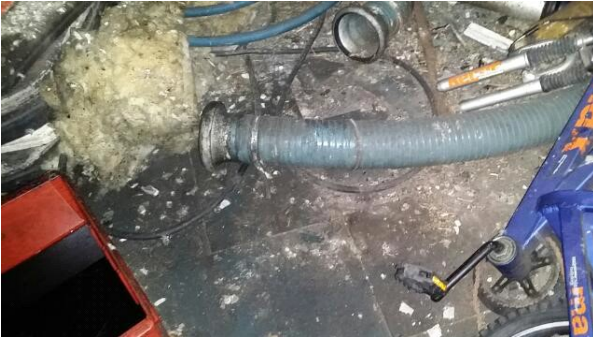
Item 16 Ref: 07

The floor tiles in the Store Room (Rm 0/35) contain asbestos.

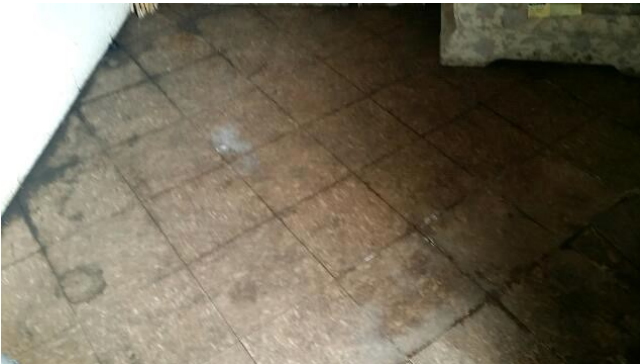
Item 18 Ref: 08

The floor tiles in the Rest Room (Rm 0/36) do not contain asbestos.

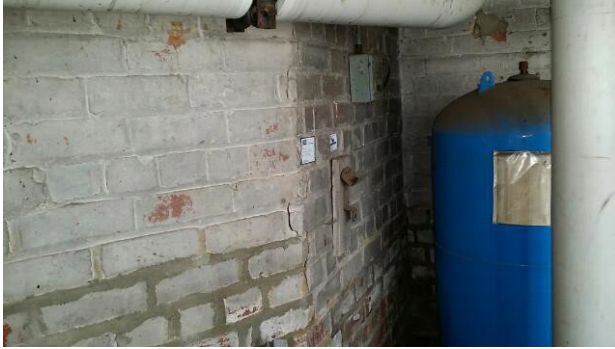
Item 25 Ref: 12

The debris to rear of tank in the Boiler Room (Rm 0/40) does not contain asbestos.

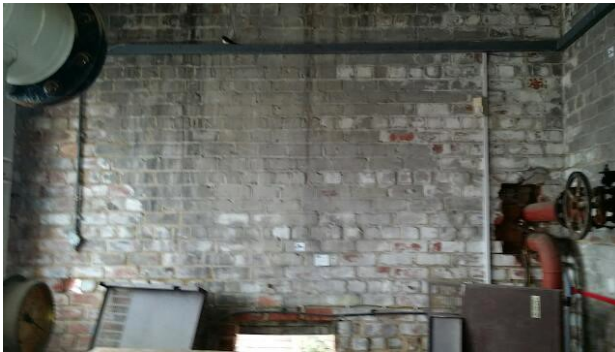
Item 26 Ref: 11

The debris to wall right hand side of boiler in the Boiler Room (Rm 0/40) does not contain asbestos.

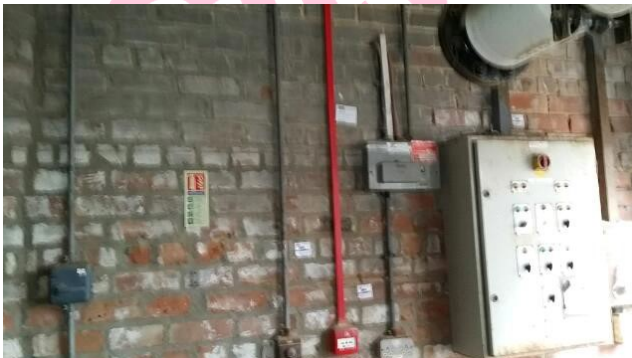
Item 27 Ref: 13

The debris to wall left hand side of electrical equipment in the Boiler Room (Rm 0/40) does not contain asbestos.

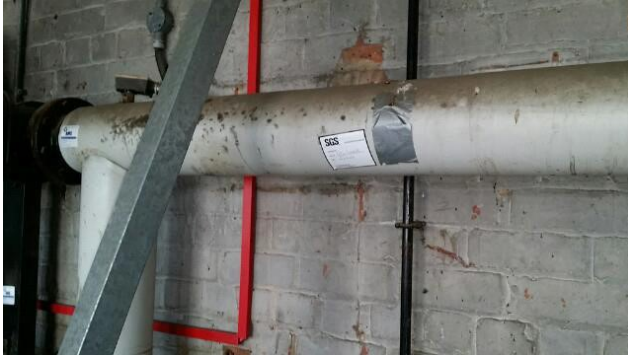
Item 31 Ref: 15

The pipework insulation in the Boiler Room (Rm 0/40) does not contain asbestos.

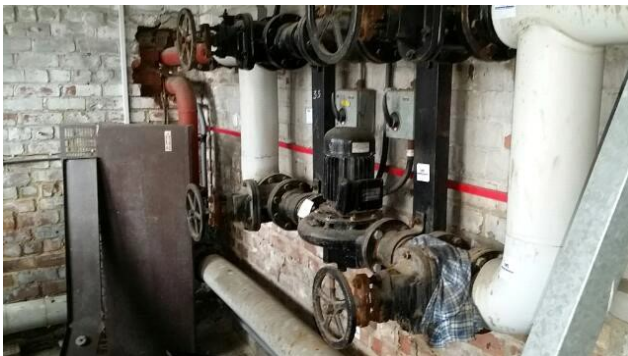
Item 32 Ref: 09

The gaskets in the Boiler Room (Rm 0/40) do not contain asbestos.

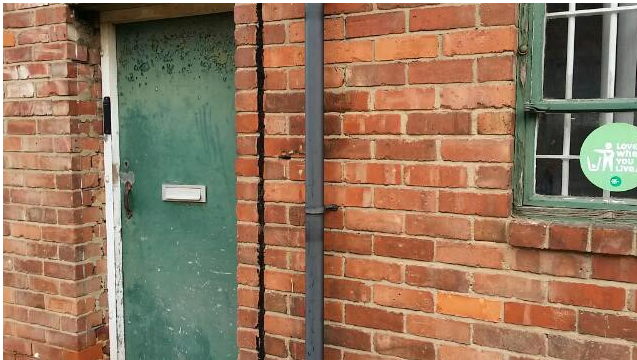
Item 60 Ref: 29

The jointing compound to the wall (External) does not contain asbestos.

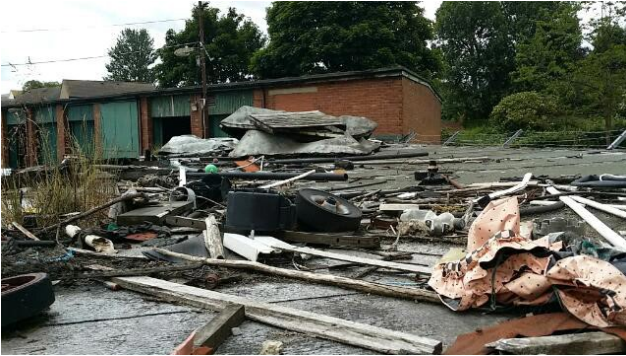
Item 61 Ref: 30

The felt to the shed roof
(External) does not contain
asbestos.

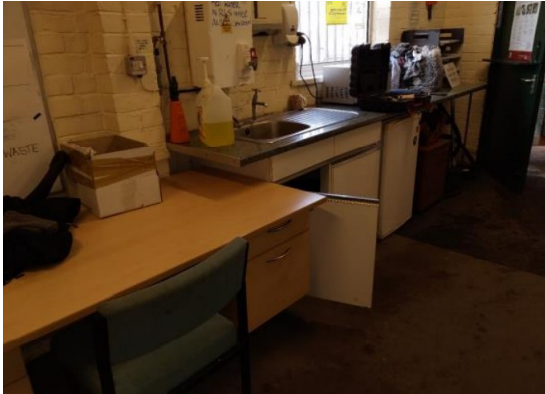
Item 67 Ref: 21-30764-2

The sink pad in Area 3/Refuge Office does not contain asbestos.

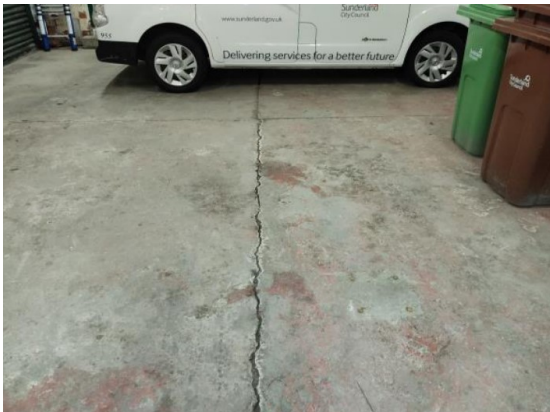
Item 68 Ref: 21-30764-3

The putty on floor in Area 4/Garage and Store Area does not contain asbestos.

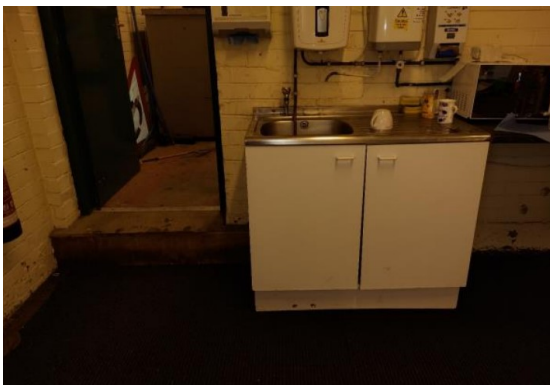
Item 69 Ref: 21-30764-4

The sink pad in Area 6/Ground Office does not contain asbestos.

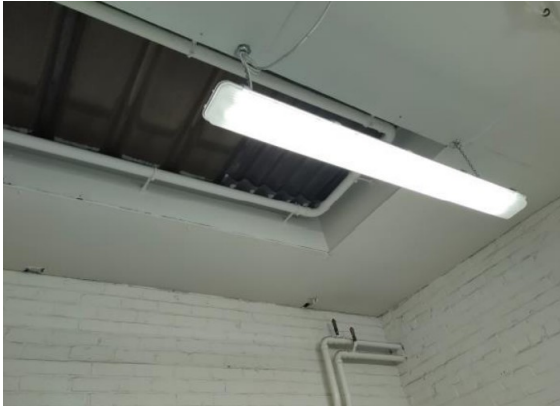
Item 70 Ref: Presumed

The corrugated Sheet ceiling in Area 6/Ground Office is presumed to contains asbestos.

Any change in its appearance should be recorded and passed to Property Services.

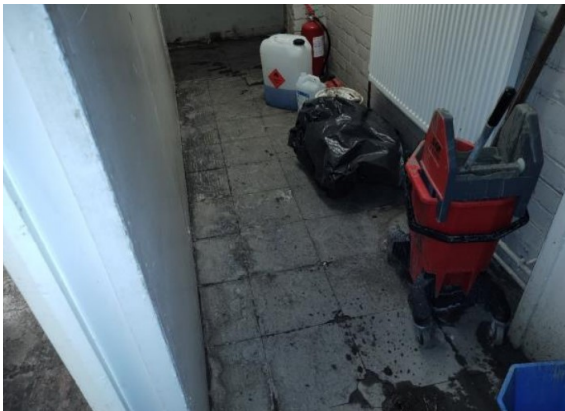
Item 71 Ref: 21-30764-10

The floor tiles and adhesive in Area 12/Hall does not contain asbestos.

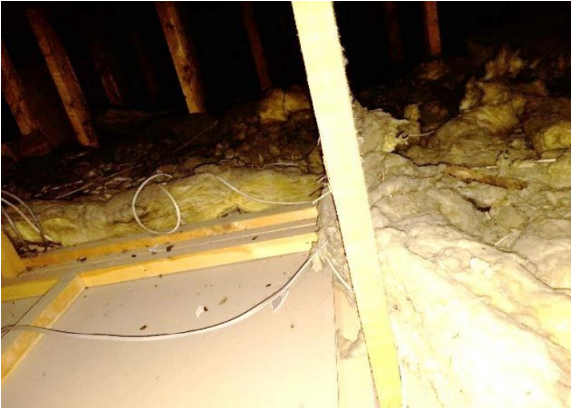
Item 74 Ref: 21-30764-9

The debris in Area 198/Loft space above areas 8,9,10 and 11 contains asbestos.

Any change in its appearance should be recorded and passed to Property Services.

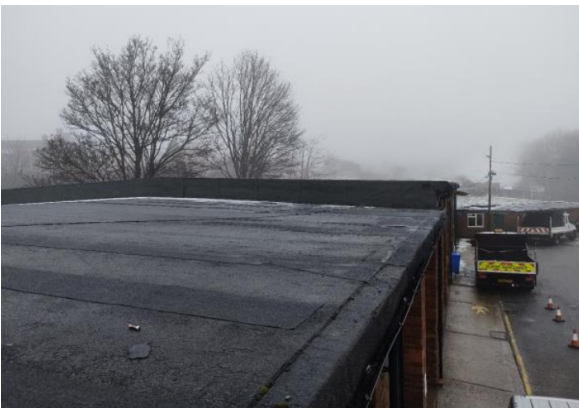
Item 75 Ref: 21-30764-13

The roof felt in Area 24/External roofs above garages and mess hall does not contain asbestos.

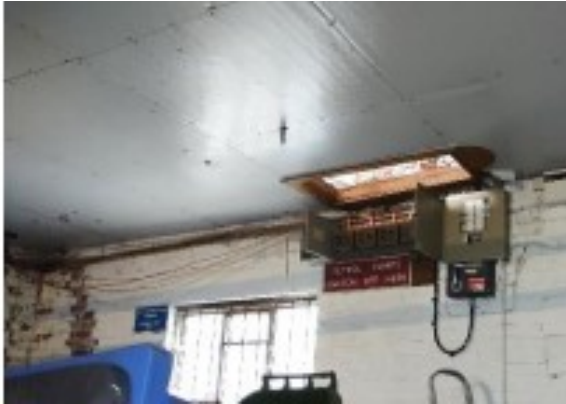
Item 82 Ref: Presumed

The flash guards within live equipment (Bin Store Wall around DB) are presumed to contain asbestos.

Removed 2023

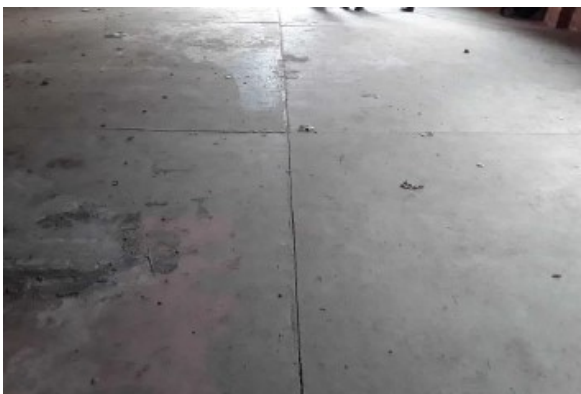
Item 84 Ref: 22-46862-11

The expansion joints to concrete floor slabs in Warehouse 2 contains asbestos.

Removed 2023

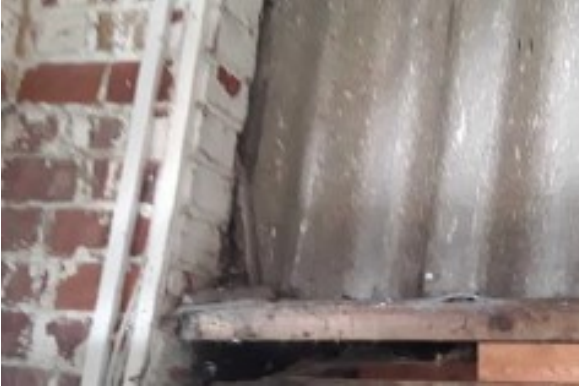
Item 85 Ref: 22-46862-3

The flashing to cement walls above doorway in Warehouse 2 does not contain asbestos.

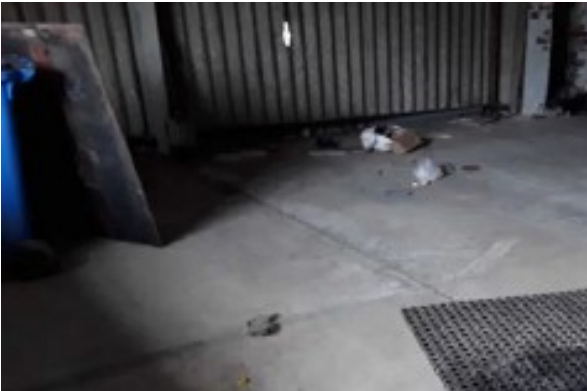
Item 86 Ref: 22-46862-11

The expansion joints to concrete floor slabs in Warehouse 3 contains asbestos.

Removed 2023

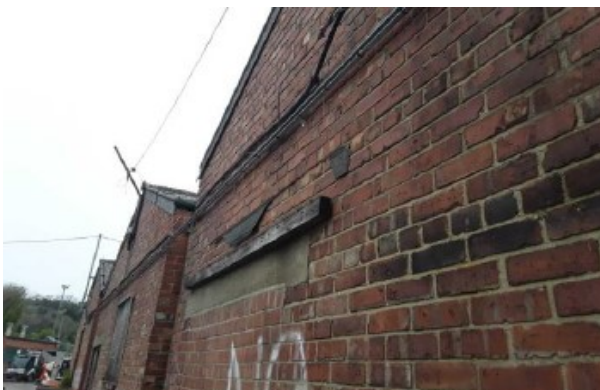
Item 93 Ref: 22-46862-17

The wall flashing (External) does not contain asbestos.

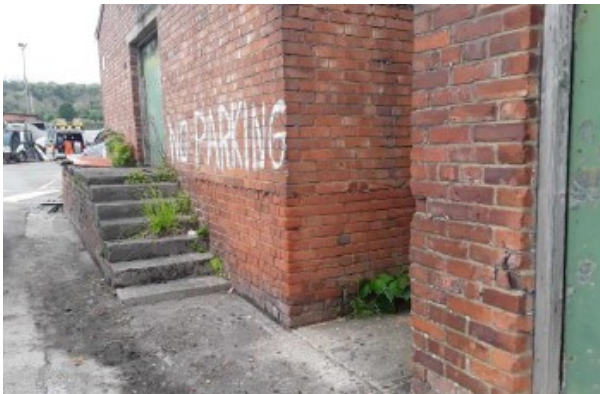
Item 95 Ref: 22-46862-19

The damp proof course (External) does not contain asbestos.

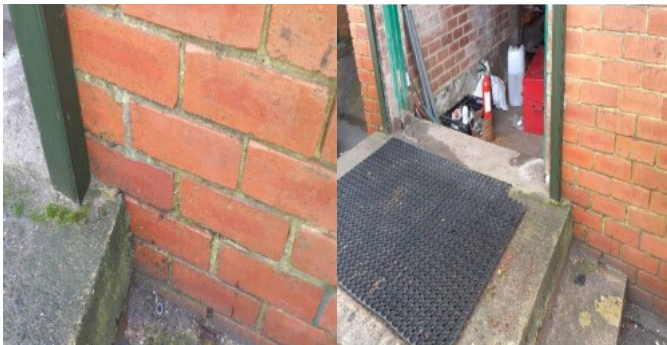
Item 104 Ref: OU001451

The damp proof course to the external area (E/01) does not contain asbestos.

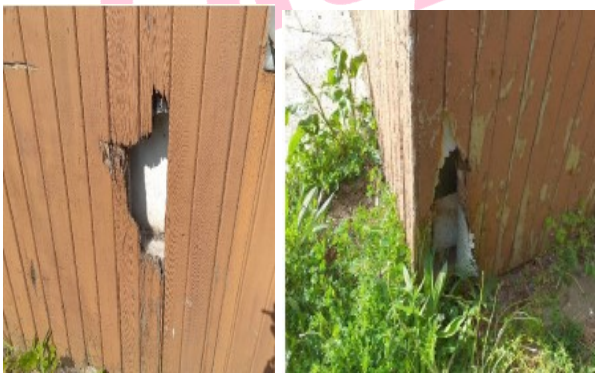
Item 105 Ref: Presumed

Presumed – Paper coated fibreboard (Behind broken wall panel) (External E/01)
(Item 105) – Low Risk

The paper coated fibreboard to the external area (E/01) is presumed to contain asbestos.

Any change in appearance should be reported to Property Services.

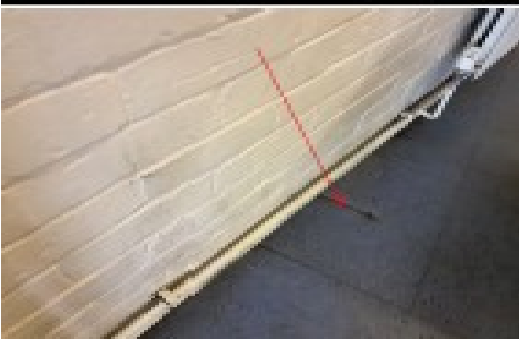
Item 106 Ref: KG000707

The tile debris under modern tile in the Mess Room (G/01) does not contain asbestos.

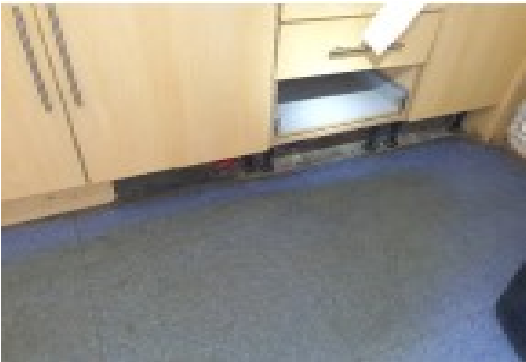
Item 107 Ref: As KG000707

The tile debris under cupboards in the Mess Room (G/01) does not contain asbestos.
