ASBESTOS SURVEY REPORT FOR SUNDERLAND MUSEUM AND WINTER GARDENS, BURDON ROAD, SUNDERLAND, SR1 1PP.

Asbestos Register for Sunderland Museum and Winter Gardens

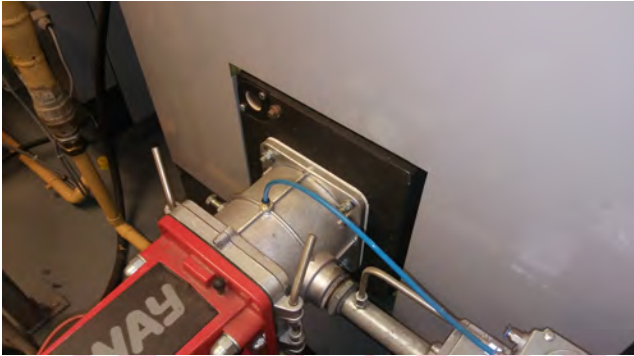
Item 5 Ref: 402578-31

The gasket to boilers in -1/009/Boiler Room does not contain asbestos.

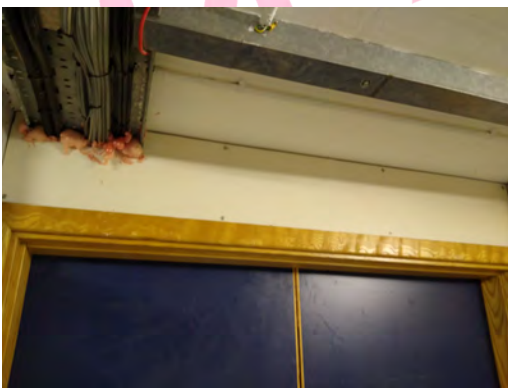
Item 9 Ref: As 402578-15

The door header panel in -1/015/Store does not contain asbestos.

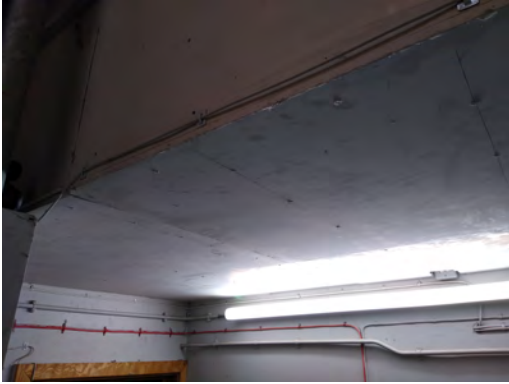
Item 10 Ref: 402578-10

The ceiling in -1/019a/Stairwell does not contain asbestos.

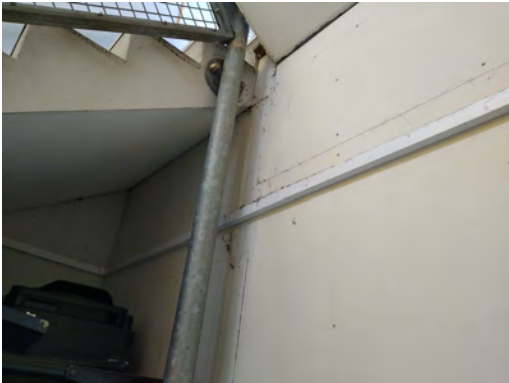
Item 11 Ref: As 402578-10

The wall panels in -1/019a/Stairwell does not contain asbestos.

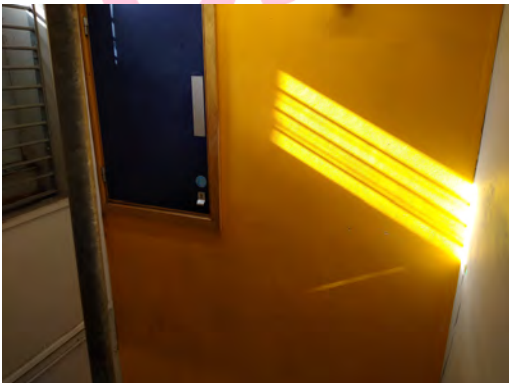
Item 12 Ref: 402578-11

The wall coating in -1/019a/Stairwell does not contain asbestos.

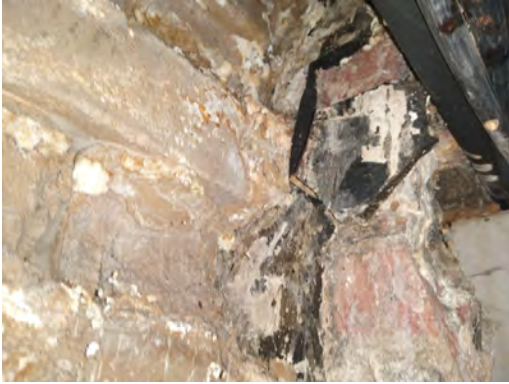
Item 13 Ref: 402578-33

The lining within wall cavity in -1/024/Riser pit does not contain asbestos.

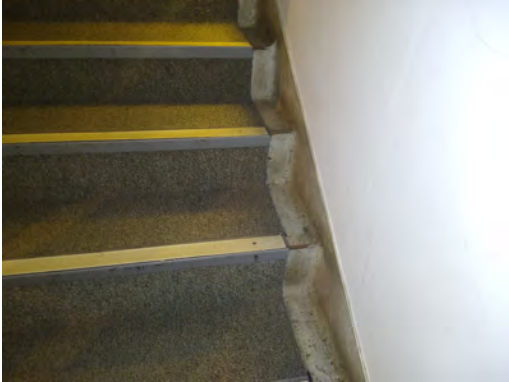
Item 16 Ref: As 402578-23

- (Item 16) Ref: As 402578-23 – Stairs (0/006/Archaeology) – Very Low Risk
- (Item 17) Ref: As 402578-29 – Glazing mastic (0/013/Circulation) – No Risk
- (Item 18) Ref: 402578-30 – Lining within doors (0/014/Lift lobby) – No Risk

The stairs in 0/006/
Archaeology contains
asbestos.

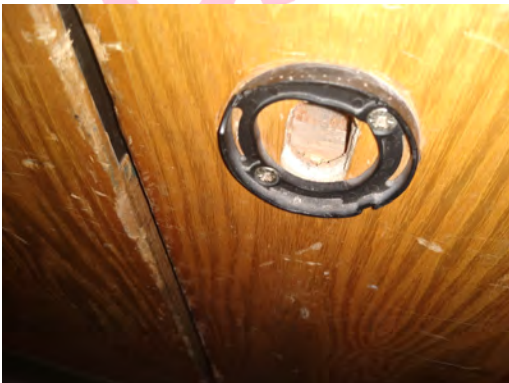
Item 18 Ref: 402578-30

The lining within doors in
0/014/Lift lobby does not
contain asbestos.

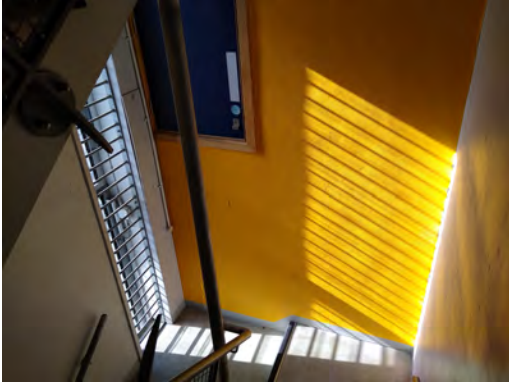
Item 19 Ref: As 402578-11

The wall coating in 0/017/Stairwell does not contain asbestos.

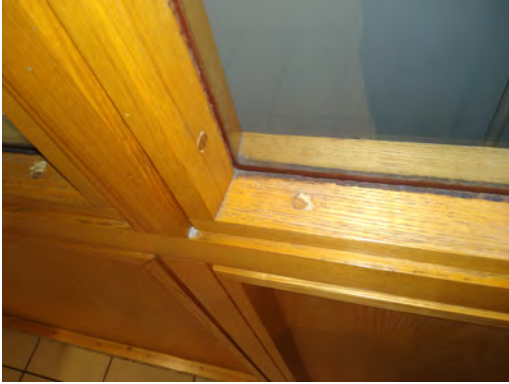
Item 22 Ref: 402578-29

The sealant to glazing in 0/023/Lift lobby does not contain asbestos.

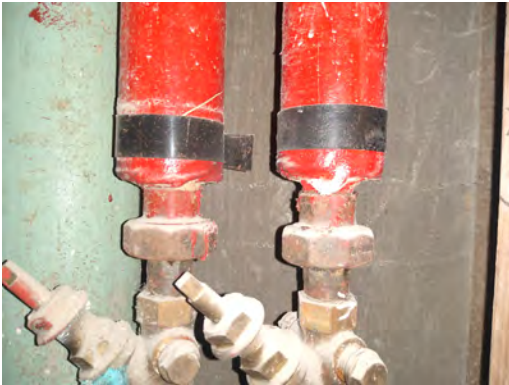
Item 23 Ref: As 402578-25

- (Item 22) Ref: 402578-29 – Sealant to glazing (0/023/Lift lobby) – No Risk
- (Item 23) Ref: As 402578-25 – Pipe lagging end capping (0/024b/void behind display) – Low Risk

The pipe lagging end capping in 0/024b/void behind display contains asbestos.

Any change in its appearance should be recorded and passed to Property Services.

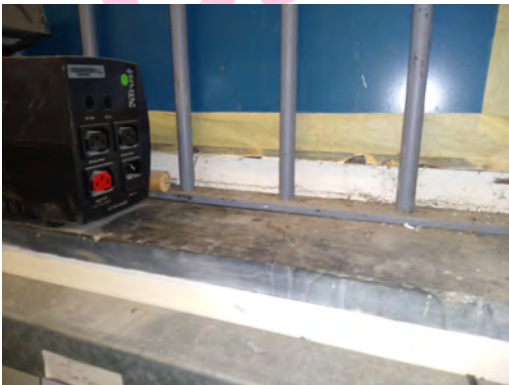
Item 24 Ref: As 402578-28

The windowsill in 0/029/Switch room does not contain asbestos.

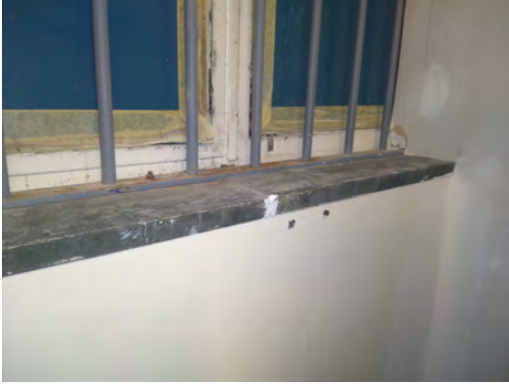
Item 25 Ref: 402578-28

The windowsill in 0/031/Lobby does not contain asbestos.

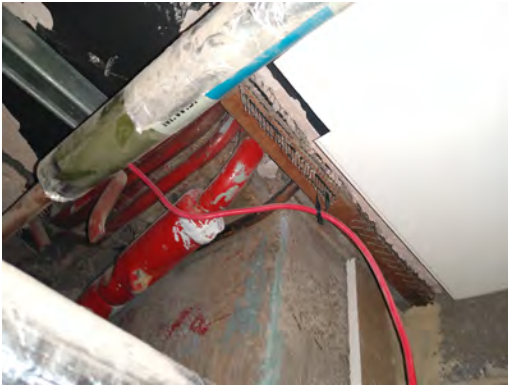
Item 29 Ref: 402578-25

- (Item 27) Ref: As 402578-23 – Floor (1/001/Stairwell) – Very Low Risk
- (Item 28) Ref: 402578-24 – Glazing mastic (1/001a/Lift lobby) – No Risk
- (Item 29) Ref: 402578-25 – Pipe lagging end capping (1/001a/Lift lobby void above) – Low Risk

The pipe lagging end capping in 1/001a/Lift lobby void above contains asbestos.

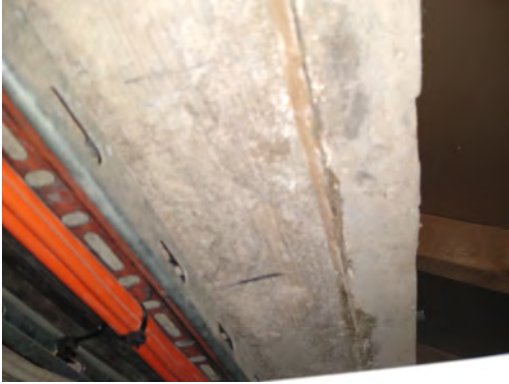
Item 37 Ref: 402578-26

The remaining putty to concrete beam in 1/014a/Lift lobby void above does not contain asbestos.

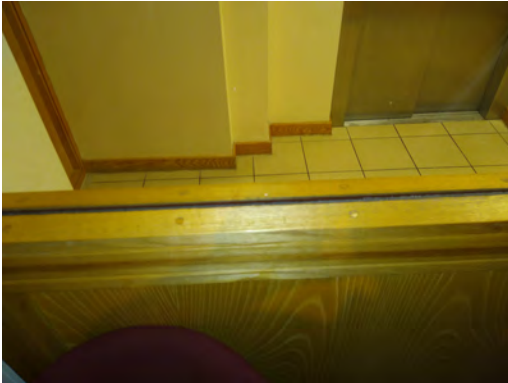
Item 40 Ref: As 402578-19

The glazing mastic in 2/011/ship building display does not contain asbestos.

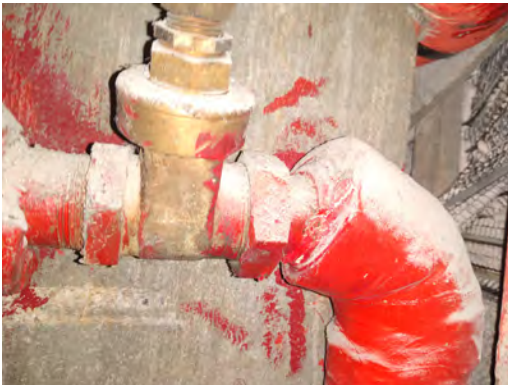
Item 41 Ref: 402578-20

- (Item 41) Ref: 402578-20 – Pipe lagging end capping (2/011/ship building display) – Low Risk
- (Item 42) Ref: As 402578-19 – Glazing mastic (2/016/Lift lobby) – No Risk

The pipe lagging end capping in 2/011/ship building display contains asbestos.

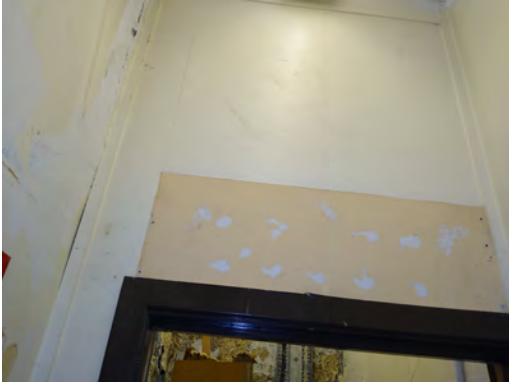
Item 43 Ref: As 402578-21

The door surrounds/header panels in 2/020/Corridor do not contain asbestos.

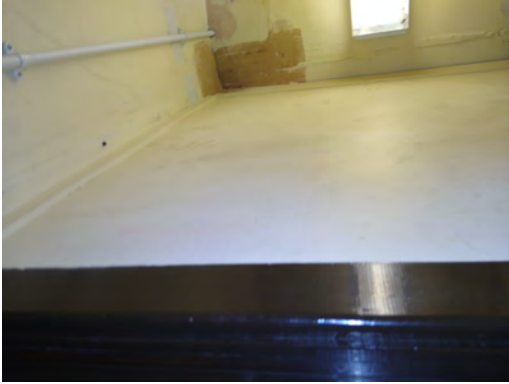
Item 46 Ref: As 402578-21

The door surrounds in 2/024/Electrical cupboard do not contain asbestos.

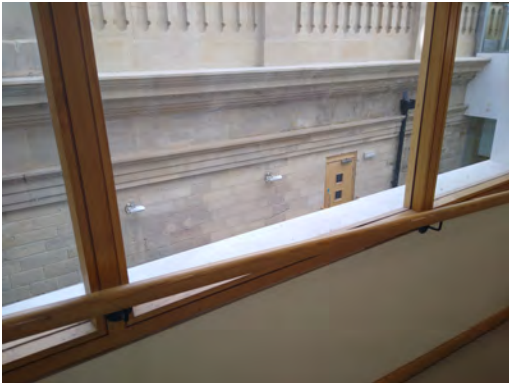
Item 47 Ref: As 402578-19

The glazing mastic in 2/027/Corridor does not contain asbestos.

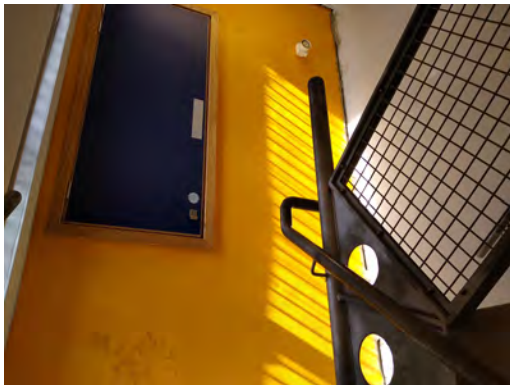
Item 50 Ref: As 402578-11

The wall coating in 2/030/Stairwell does not contain asbestos.

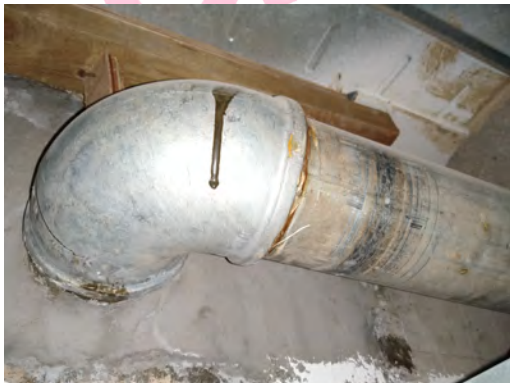
Item 51 Ref: 402578-12

The sealant to pipework collars in 2/030/Stairwell void above does not contain asbestos.

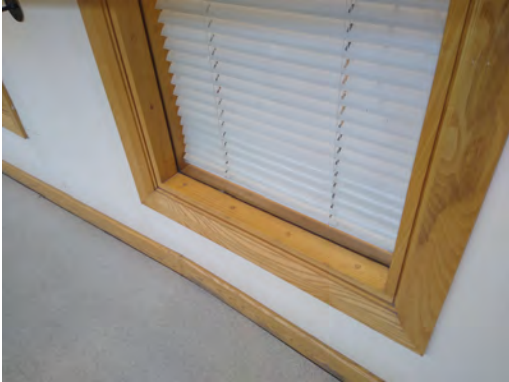
Item 52 Ref: 402578-19

The glazing mastic in 2/034/Office does not contain asbestos.

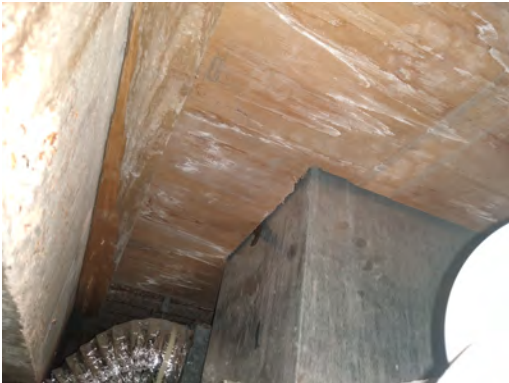
Item 53 Ref: 402578-13

The felt hanging from wood roof panel in 3/004/Shower room void above does not contain asbestos.

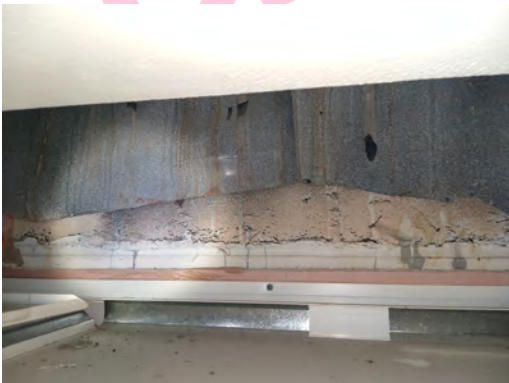
Item 54 Ref: As 402578-7

The coating to concrete beam in 3/006/Corridor void above does not contain asbestos.

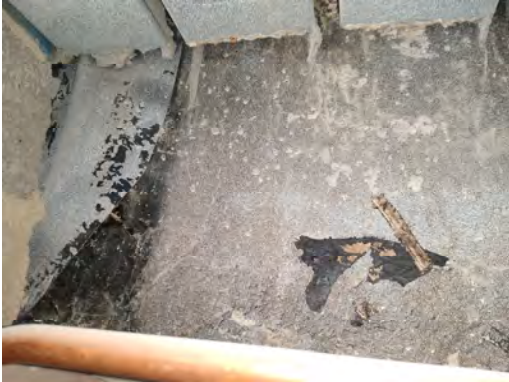
Item 55 Ref: 402578-7

The coating to concrete beam in 3/009/Lift lobby void above does not contain asbestos.

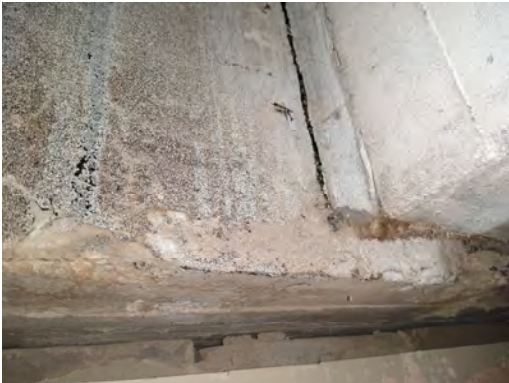
Item 56 Ref: 402578-8

The expansion joint between concrete beams in 3/009/Lift lobby void above does not contain asbestos.

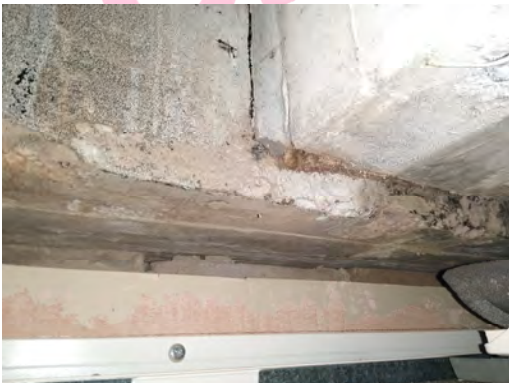
Item 57 Ref: 402578-9

The expansion joint between concrete beams in 3/009/Lift lobby void above does not contain asbestos.

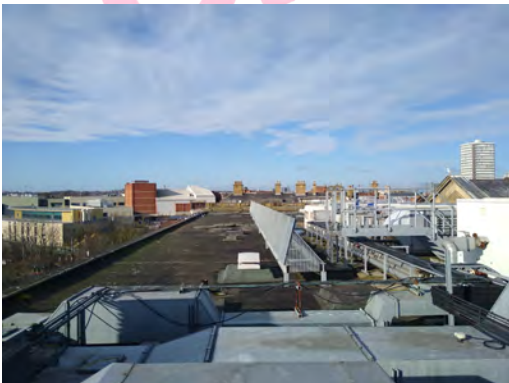
Item 69 Ref: 402578-3

The roof felt (External/Roof top) does not contain asbestos.

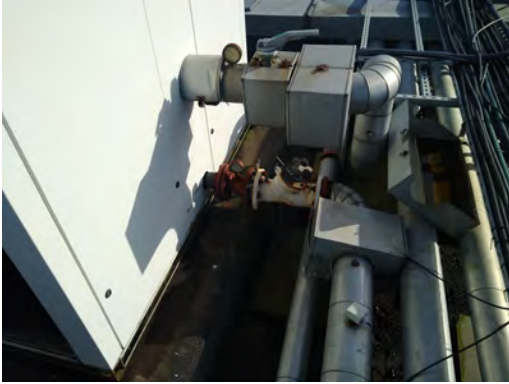
Item 70 Ref: 402578-4

The pipework flange gasket (External/Roof top) does not contain asbestos.

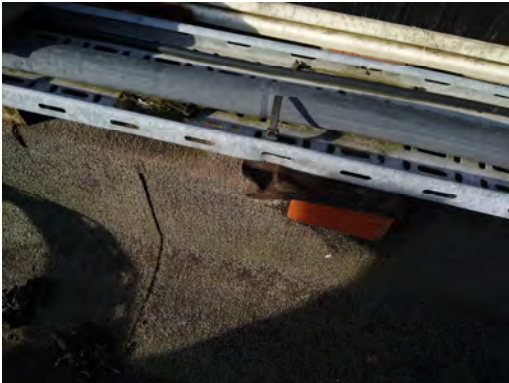
Item 71 Ref: 402578-5

The packer between brick and metal cable tray beneath chiller (External/Roof top) does not contain asbestos.

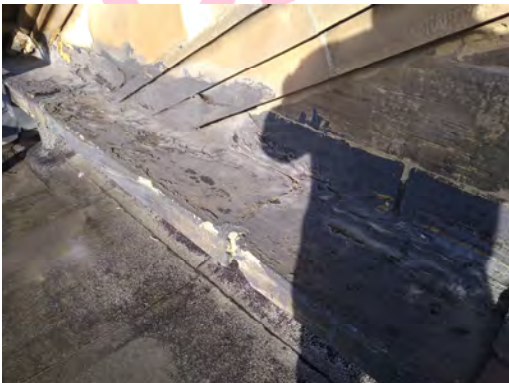
Item 72 Ref: 402578-6

The remaining bitumen to external perimeter of pitched areas (External/Roof top) contains asbestos.

Any change in its appearance should be recorded and passed to Property Services.

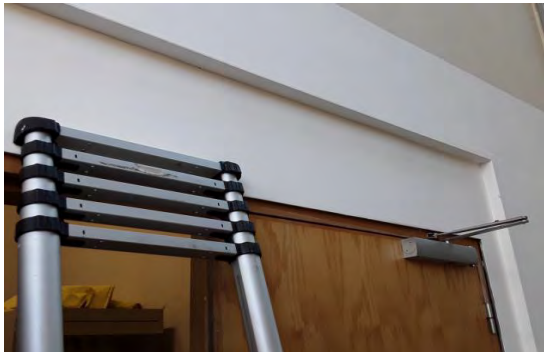
Item 73 Ref: 20-27689-1

The textured coating to the door header in the Corridor does not contain asbestos.
