ASBESTOS SURVEY REPORT FOR ARTS CENTRE WASHINGTON, FATFIELD, WASHINGTON

*Control of Asbestos
Regulations 2012*

Asbestos Register for

**ARTS CENTRE WASHINGTON,
FATFIELD, WASHINGTON**

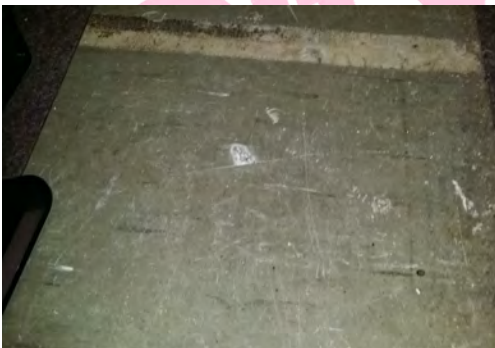
Item 3 Ref: 106990-7

The vinyl floor tiles to the store in the main building (Room 007) do not contain asbestos.

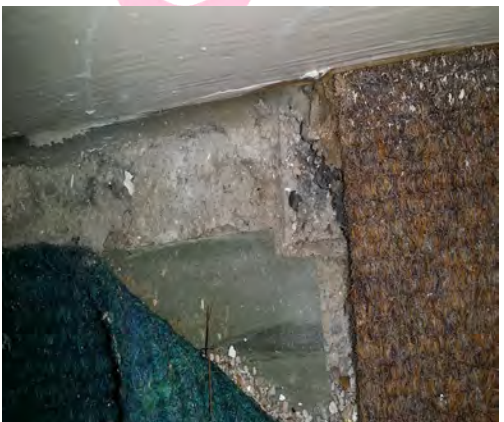
Item 9 As: 106990-8

The vinyl flooring to the corridor in the main building (Room 023) does not contain asbestos.

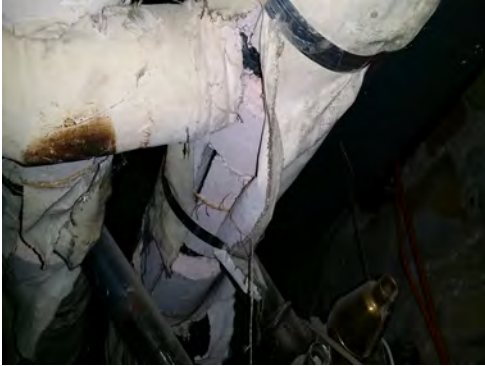
Item 10 Ref: 106990-10

The pipe lagging in the ceiling void of the lobby in the main building (Room 027) does not contain asbestos.

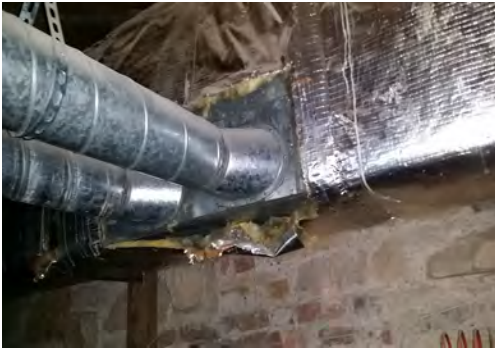
Item 11 Ref: 106990-11

The sealant to the ducts of the air handling duct work to the ceiling void above the male WC (Room 030) does not contain asbestos.

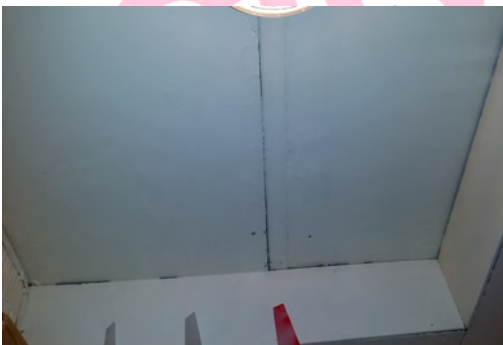
Item 12 Ref: 106990-3

The ceiling to the lobby in the main building (Room 054) contains asbestos.

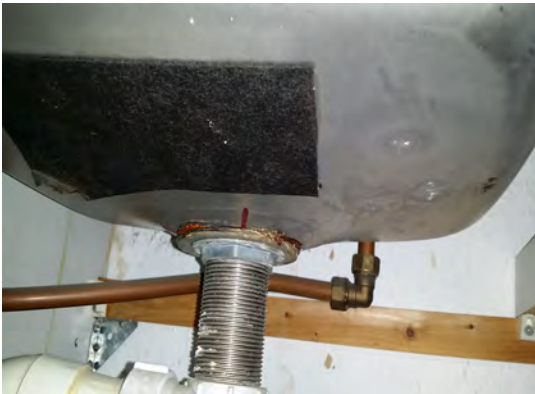
Item 14 Ref:106990-2

The sink pad in Studio 1 of main building (Room 058) does not contain asbestos.

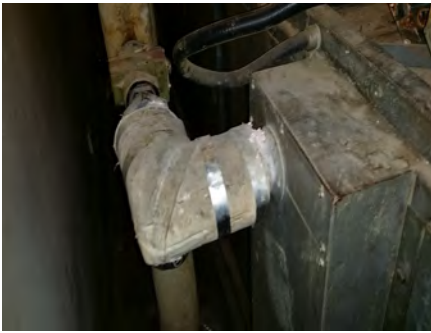
Item 16 Ref: 106990-12

The pipe lagging to the plant room in the main building (Room 005) does not contain asbestos.

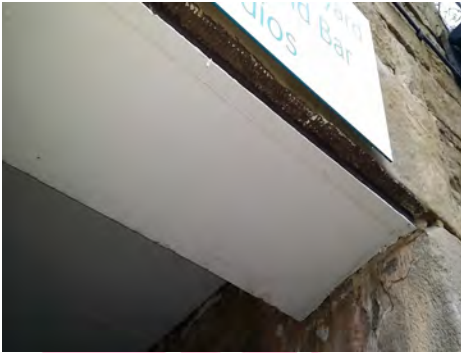
Item 17 Ref: 106990-15

The boxing above the walkway between the sub-station and studio 10 to the external contain asbestos.

Any change in its appearance should be recorded and passed to Property Services.

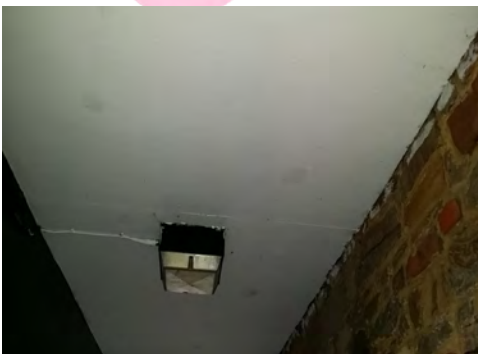
Item 18 Ref: 106990-16

The soffit above the walkway between the sub-station and studio 10 to the external contain asbestos.

Removed January 2020

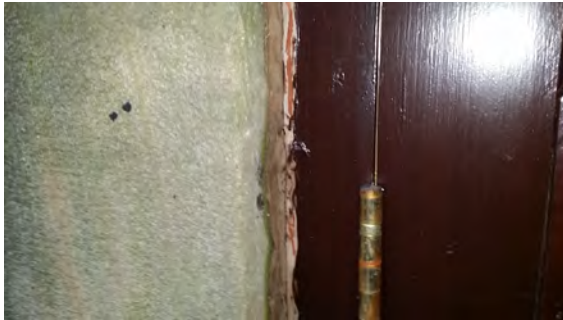
Item 19 Ref: 106990-17

The sealant to the door frame and windows to the external of the main building contains asbestos.

Any change in its appearance should be recorded and passed to Property Services.

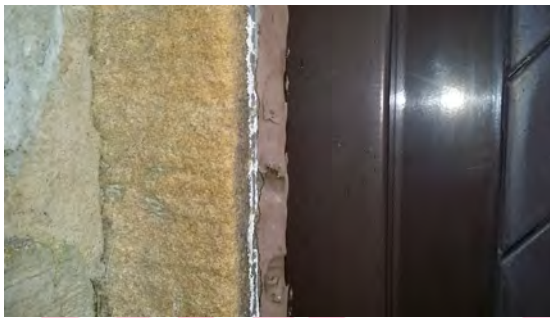
Item 20 Ref: 106990-18

The sealant to the door frame and windows to the external of the studios does not contain asbestos.

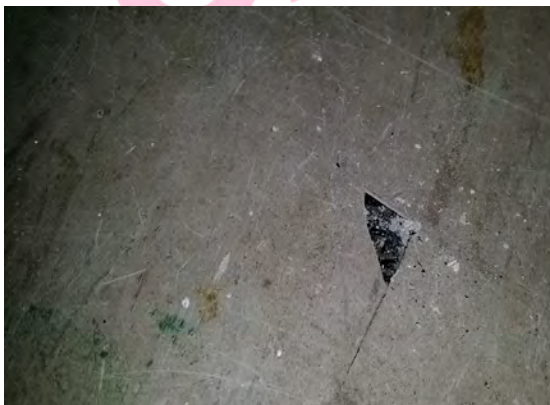
Item 21 Ref: 106990-4

The floor tiles to the store in unit 6 Studio (Room 003) contain asbestos.

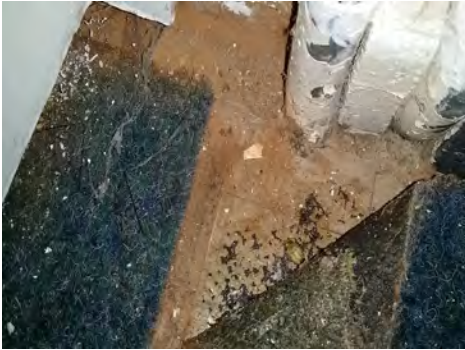
Item 22 As: 106990-4

The floor tiles and adhesive to the floor in the Corridor in Unit 6 Studio (Room 004) contains asbestos.

Removed October 2020

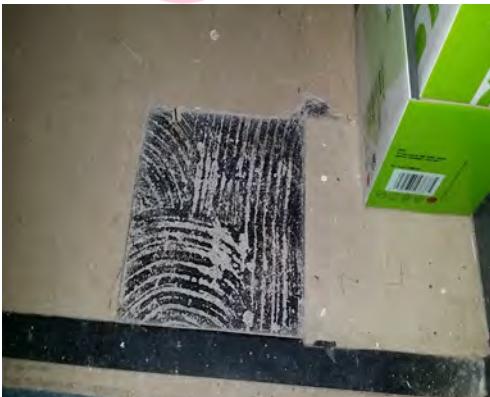
Item 24 As: 106990-4

The floor tiles and adhesive to the floor in the lobby in Unit 6 (Room 6) Studio contains asbestos.

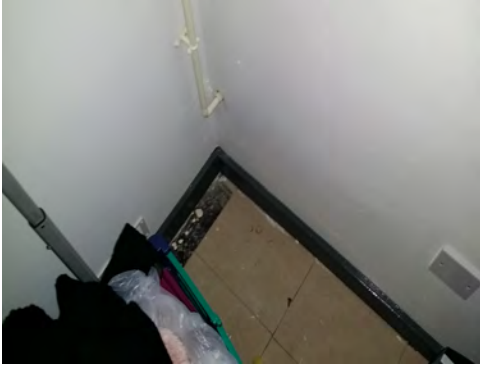
Item 25 As: 106990-4

The floor tiles and adhesive to the floor in the store in Unit 6 Studio (Room 007) contains asbestos.

Any change in its appearance should be recorded and passed to Property Services.

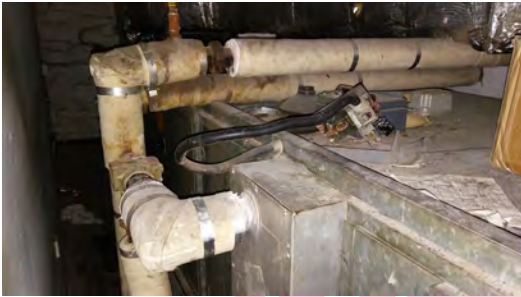
Item 26: 234441-1

The pipe lagging in the plant room (Room 001) does not contain asbestos.

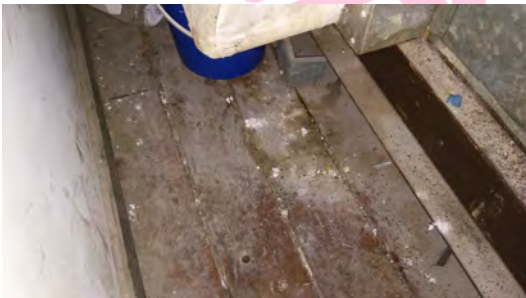
Item 27: 234441-2

The pipe lagging debris to the floor adjacent to entrance in the plant room (Room 001) does not contain asbestos.

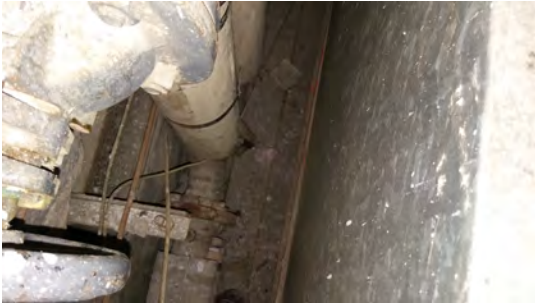
Item 28: 234441-3

The pipe lagging debris to the floor and horizontal surfaces near LHS elevation in the plant room (Room 001) does not contain asbestos.

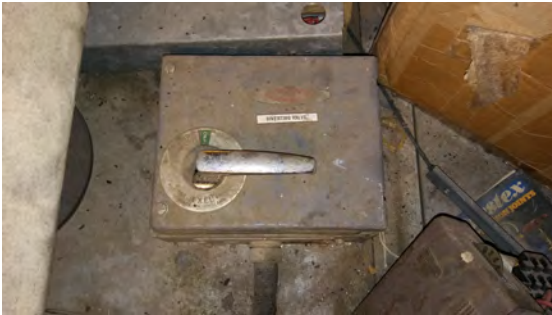
Item 29: Presumed

The electrics in the plant room (Room 001) are presumed to contain asbestos.

Item 28	No asbestos	Is present		
Item 29	Electrics - Room 001	Presumed	6 monthly	Noted as removed – No WCN paperwork received
Item 30	Pipework Flange Gasket – Room 001	Presumed	6 monthly	Removed 2024

Removed May 2024 but no WCN received

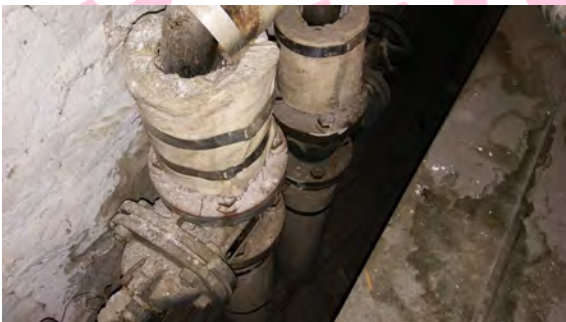
Item 30: Presumed

The pipework flange gasket adjacent to rear wall in the plant room (Room 001) are presumed to contain asbestos.

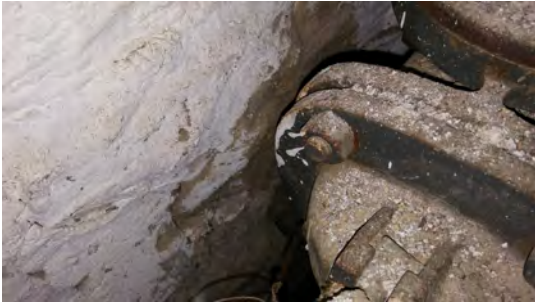
Item 31: 234441-4

The pipe lagging debris to the walls in the plant room (Room 001) does not contain asbestos.

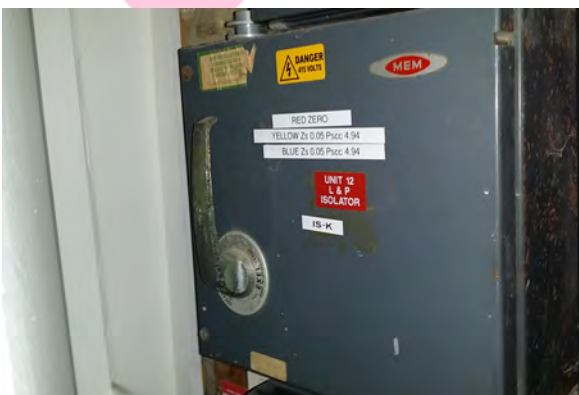
Item 39: Presumed (106990)

The electrics in the workshop (Room 053) is presumed to contain asbestos.

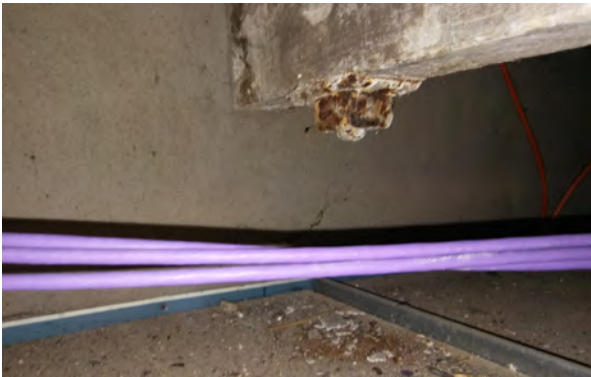
Item 44 Ref: As 349632-1

The debris to beams and void in the ceiling void above the store (Room 007) does not contain asbestos.

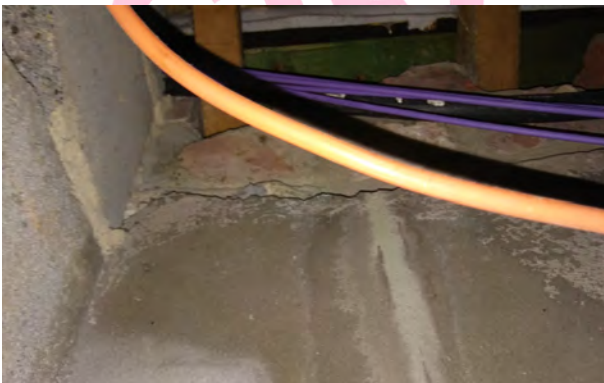
Item 45 Ref: As 349632-32

The felt to wall top along cable route in the ceiling void above the store (Room 007) does not contain asbestos.

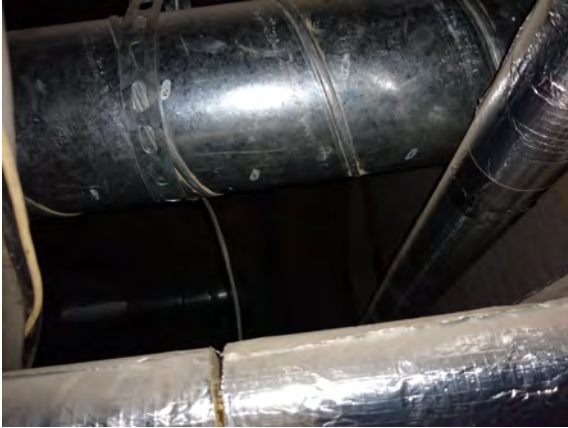
Item 55 Ref: 76353-2

The mastic to ductwork (Rm 003/Female WC void above) does not contain asbestos.

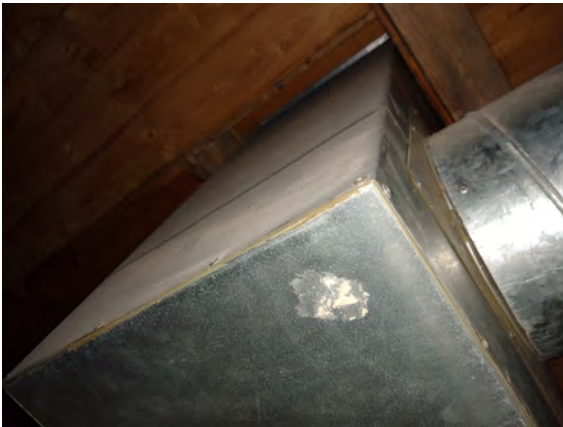
Item 56 Ref: As 76353-2

The mastic to ductwork (Rm 004/Male WC void above) does not contain asbestos.

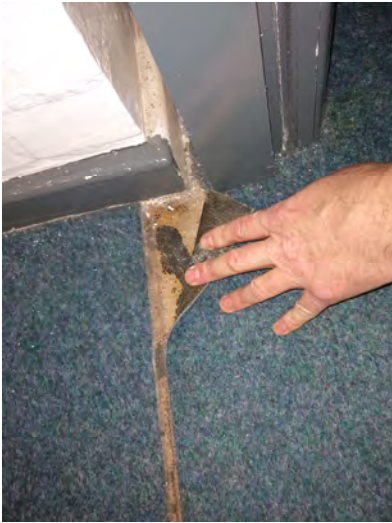
Item 83 Ref: 371873-9

The floor covering (Rm 067/ukulele music room) does contain asbestos.

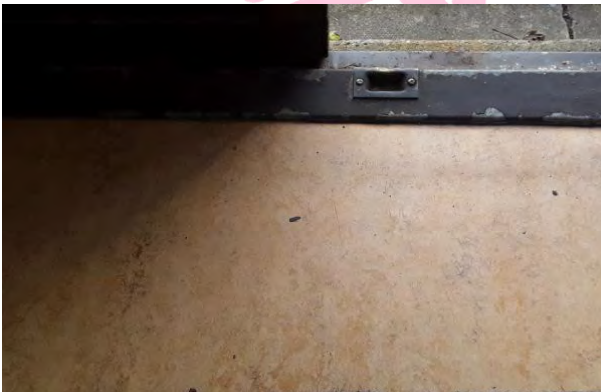
Item 103 Ref: 20-27852-2

The vinyl flooring in the rear – side fire exit doorway does not contain asbestos.

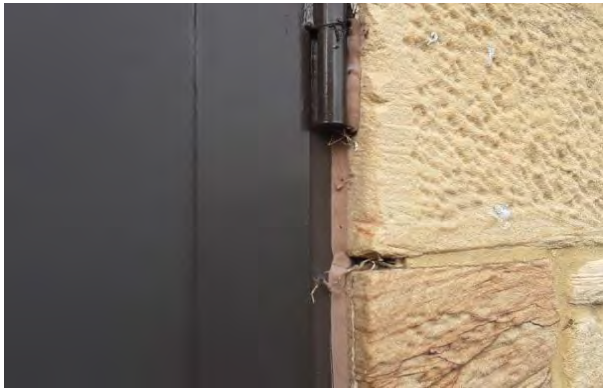
Item 104 Ref: 20-27852-3

The door frame sealant to rear – side fire exit doorway does not contain asbestos.

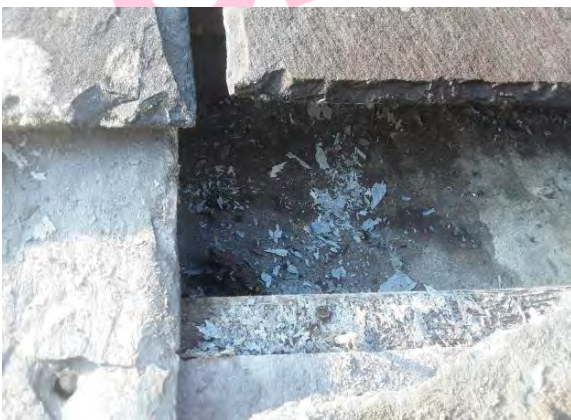
Item 109 Ref: 21-378903-4

The roof sarking felt (Bitumen) (Area 2/Roof Area 2) does not contain asbestos.

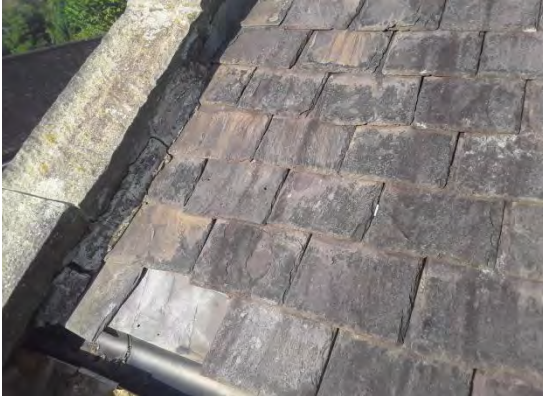
Item 110 Ref: 21-378903-5

The roof sarking felt (Bitumen) (Area 3/Roof Area 3) does not contain asbestos.

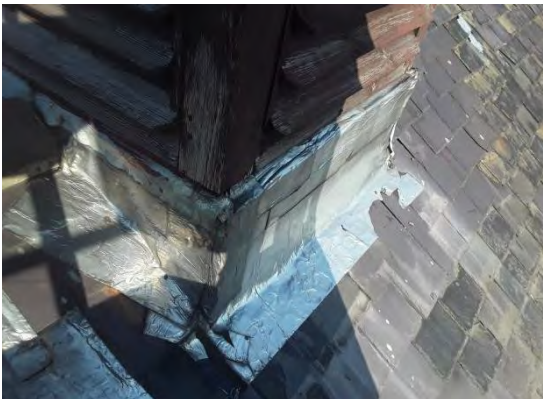
Item 111 Ref: 21-378903-6

The flashing to roof vents (Bitumen) (Area 3/Roof Area 3) does not contain asbestos.

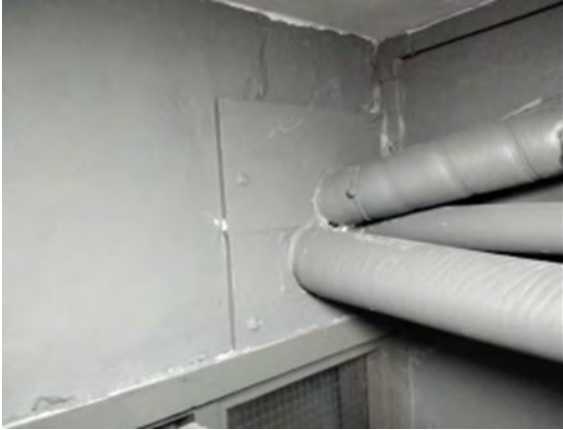
Item 113 Ref: KX001131

The pipe penetration panel above inner door in the Corridor (Room 29) does not contain asbestos.

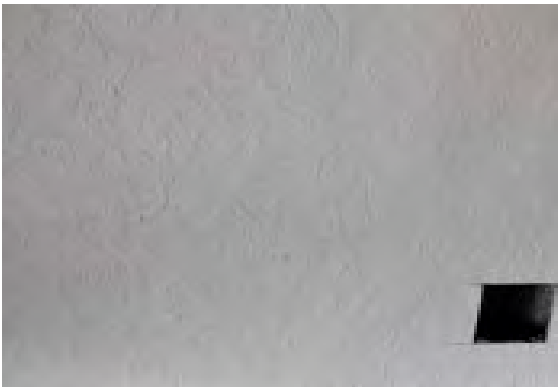
Item 114 Ref: SC004788

The adhesive residues below modern floor covering in the Granary Bar and Shop (Room G/001) does not contain asbestos.

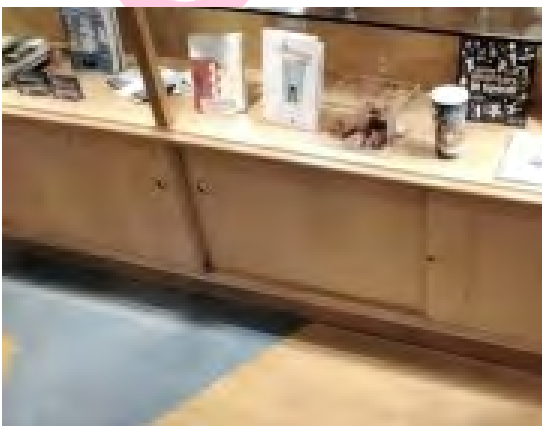
Item 115 Ref: SC004787

The debris/residue within plasterboard partition to brick/block and plaster in the Granary Bar and Shop (Room G/001) does not contain asbestos.

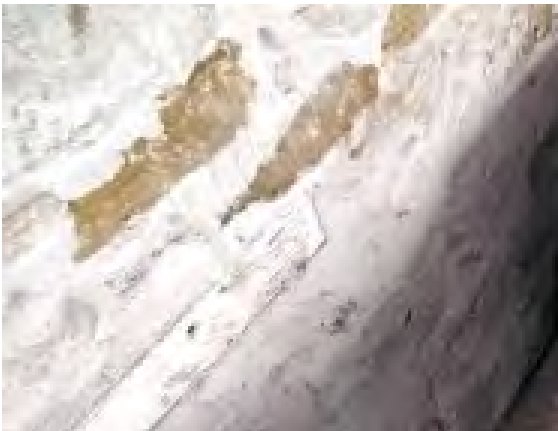
Item 118 Ref: SC004282

The wall – Plug/Packing in Plant Room does not contain asbestos.

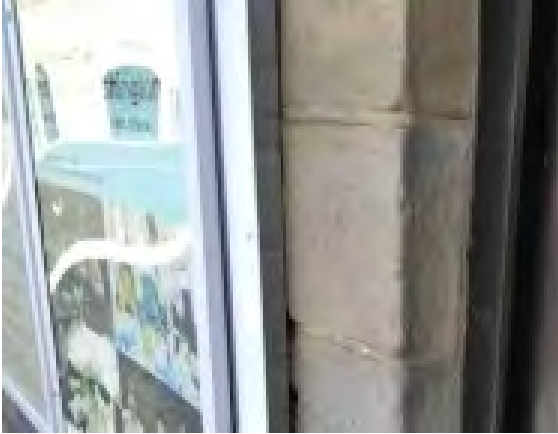
Item 128 Ref: AW005891

The brown door frame sealant External to Studio Building does not contain asbestos.

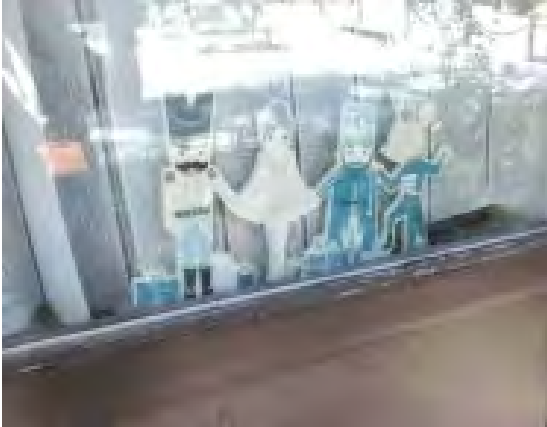
Item 131 Ref: AW005894

The window remains of old sealant External to Main Building does not contain asbestos.

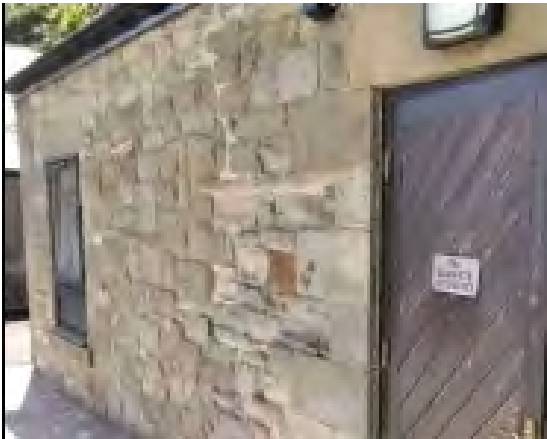
Item 132 Ref: AW005895

The brown door frame sealant External to Main Building does not contain asbestos.

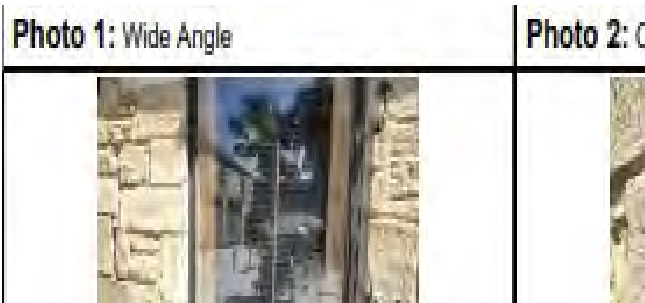
Item 136 Ref: AW005899

The window remains of old
sealant External to Main
Building does contain
asbestos.

Any change in appearance
should be reported to
Property Services.

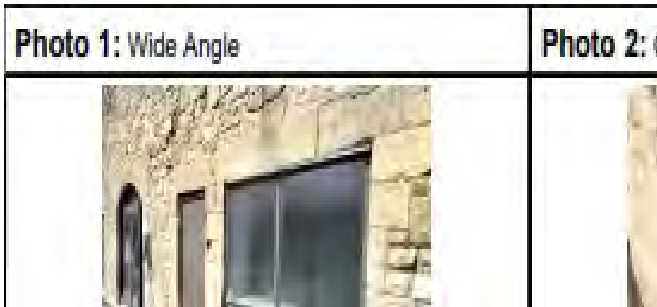
Item 138 Ref: AW005901

The window remains of old sealant External to Main Building does contain asbestos.

Item 137	No asbestos	Is present		
Item 138	Window remains of old sealant (External Main Building E/002)	Medium	3 monthly	Noted as removed – No WCN paperwork received

Any change in appearance should be reported to Property Services.

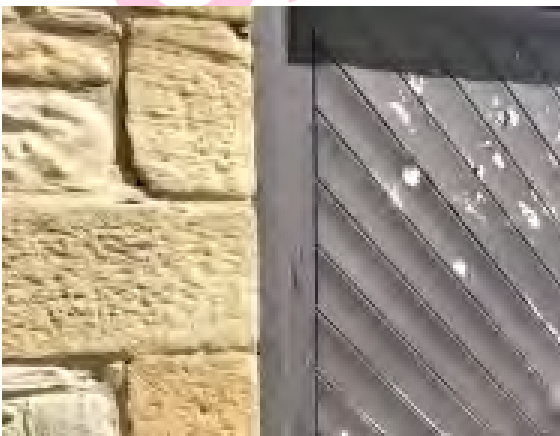
Item 139 Ref: AW005902

The door remains of old sealant External to Main Building does not contain asbestos.

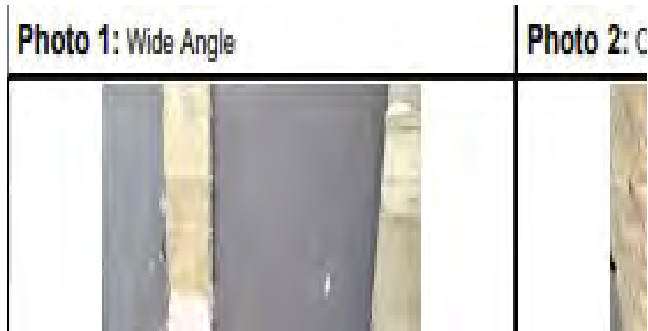
Item 140 Ref: AW005903

The door remains of old sealant External to Main Building does contain asbestos.

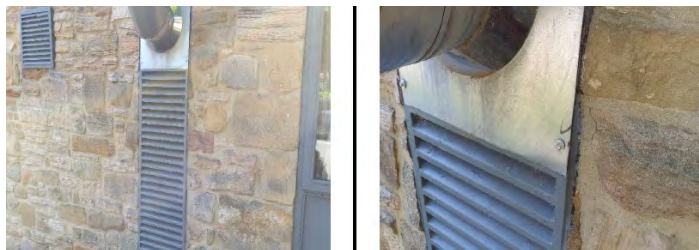
Item 142 Ref: RT000807

The Mastic seal - to louvered panel (External Cable Run, E/01) contains asbestos.
