ASBESTOS SURVEY REPORT FOR 64 FAWCETT STREET, SUNDERLAND, SR1 1BB.

Asbestos Register for

64 Fawcett Street, Sunderland, SR1 1BB

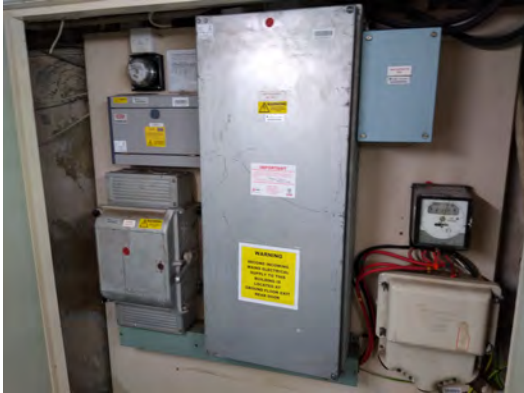
Item 10 Ref: Presumed

The flashguards within 'Bill' electrics in the electric cupboard in the store Store (Room -1/003a) are presumed to contain asbestos.

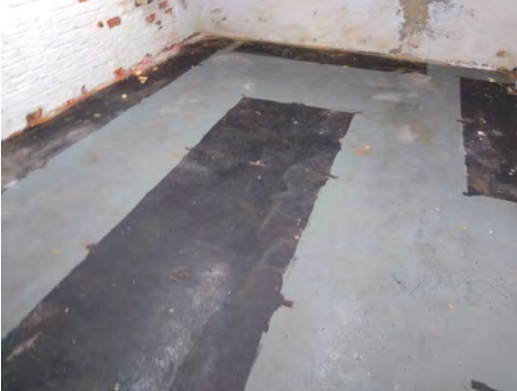
Item 13 Ref: As 347395-6

The coating to the floor in the Store (Room -1/004) does not contain asbestos.

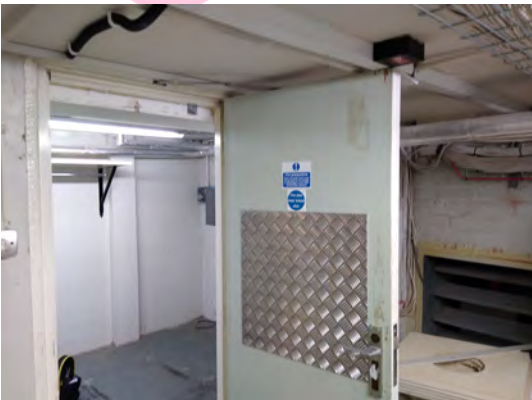
Item 15 Ref: 347395-9

The panel within the door on the boiler room (Room -1/005) contains asbestos.

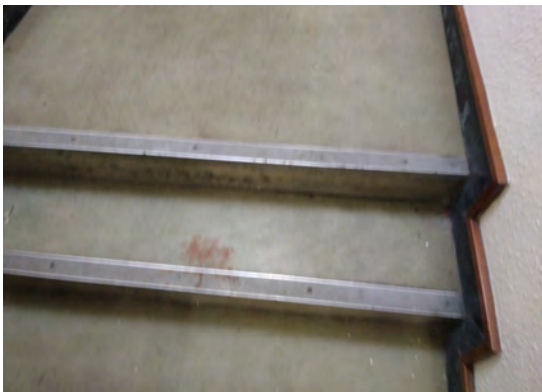
Item 17 Ref: As 347395-1

The stair nosing in the corridor (Room -1/006) does not contain asbestos.

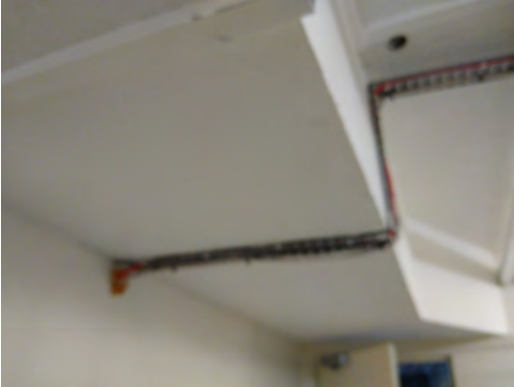
Item 19 Ref: 347395-11

The coating to the boxing in the corridor (Room -1/006) contains asbestos.

Any change in appearance should be reported to Property Services.

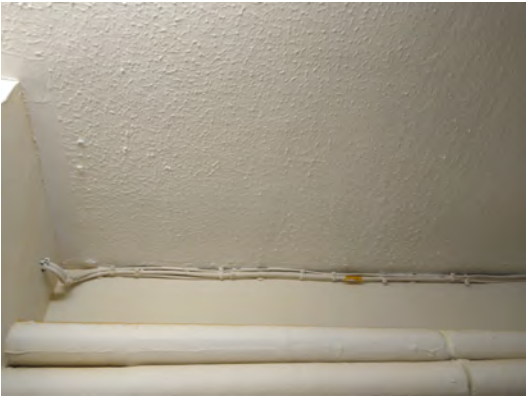
Item 20 Ref: 347395-12

The coating to the ceiling in the corridor (Room -1/006) contains asbestos.

Any change in appearance should be reported to Property Services.

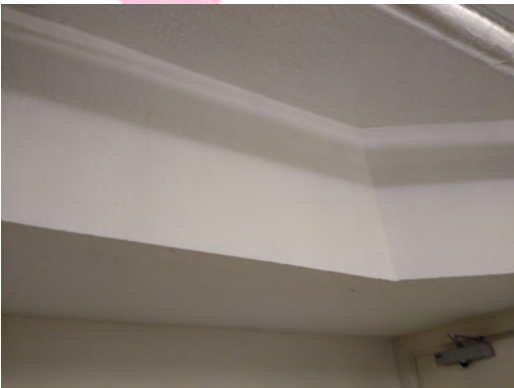
Item 21 Ref: As 347395-3

The boxing in the corridor (Room -1/006) does not contain asbestos.

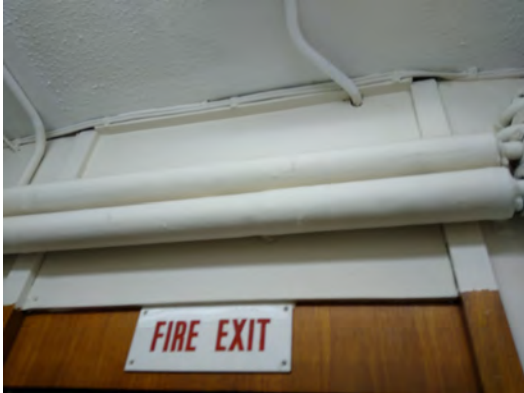
Item 22 Ref: As 347395-8

The panel above the door in the corridor (Room -1/006) does not contain asbestos.

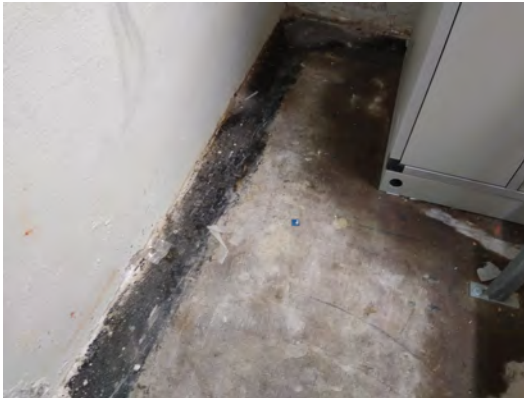
Item 23 Ref: As 347395-6

The coating to the floor in the boiler room (Room -1/007) does not contain asbestos.

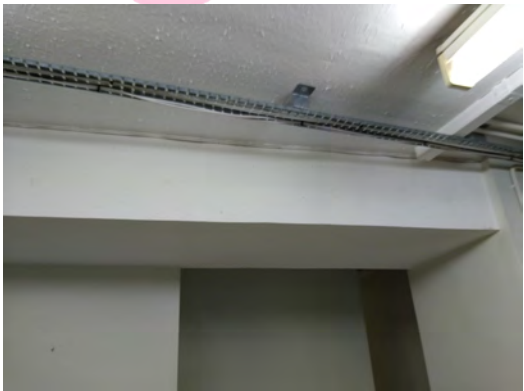
Item 24 Ref: As 347395-11

The coating to duct boxing in the lobby and circulation area (Room -1/008) does contain asbestos.

Any change in appearance should be reported to Property Services.

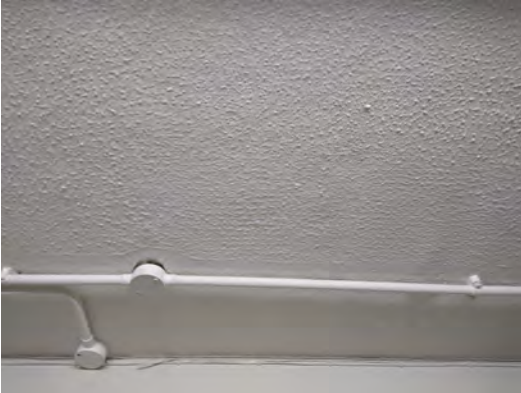
Item 25 Ref: As 347395-12

The coating to the ceiling in the lobby and circulation area (Room -1/008) does contain asbestos.

Any change in appearance should be reported to Property Services.

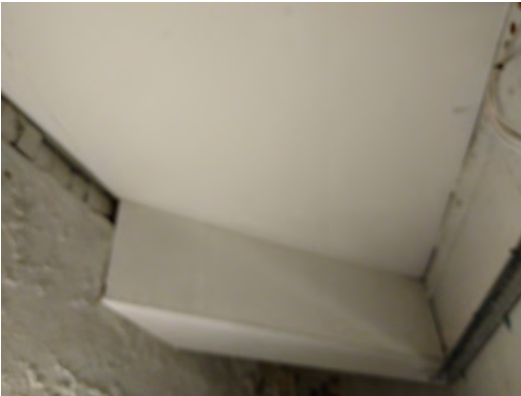
Item 26 Ref: 347395-13

The ceiling and boxing to circulation area (Room -1/008) does not contain asbestos.

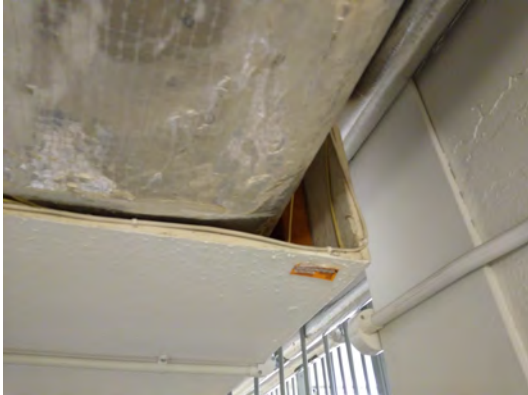
Item 28 Ref: As 347395-3

The boxing to front of vault in the lobby and circulation area (Room -1/008) does not contain asbestos.

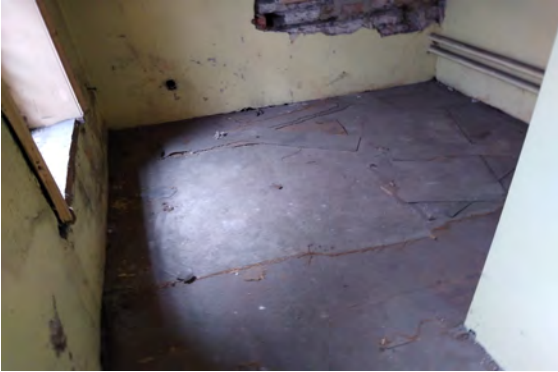
Item 61 Ref: As 347395-33

The floor covering in the store (Room 2/006) does not contain asbestos.

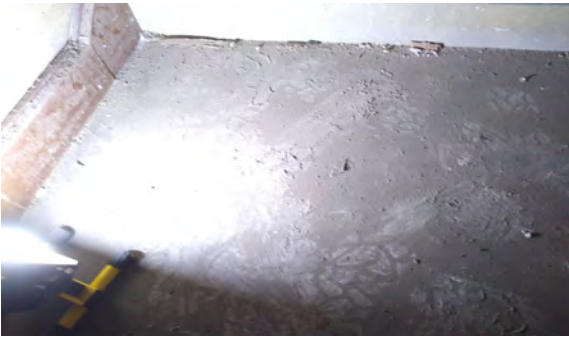
Item 76 Ref: 349273-4

The floor covering (Redundant Stairwell Rm 0/09a) does not contain asbestos.

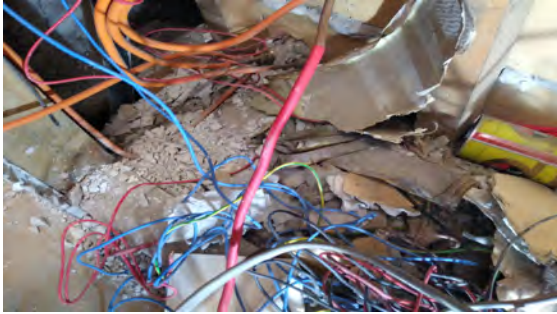
Item 79 Ref: 349273-7

The debris to floor (Redundant Stairwell Rm 0/09a) does not contain asbestos.

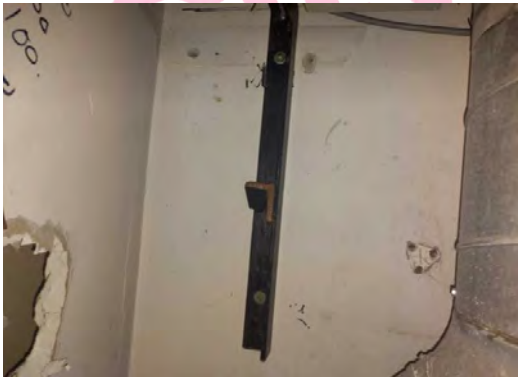
Item 81 Ref: 21-39587-3

The external wall - plaster (Area 2/Cupboard) does not contain asbestos.

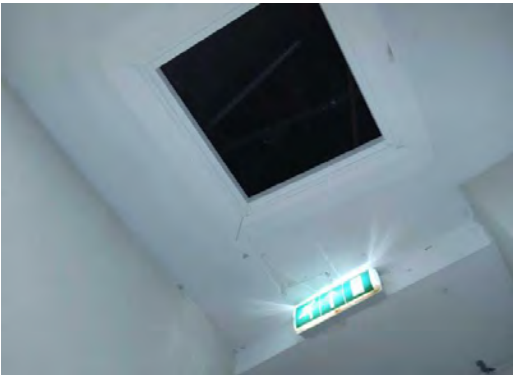
Item 88 Ref: 21-39587-9

The ceiling – plasterboard area around open ceiling (Area 5/Lobby Adjacent to Emergency Exit) does not contain asbestos.
