ASBESTOS SURVEY REPORT FOR FORMER AWARDS CENTRE
HAVELOCK TOWERS, 270A HYLTON ROAD, SUNDERLAND, SR4 7XJ

**Asbestos Register for
Havelock Towers, 27a Hylton Road,
Sunderland, SR4 7XJ**

Date: 16 November 2022

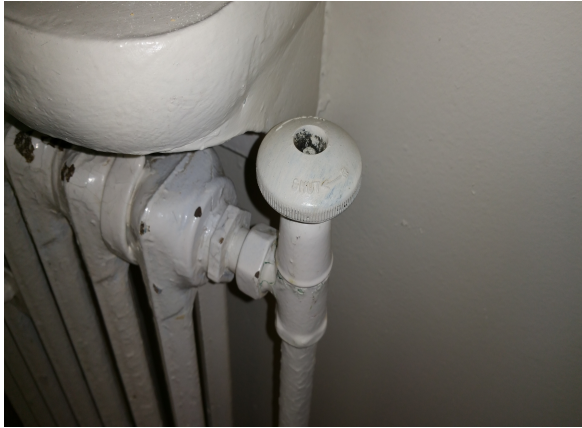
Item 22 Ref: 149012-10

The radiator knob in the female WC (Rm 1/02) does not contain asbestos.

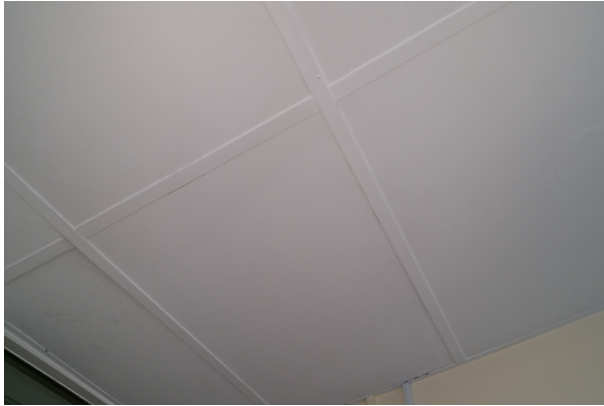
Item 40 Ref: As 149012-7

The suspended ceiling in the staff room (Rm 1/10) does not contain asbestos.

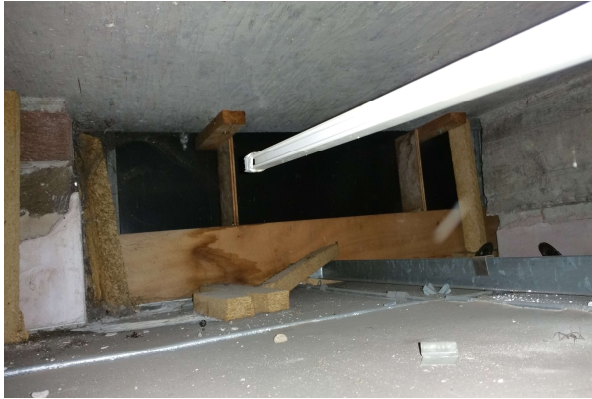
Item 49 Ref: As 149012-3

The sealant to windows in the office ceiling void (Rm 2/04) does not contain asbestos.

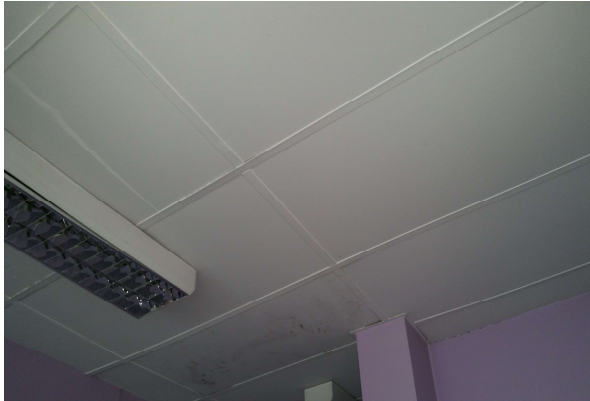
Item 55 Ref: As 149012-7

The suspended ceiling in the office (Rm 2/07) does not contain asbestos.

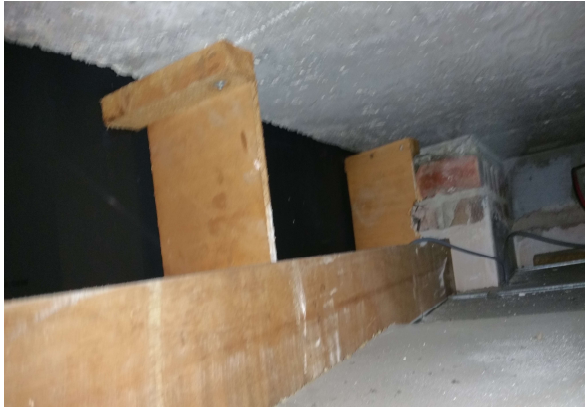
Item 64 Ref: As 149012-3

The sealant to windows in the staff room ceiling void (Rm 2/09) does not contain asbestos.

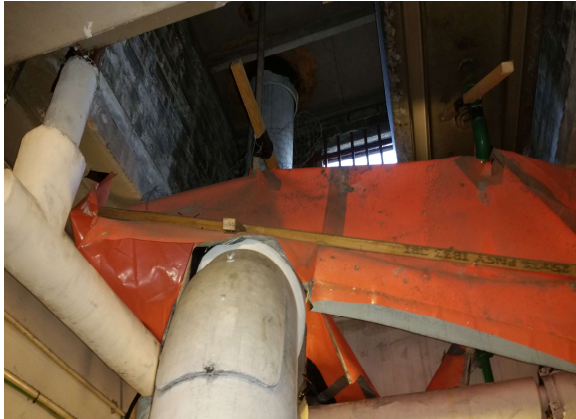
Item 67 Ref: 149012-17

The boiler flue in the boiler room (Rm 2/10) contains asbestos.

Item 66	Gasket to Boiler – Rm 2/10	Low Risk	6 Monthly	23/07/2021
Item 67	Boiler Flue – Rm 2/10	Very Low Risk	12 Monthly	23/01/2022
Item 68	Loose Lying Cartridge Fuses – Rm 2/10	Very Low Risk	12 Monthly	23/01/2022

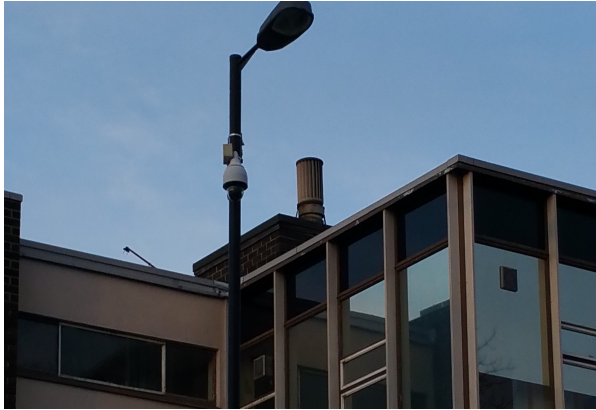
Item 73 Ref: Presumed

The boiler flue cowl
(External) is presumed to
contain asbestos.

Any change in its
appearance should be
recorded and passed to
Property Services.

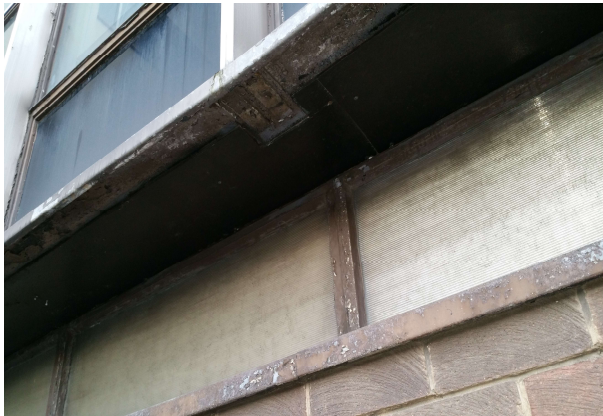
Item 74 Ref: 149012-23

The putty to the windows
(External) does not contain
asbestos.
