ASBESTOS SURVEY REPORT FOR RYHOPE RECREATION PARK, SUNDERLAND

Asbestos Register for Ryhope Park

UPRN: - J552465

TF Ref: PPO049-01-02-03

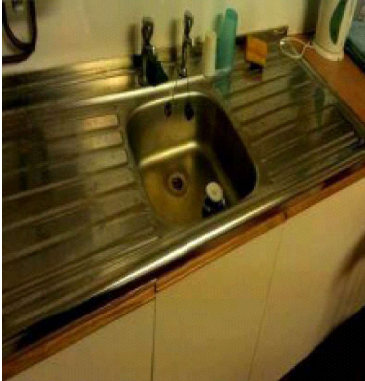
Item 4: Ref EA003365

The sink pads to the female changing area (Room 3) do not contain asbestos.

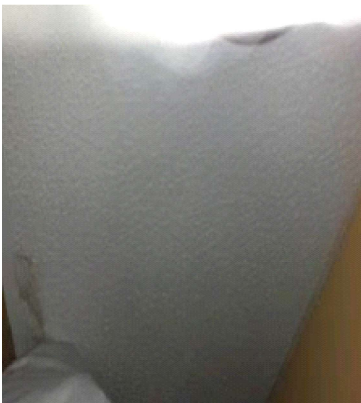
Item 8:Ref: EA003367

The textured coating to the ceiling in the cupboard (Room 6) does not contain asbestos.

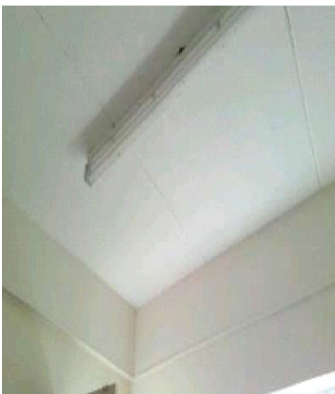
Item 16: Ref: EA003353

The fibreglass ceiling panels to the LHS changing Room (Room 4) do not contain asbestos.

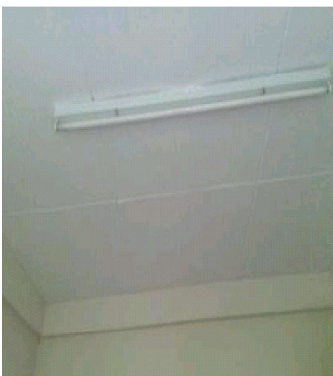
Item 18: As: EA003353

The fibre board ceiling panels to the changing room (RHS) (Room 7) do not contain asbestos.

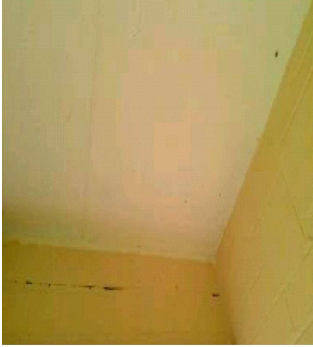
Item 20: As: EA003353

The fibreglass ceiling panels to the lady's toilet (Room 11) do not contain asbestos.

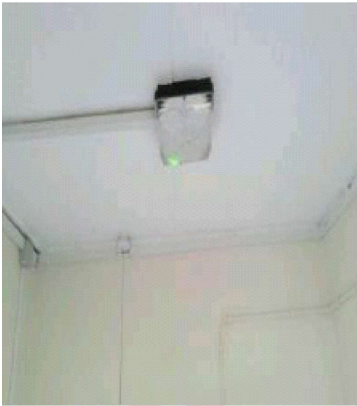
Item 21: As: EA003353

The fibreglass ceiling panels to the disabled toilet (Room 12) do not contain asbestos.

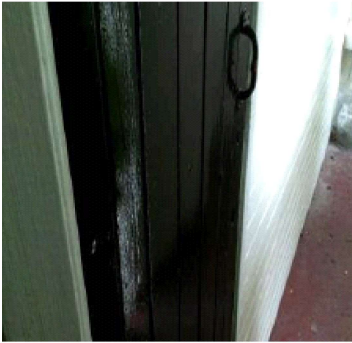
Room 14 (Cupboard) was inaccessible as there was no key. Further investigation will be required.

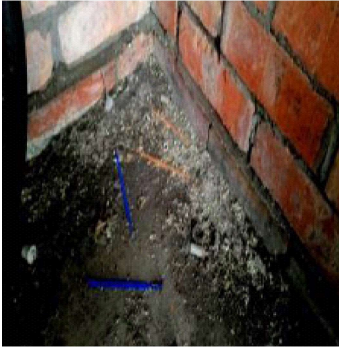
Item 27: Ref: EA003378

The damp proof course to the external of the electrical intake does not contain asbestos.

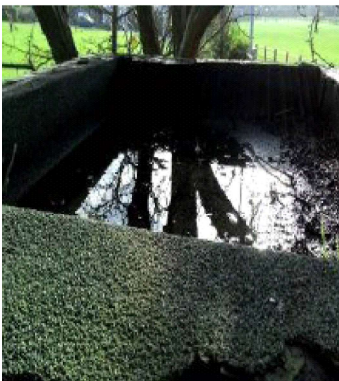
Item 28: Ref: EA003379

The bitumen to the roof of the electrical intake does not contain asbestos.

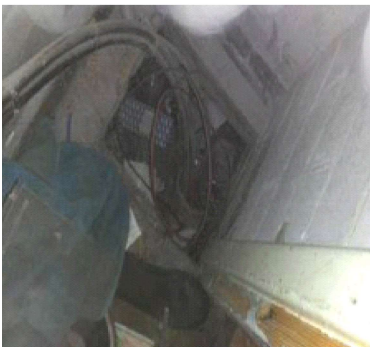
Item 33: Ref: EA003360

The debris to the floor void in the electrical cupboard (Room 7) does not contain asbestos.

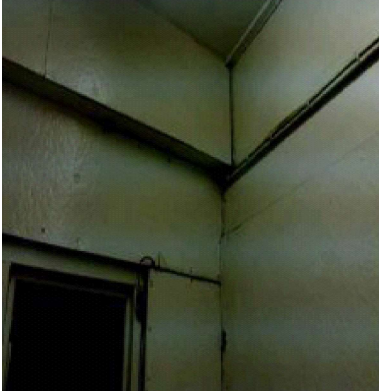
Item 38 Ref:EA003349

The fibreglass cladding to the walls in the office (Room 2) do not contain asbestos.

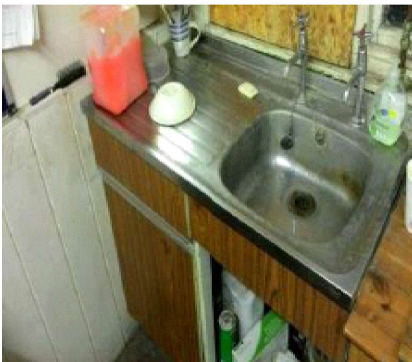
Item 40 Ref: EA003350

The sink pads to the sink and drainer in the staff room (Room 3) do not contain asbestos.
