ASBESTOS SURVEY REPORT FOR FULWELL DAY CENTRE FULWELL ROAD, SUNDERLAND, SR6 9QW.

Asbestos Register for Fulwell Day Centre, Fulwell Road, Sunderland

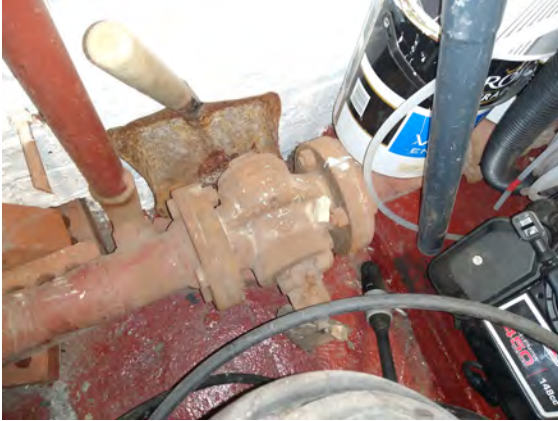
Item 1 Ref: 403866-36

The pipework flange gasket in 0/001/maintenance store contains asbestos.

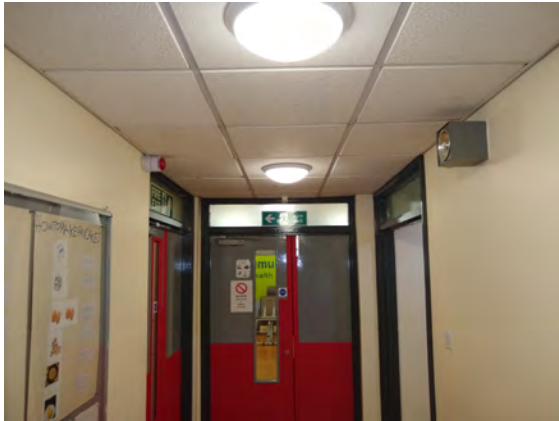
Item 7 Ref: As 403866-31

The putty to glass door headers in 0/018/Corridor does not contain asbestos.

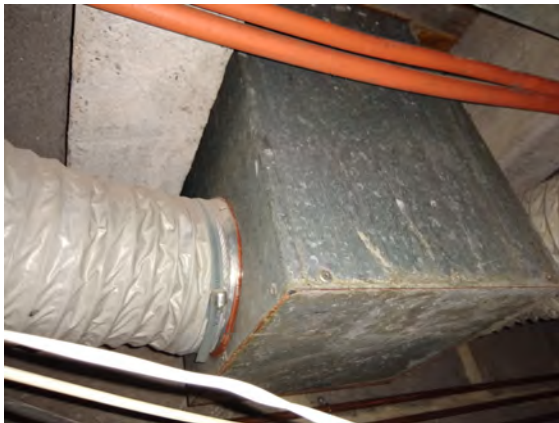
Item 11 Ref: 403866-20

The mastic to ducting in 0/027/Female WC void above contains asbestos.

Any change in its appearance should be recorded and passed to Property Services.

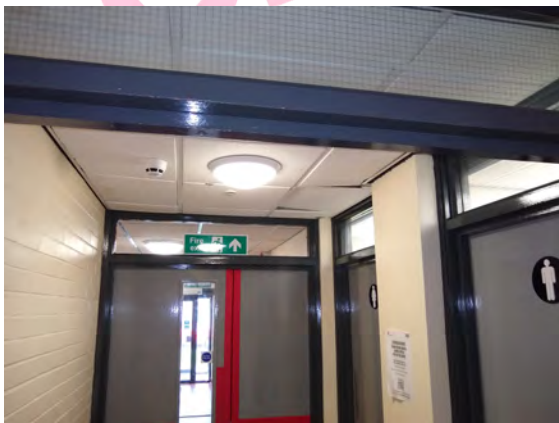
Item 12 Ref: As 403866-19

The putty to glass door headers in 0/030/Corridor to stairwell does not contain asbestos.

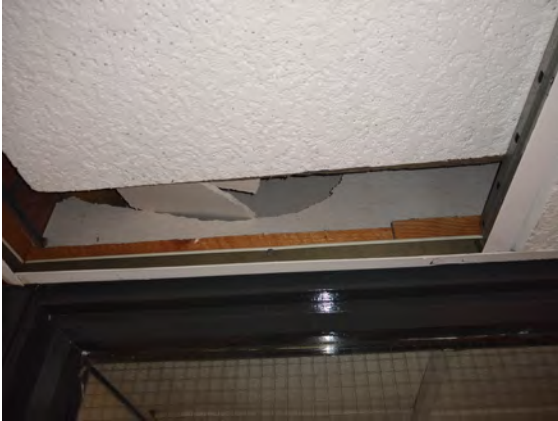
Item 13 Ref: 403866-5

The panels above door in 0/030/Corridor to stairwell – void above does not contain asbestos.

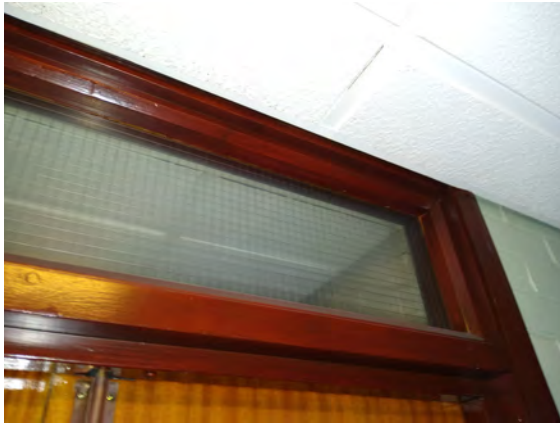
Item 34 Ref: As 403866-13

The sealant to door header glazing in 1/048/Communal lounge does not contain asbestos.

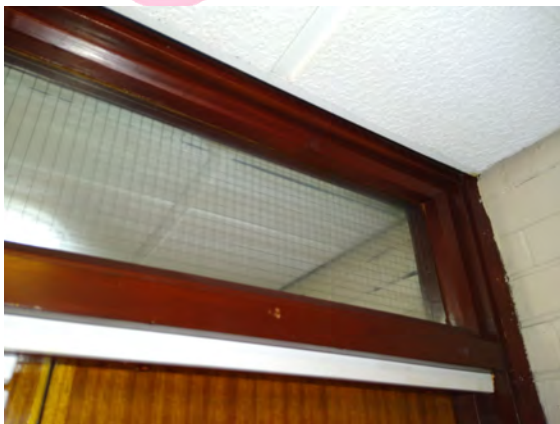
Item 36 Ref: As 403866-13

The sealant to door header glazing in 1/048a/Corridor does not contain asbestos.

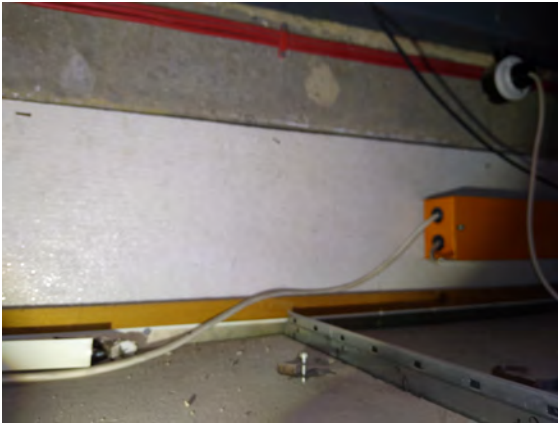
Item 37 Ref: As 403866-14

The panel above door in 1/048a/Corridor ceiling void does not contain asbestos.

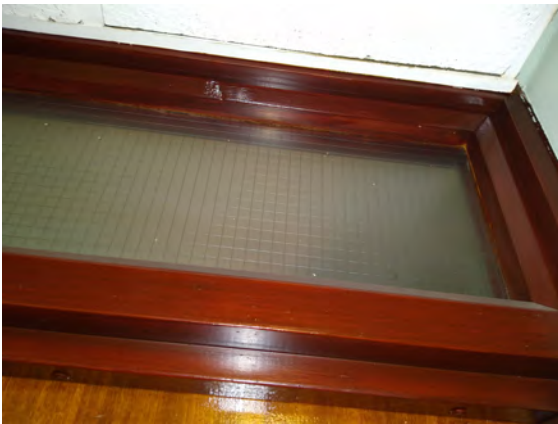
Item 38 Ref: As 403866-13

The sealant to door header glazing in 1/049/Kitchen does not contain asbestos.

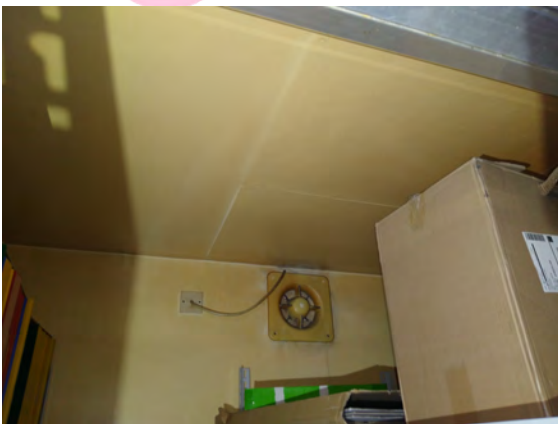
Item 39 Ref: 403866-15

The ceiling behind roller door in 1/049/Kitchen does not contain asbestos.

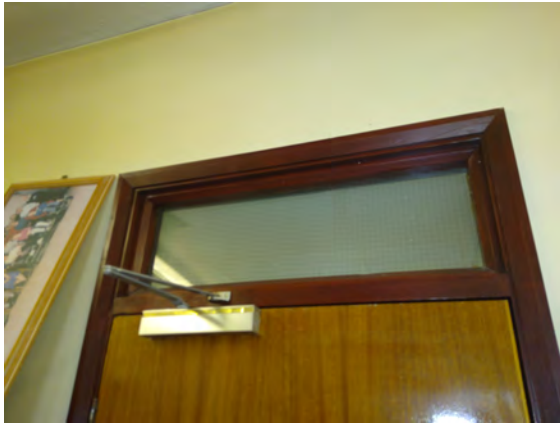
Item 40 Ref: As 403866-13

The sealant to door header glazing in 1/049a/Store does not contain asbestos.

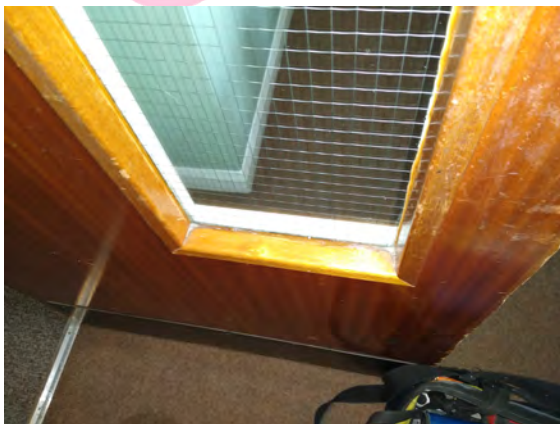
Item 42 Ref: As 403866-7

The sealant to door glazing in 1/050/Kitchen and dining room does not contain asbestos.

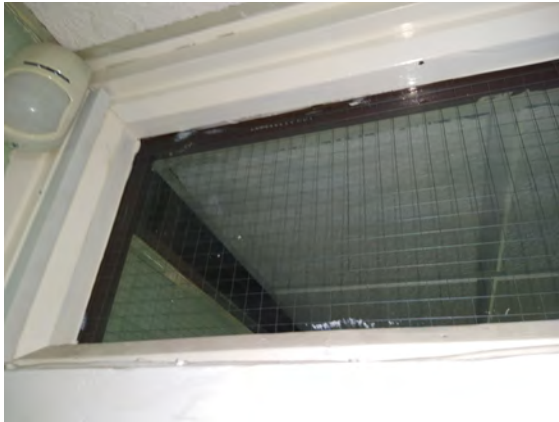
Item 43 Ref: As 403866-13

The sealant to door header glazing in 1/050/Kitchen and dining room does not contain asbestos.

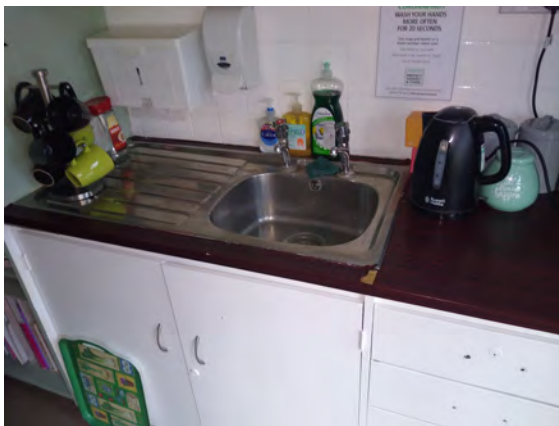
Item 44 Ref: As 403866-10

The sink pad in 1/050/Kitchen and dining room does not contain asbestos.

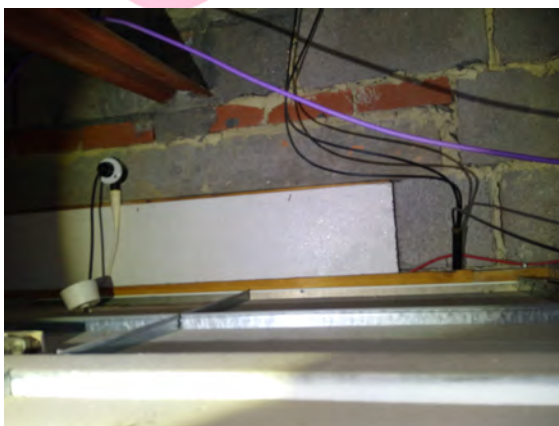
Item 45 Ref: As 403866-14

The panel above door in 1/050/Kitchen and dining room void above does not contain asbestos.

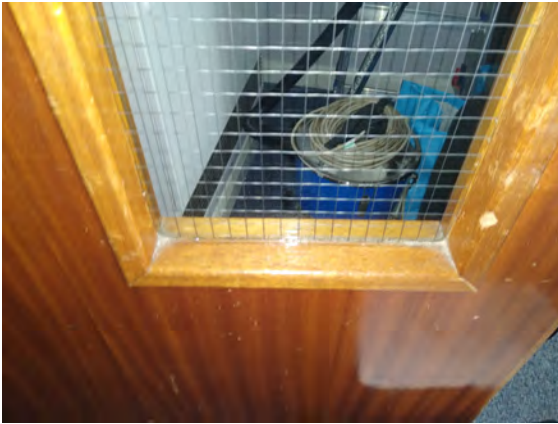
Item 46 Ref: As 403866-7

The sealant to door glazing in 1/051/Office does not contain asbestos.

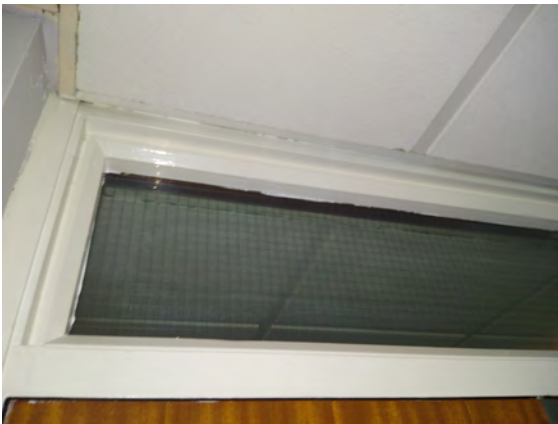
Item 47 Ref: As 403866-13

The sealant to door header glazing in 1/051/Office does not contain asbestos.

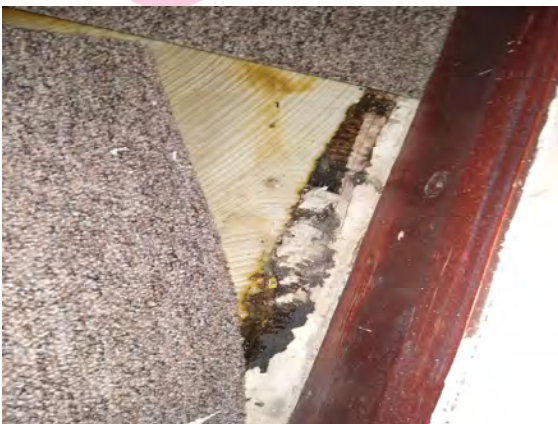
Item 48 Ref: 403866-12

The floor covering in 1/053a/ Corridor does not contain asbestos.

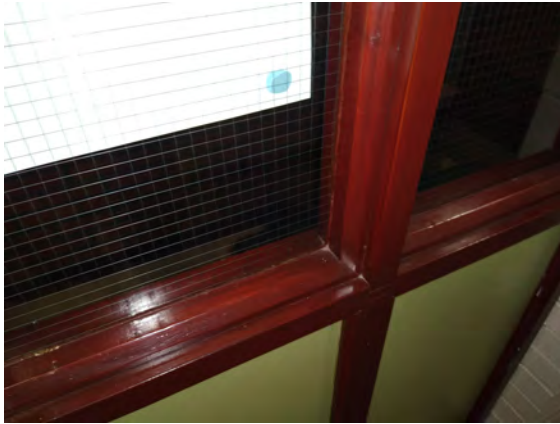
Item 49 Ref: 403866-13

The sealant to stairwell glazing in 1/053a/Corridor does not contain asbestos.

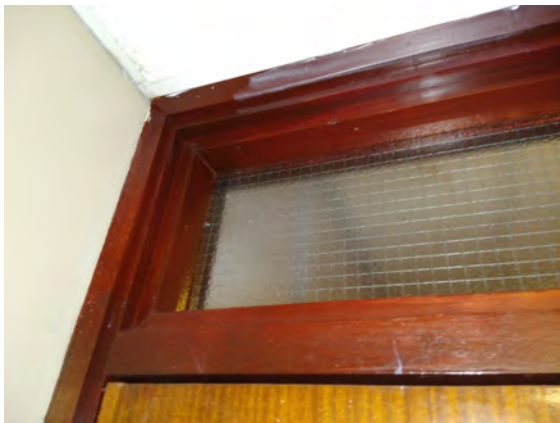
Item 51 Ref: As 403866-13

The sealant to door header glazing in 1/053a/Corridor does not contain asbestos.

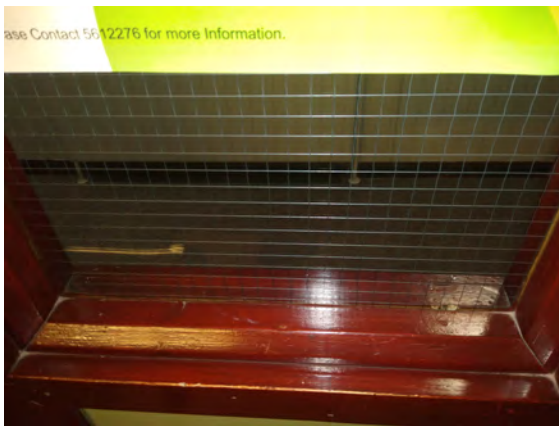
Item 53 Ref: As 403866-13

The sealant to stairwell glazing in 1/053b/Stairwell does not contain asbestos.

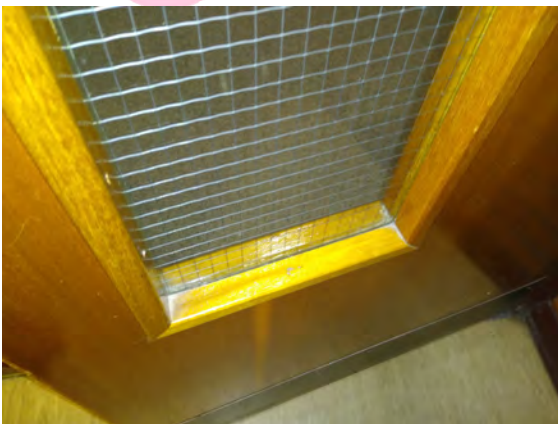
Item 54 Ref: As 403866-7

The sealant to door glazing in 1/053b/Stairwell does not contain asbestos.

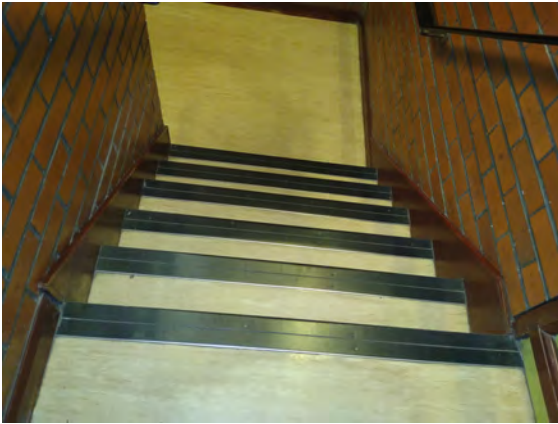
Item 55 Ref: 403866-24

The stair nosing in 1/053b/
Stairwell does not contain
asbestos.

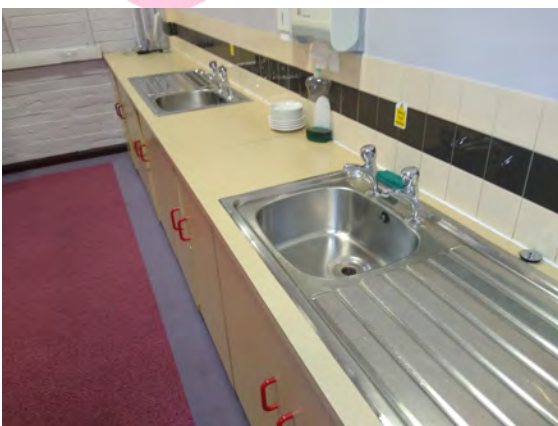
Item 57 Ref: 403866-10

The sink pad in 1/056/
Communal room does not
contain asbestos.

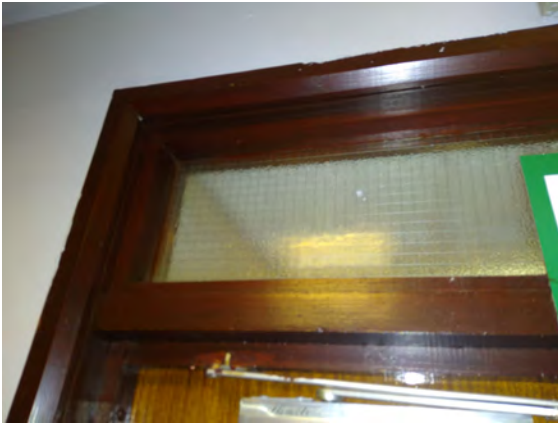
Item 58 Ref: As 403866-13

The sealant to door header glazing in 1/056/Communal room does not contain asbestos.

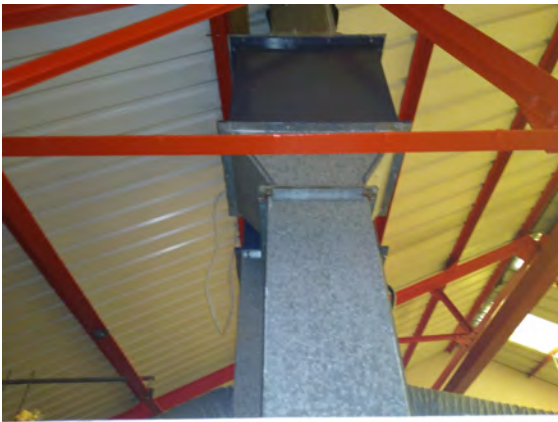
Item 59 Ref: 403866-11

The mastic to ducting in 1/056/Communal room – ceiling void contains asbestos.

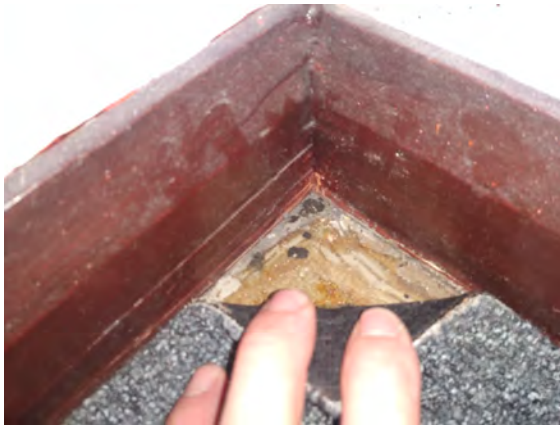
Item 61 Ref: As 403866-6

The subfloor covering in 1/057/Kitchen and lounge does not contain asbestos.

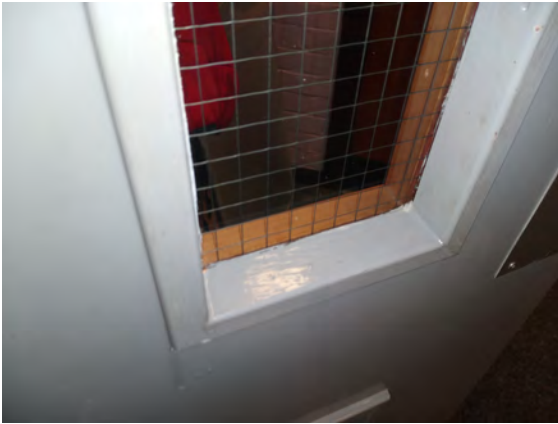
Item 64 Ref: 403866-7

The sealant to door glazing in 1/057/Stairwell and landing does not contain asbestos.

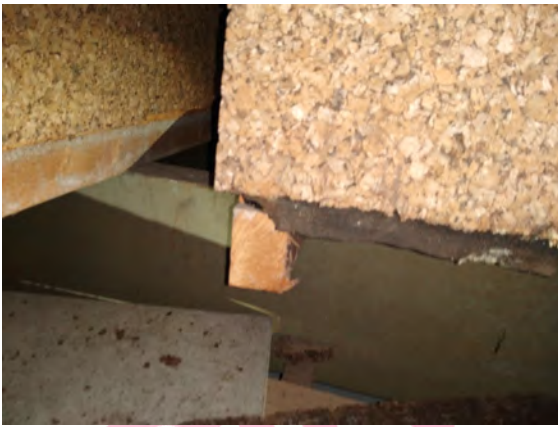
Item 65 Ref: 403866-9

The packer between tank and plinth in 1/057a/stairwell and landing ceiling void does not contain asbestos.

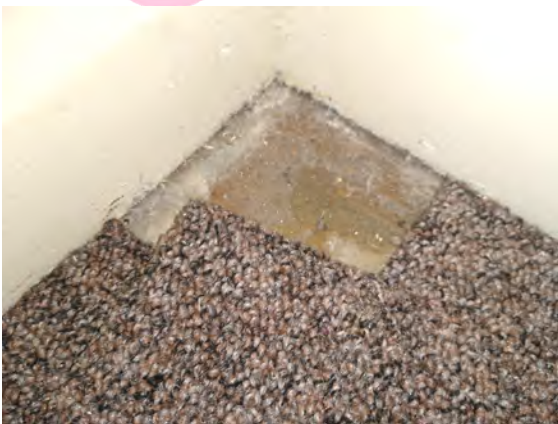
Item 66 Ref: As 403866-6

The subfloor covering in 1/058/Store does not contain asbestos.

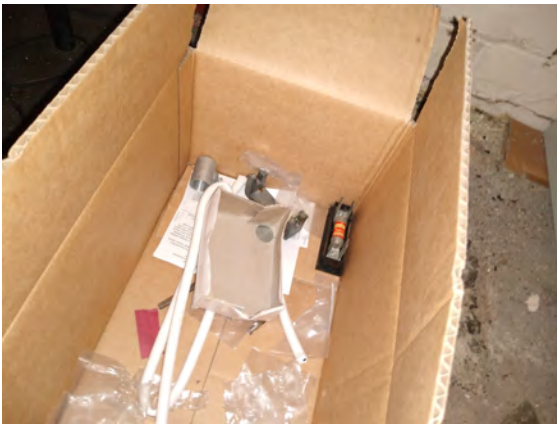
Item 68 Ref: Presumed

The end caps within redundant fuse in 1/059/Store are presumed to contain asbestos.

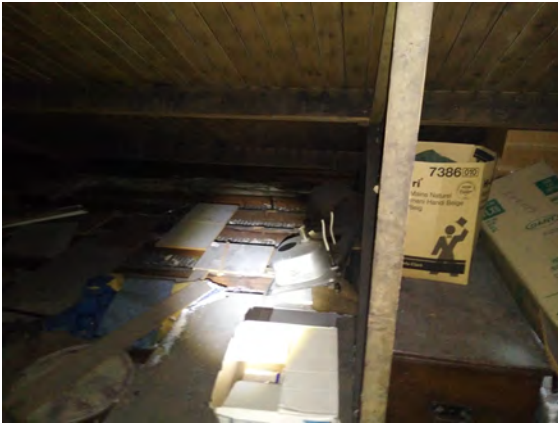
Item 70 Ref: As 403866-10

The sink pad to redundant sink in 1/060a/roof space does not contain asbestos.

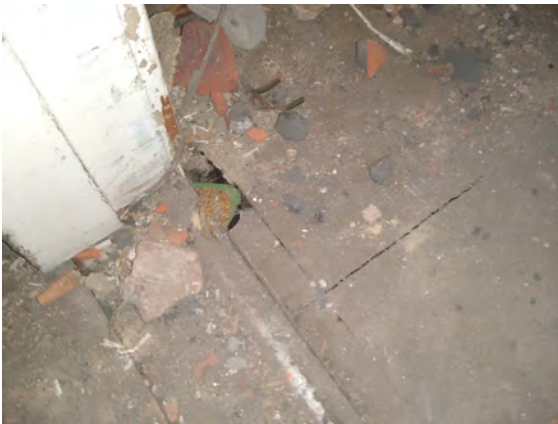
Item 71 Ref: 403866-26

The floor covering in 1/060b/Roof space does not contain asbestos.

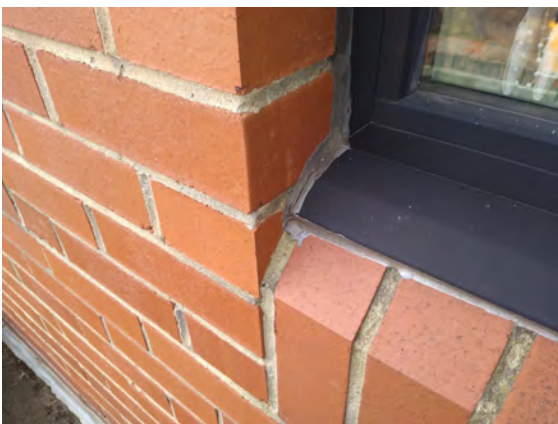
Item 72 Ref: 403866-21

The sealant to window door frames (Balcony) does not contain asbestos.

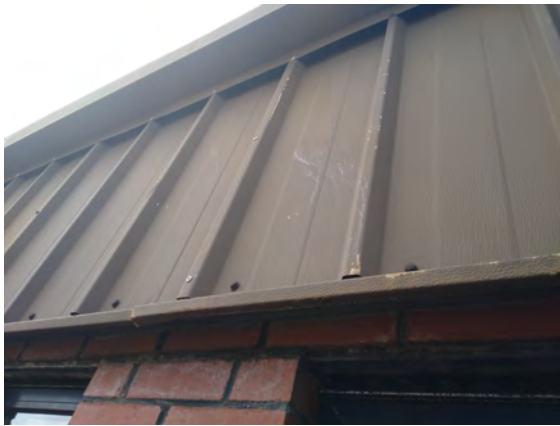
Item 73 Ref: 403866-22

The coating to corrugated wall cladding and fascia (Balcony) does not contain asbestos.

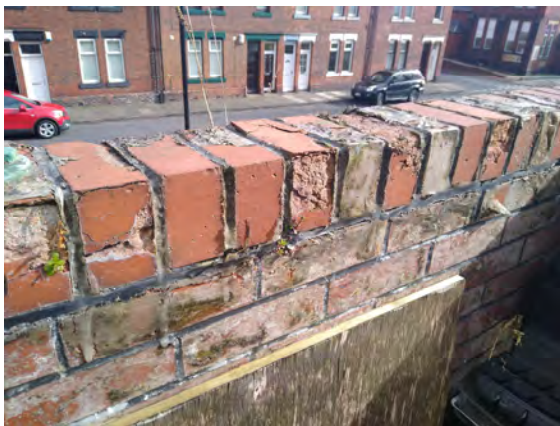
Item 74 Ref: 403866-23

The brick wall (Balcony) does not contain asbestos.

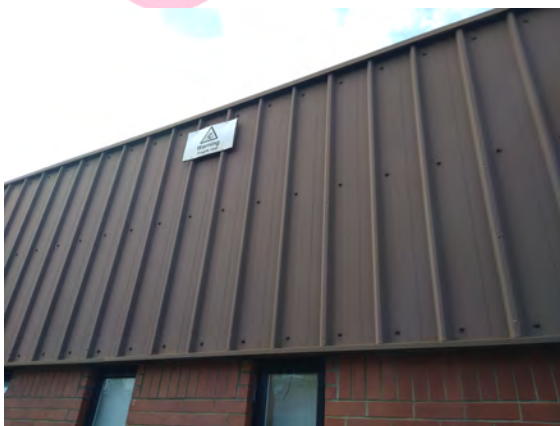
Item 75 Ref: As 403866-22

The coating to corrugated metal wall cladding (External) does not contain asbestos.

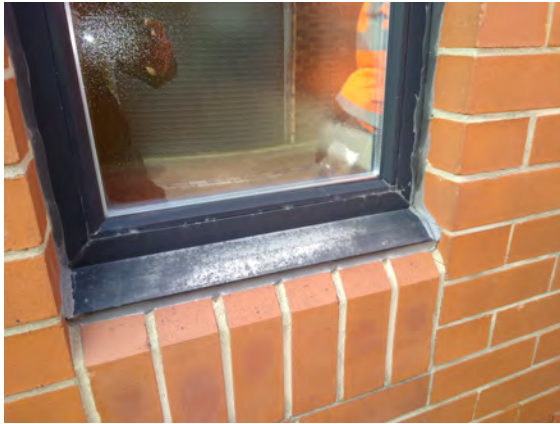
Item 76 Ref: As 403866-21

The sealant to window frames (External) does not contain asbestos.

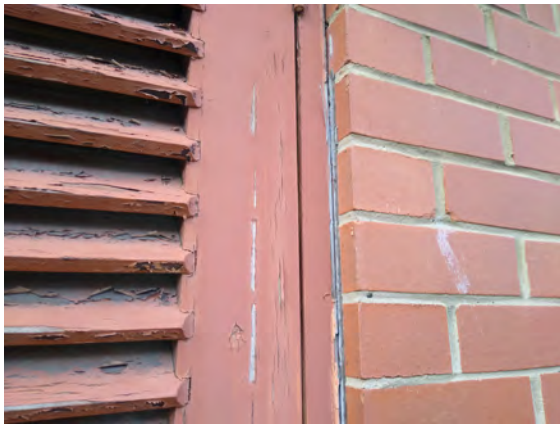
Item 77 Ref: 403866-39

The sealant to door frame (rooms 0/001 and 0/007a) (External) does not contain asbestos.

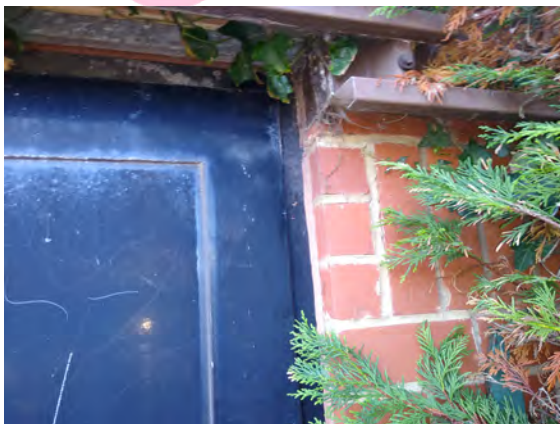
Item 78 Ref: 403866-40

The sealant to pool fire exit door (External) does not contain asbestos.

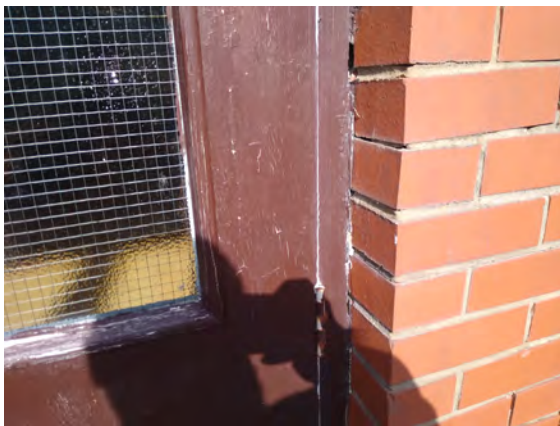
Item 80 Ref: 403866-42

The sealant to door frame (External) does not contain asbestos.

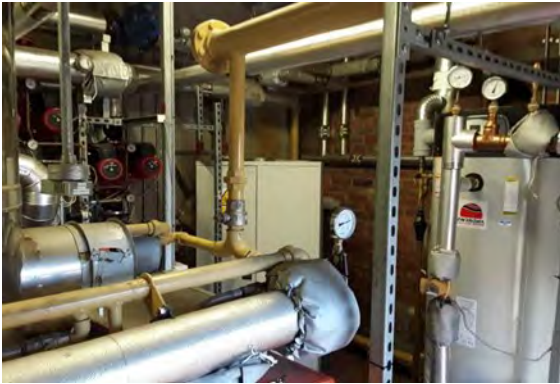
Item 82 Ref: 22-45954-1

The insulation to the walls in the Plant Room (Area 1) does not contain asbestos.

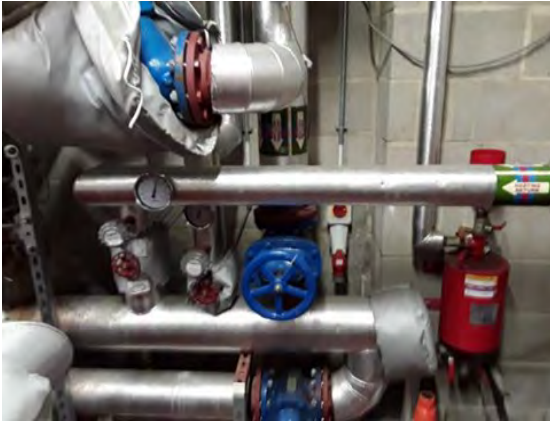
Item 83 Ref: 22-45954-2

The pipe flanges (Gaskets) in the Plant Room (Area 1) does not contain asbestos.

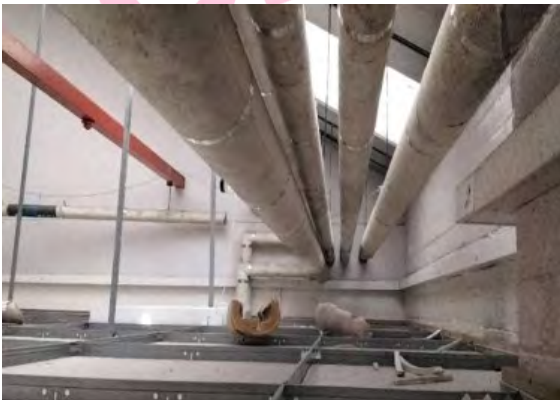
Item 84 Ref: NO000642

The pipework insulation in ceiling void with associated debris in the Large Room (Rm 1/001) does not contain asbestos.

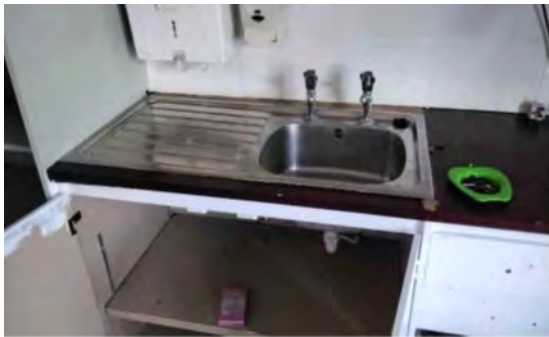
Item 85 Ref: ZA008187

The sink pads in the first-floor kitchen contains asbestos.
