ASBESTOS SURVEY REPORT FOR ROSSMERE ACADEMY, CATCOTE ROAD, HARTLEPOOL, TS25 3JL.

Rossmere Academy, Hartlepool

Date: 24 July 2025

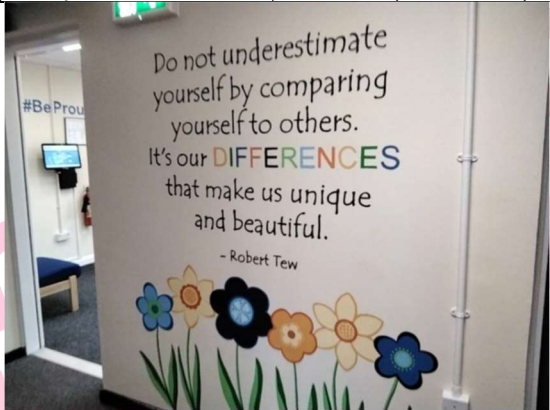
3	As KX001572	Floor screed under carpet and modern screed layer	Block A Ground Floor Corridor (Room 014)	Does not contain asbestos.

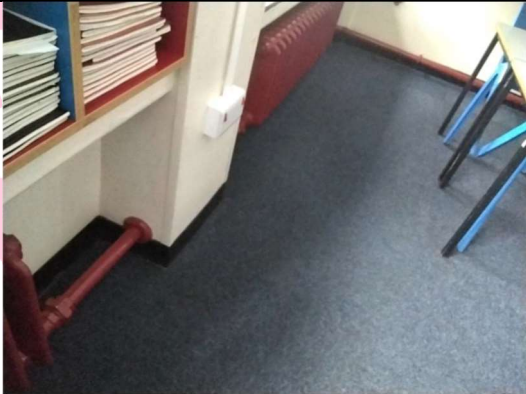
14	As KX001577	Wall Skirting	Block A Ground Floor Classroom (Room 008)	Contains asbestos - Any change in appearance should be recorded and passed to Property Services.

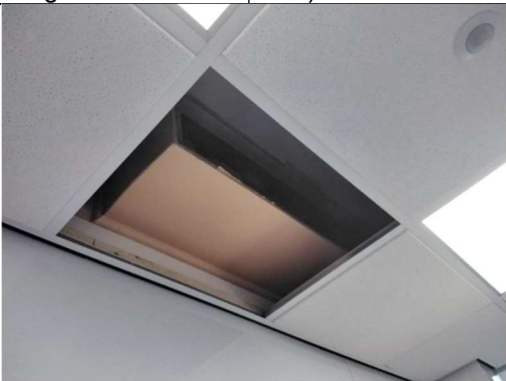
16	KX001578	Pipe joints caulking /packing painted orange	Block A Ground Floor Male Toilets (Room 012)	Do not contain asbestos.

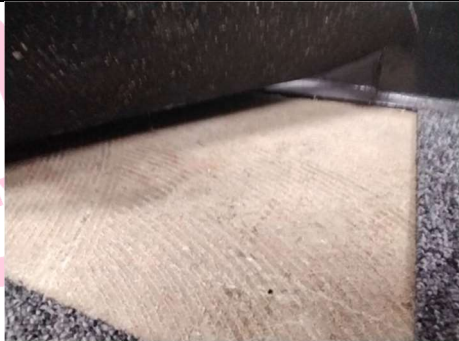
20	KX001581	Floor adhesive residue under carpet and screed	Block A Ground Floor Hallway/Passageway (Room 020)	Contains asbestos - Any change in appearance should be recorded and passed to Property Services.

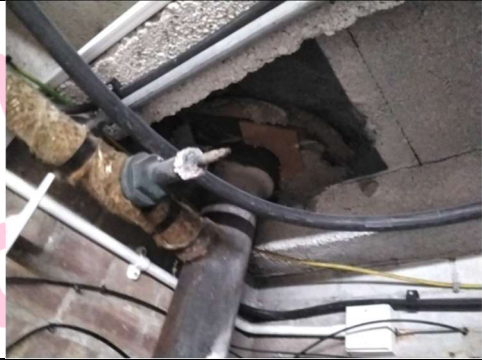
23	KX001582	Ceiling packing to stench pipe penetration	Block A Ground Floor Switch Room (Room 016)	Contains asbestos - Any change in appearance should be recorded and passed to Property Services.

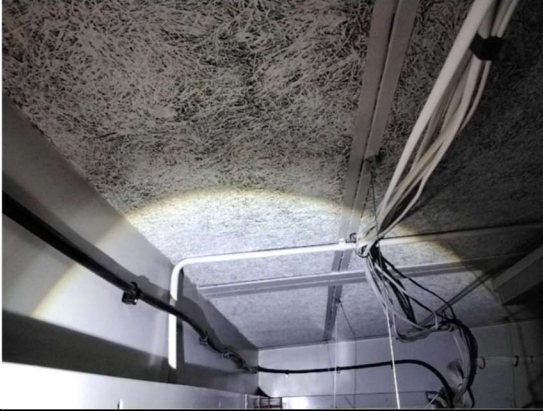
25	KX001584	Ceiling void above ceiling	Block A Ground Floor Store Room (Room 039)	Does not contain asbestos.

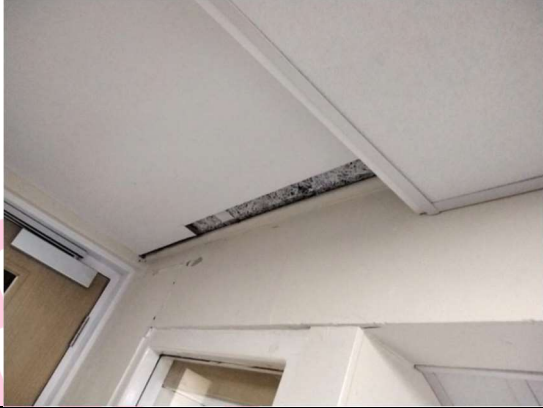
26	As KX001584	Ceiling void above ceiling	Block A Ground Floor Corridor (Room 036)	Does not contain asbestos.

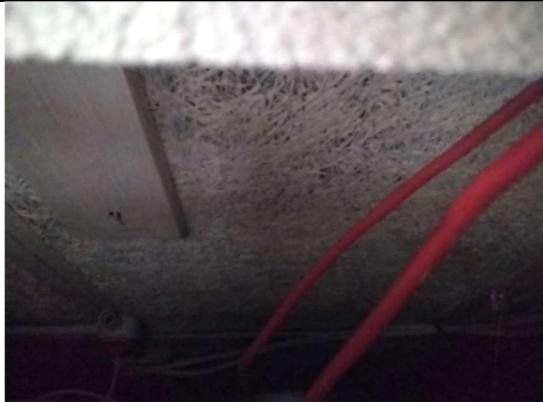
27	As KX001584	Ceiling void above ceiling	Block A Ground Floor Classroom (Room 021)	Does not contain asbestos.

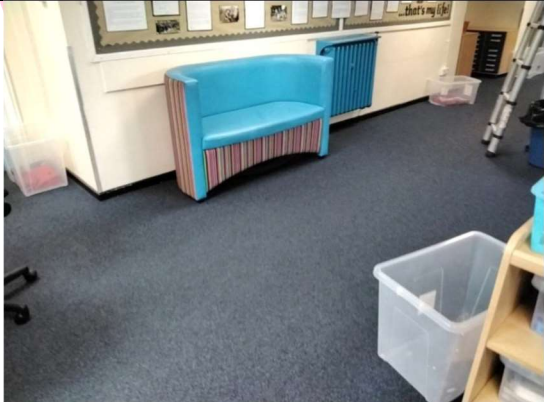
30	KX001586	Floor screed under carpet and screed	Block A Ground Floor Corridor (Room 037)	Does not contain asbestos.

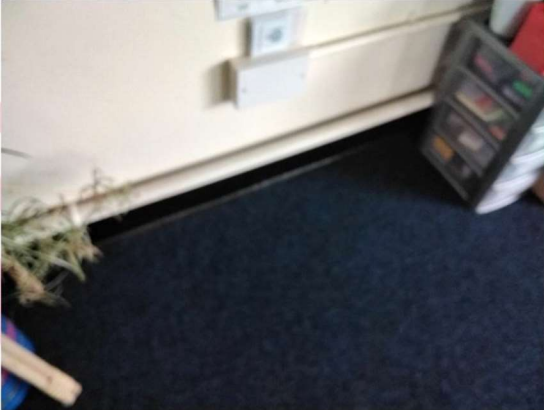
32	TL001255	Wall Skirting	Block A Ground Floor Classroom (Room 025)	Does not contain asbestos.

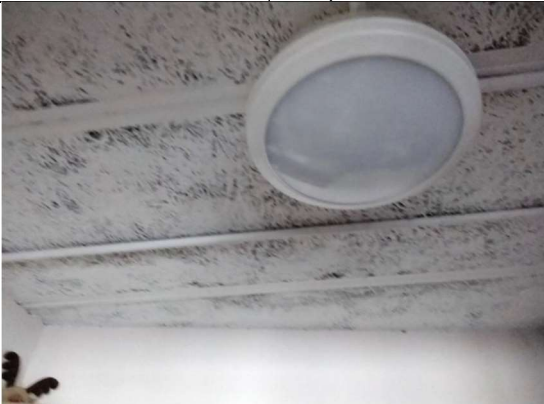
33	As KX001584	Ceiling	Block A Ground Floor Cupboard (Room 026)	Does not contain asbestos.

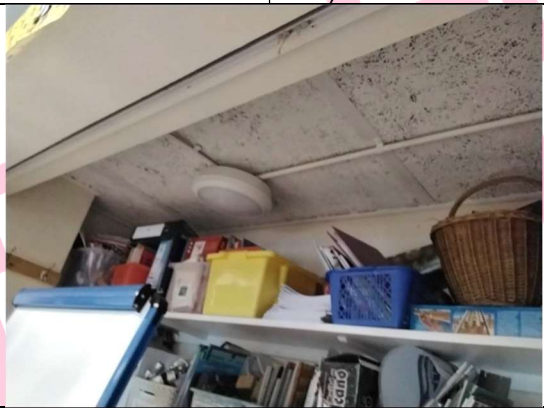
50	As KX001584	Ceiling void above ceiling	Block A Ground Floor Classroom (Room 034)	Does not contain asbestos.

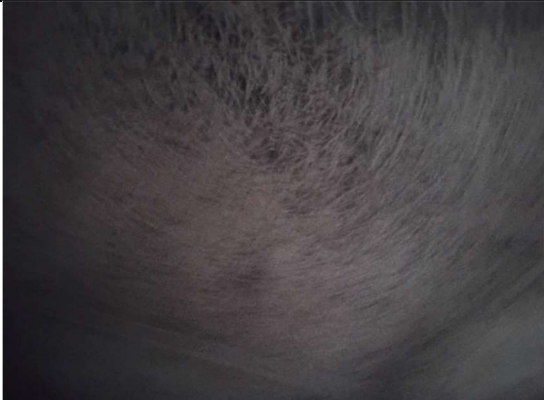
51	As KX001584	Ceiling void above ceiling	Block A Ground Floor Corridor (Room 041a)	Does not contain asbestos.

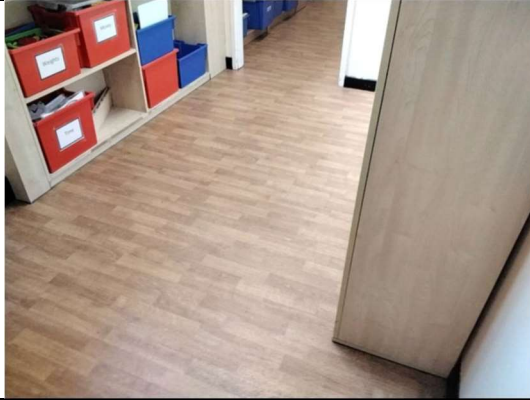
52	As KX001590	Floor adhesive residue	Block A Ground Floor Corridor (Room 041a)	Contains asbestos - Any change in appearance should be recorded and passed to Property Services.

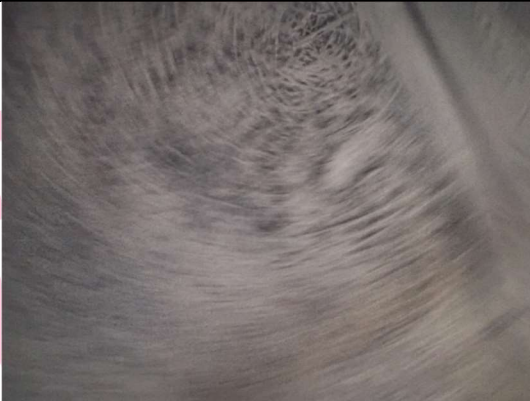
53	As KX001584	Ceiling void above ceiling	Block A Ground Floor Staff Room (Room 041)	Does not contain asbestos.

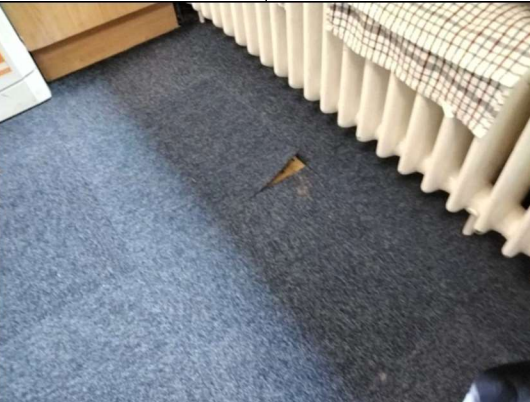
54	KX001590	Floor adhesive residue	Block A Ground Floor Staff Room (Room 041)	Contains asbestos - Any change in appearance should be recorded and passed to Property Services.

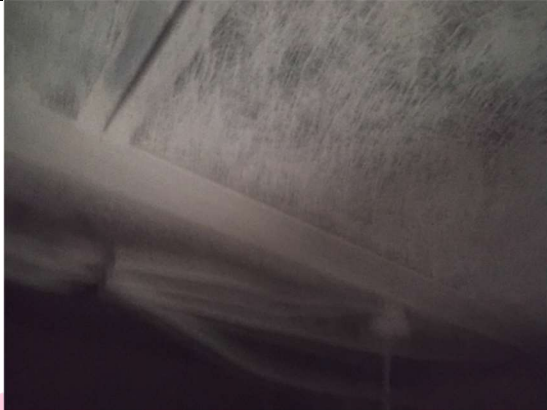
55	As KX001577	Wall Skirting	Block A Ground Floor Staff Room (Room 041)	Contains asbestos - Any change in appearance should be recorded and passed to Property Services.
No Photographic Evidence				
56	KX001591	Ceiling void ceiling above	Block A Ground Floor Corridor (Room 060)	Does not contain asbestos.

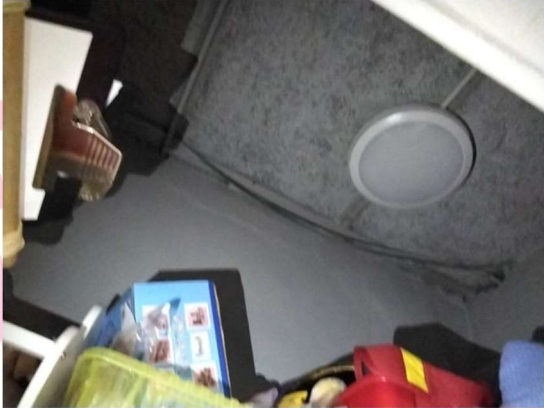
59	As KX001591	Ceiling void ceiling above	Block A Ground Floor Cupboard (Room 057)	Does not contain asbestos.

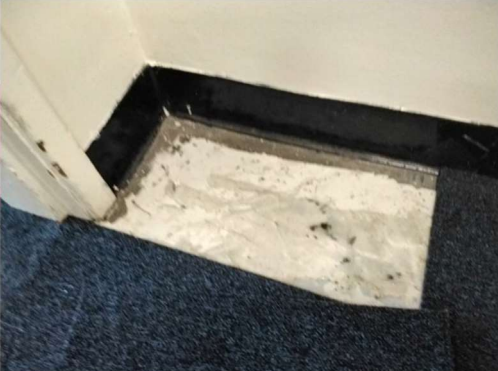
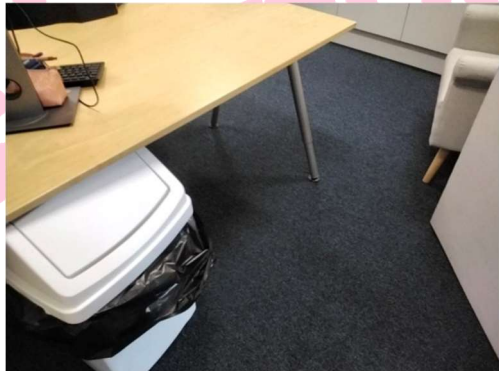
65	As KX001593	Floor tile (under floor covering) grey under screed	Block A Ground Floor Office (Room 59)	Contains asbestos - Any change in appearance should be recorded and passed to Property Services.

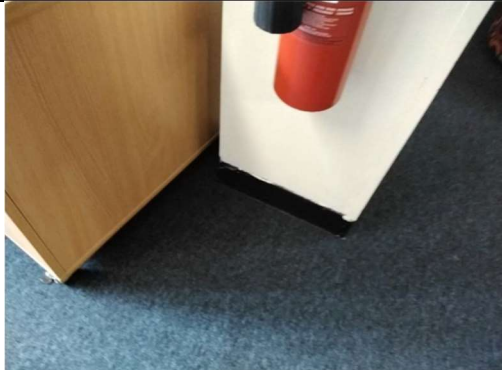
66	As KX001592	Wall skirting	Block A Ground Floor Corridor (Room 61)	Contains asbestos - Any change in appearance should be recorded and passed to Property Services.

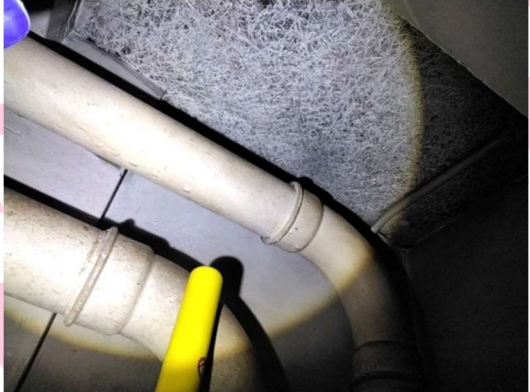
68	As KX001591	Ceiling	Block A Ground Floor Cleaners Cupboard (Room 035)	Does not contain asbestos.

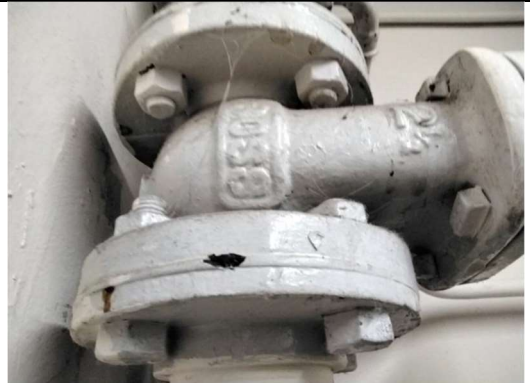
69	As KX001595	Pipework Gaskets	Block A Ground Floor Cleaners Cupboard (Room 035)	Do not contain asbestos.

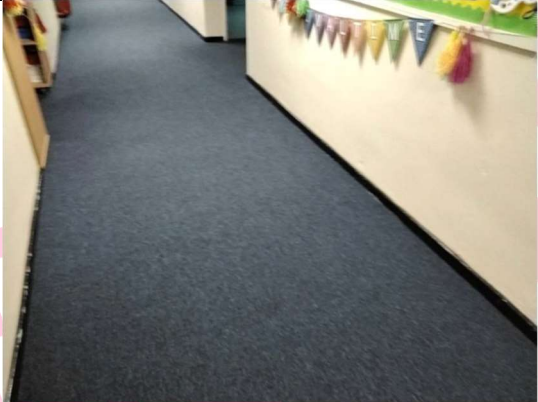
71	As KX001572	Floor screed under carpet and modern screed layer	Block A Ground Floor Corridor (Room 078)	Does not contain asbestos.

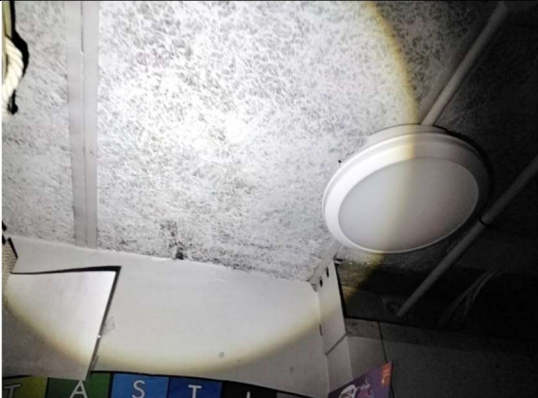
72	As KX001591	Ceiling void ceiling above	Block A Ground Floor Cupboard (Room 064)	Does not contain asbestos.

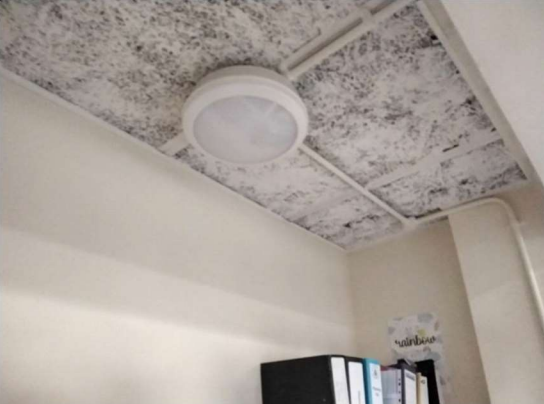
75	As KX001591	Ceiling alcove	Block A Ground Floor Classroom (Room 065)	Does not contain asbestos.

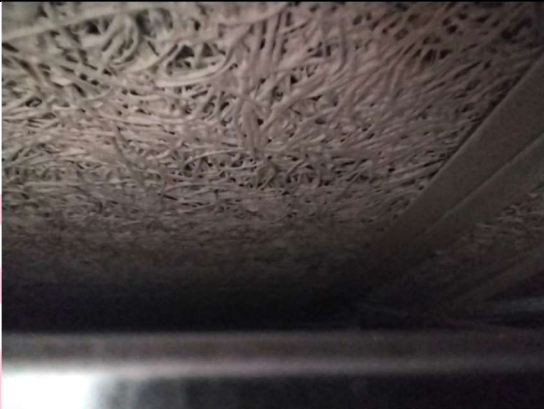
83	As KX001591	Ceiling	Block A Ground Floor Classroom (Room 076)	Does not contain asbestos.

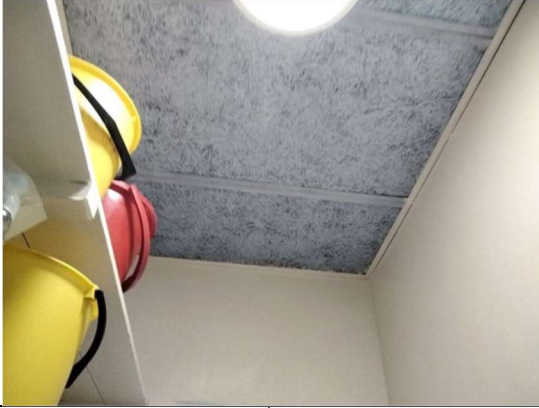
97	As KX001591	Ceiling	Block A Ground Floor Cleaners Cupboard (Room 052)	Does not contain asbestos.

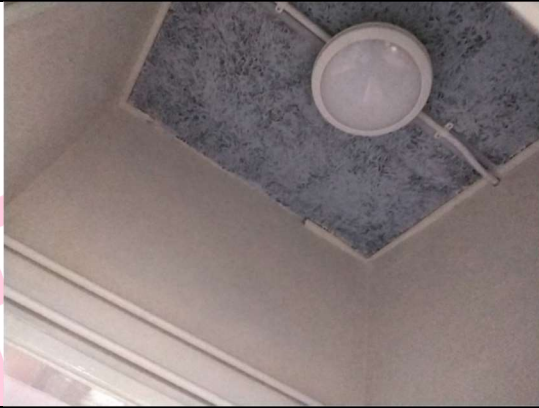
99	As KX001591	Ceiling	Block A Ground Floor Store Room (Room 044)	Does not contain asbestos.

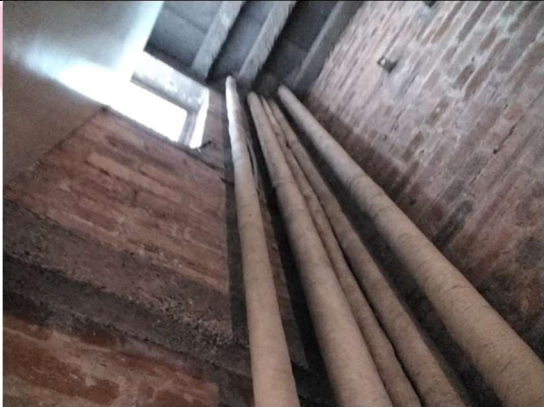
116	KX001583	Electric services cabling/braiding insulation x2	Block A First Floor Storage (Room 018)	Does not contain asbestos.
No Photographic Evidence				
117	As KX001585	Pipework insulation string binding to fibreglass	Block A First Floor Storage (Room 018)	Contains asbestos - Any change in appearance should be recorded and passed to Property Services.

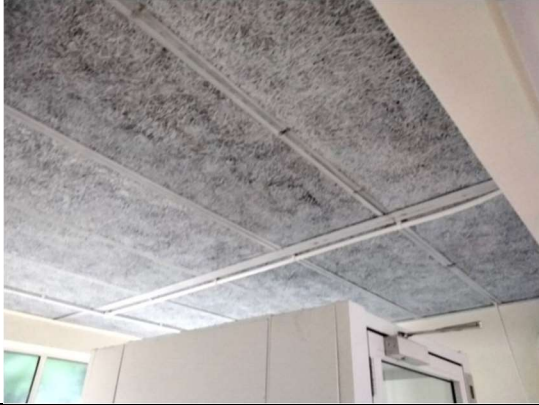
118	As KX001591	Ceiling	Block A First Floor Staircase Stairwell (Room 107)	Does not contain asbestos.

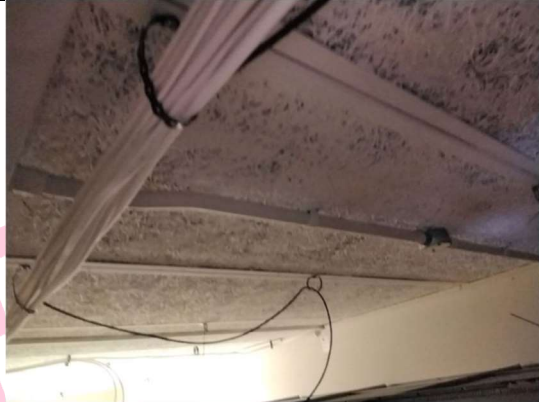
119	As KX001591	Ceiling void ceiling above	Block A First Floor Corridor (Room 106a)	Does not contain asbestos.

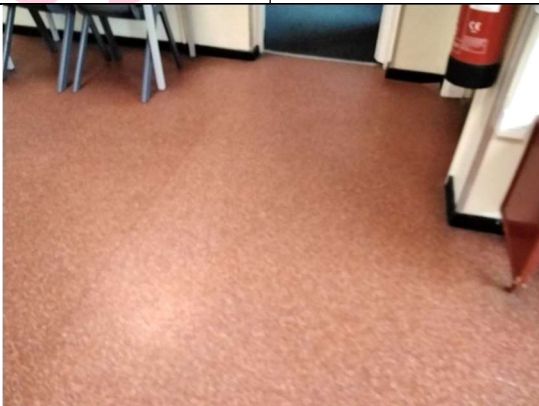
120	KX001604	Floor screed under modern lino and screed	Block A First Floor Corridor (Room 106a)	Does not contain asbestos.

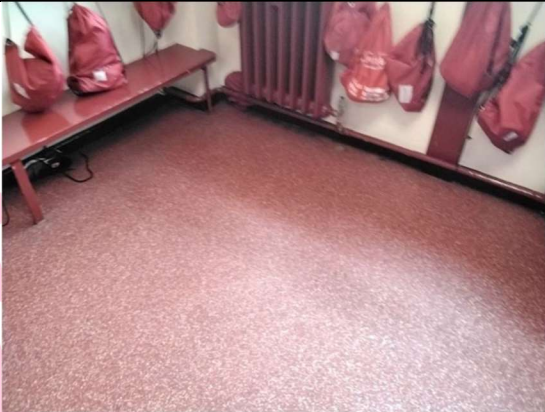
122	KX001604	Floor screed under modern lino and screed	Block A First Floor Cloakroom (Room 105)	Does not contain asbestos.

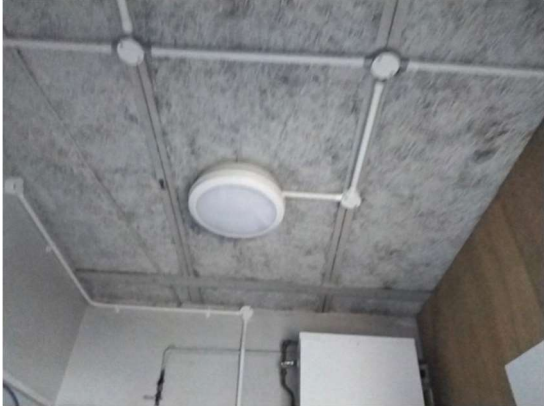
127	As KX001591	Ceiling void ceiling above	Block A First Floor Cupboard (Room 94)	Does not contain asbestos.

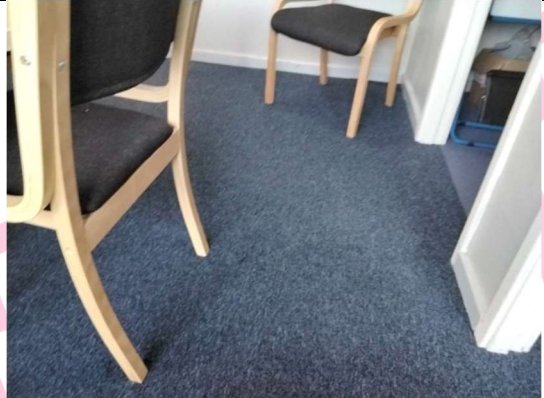
128	KX001604	Floor screed under modern carpet and screed	Block A First Floor Office (Room 92)	Does not contain asbestos.

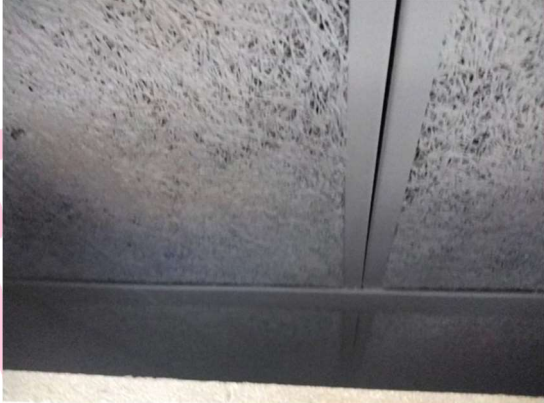
137	As KX001591	Ceiling void ceiling above	Block A First Floor Office (Room 104)	Does not contain asbestos.

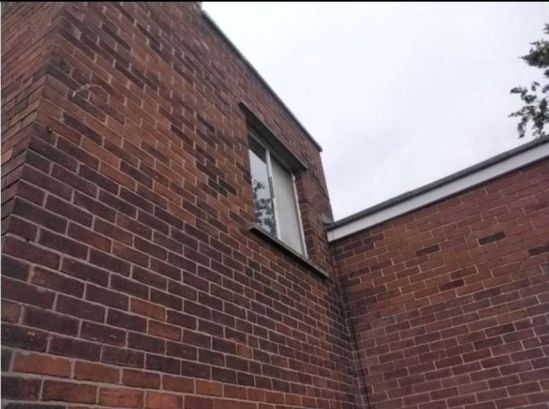
141	KX001609	Window putty seal second floor store window	Block A External	Does not contain asbestos.

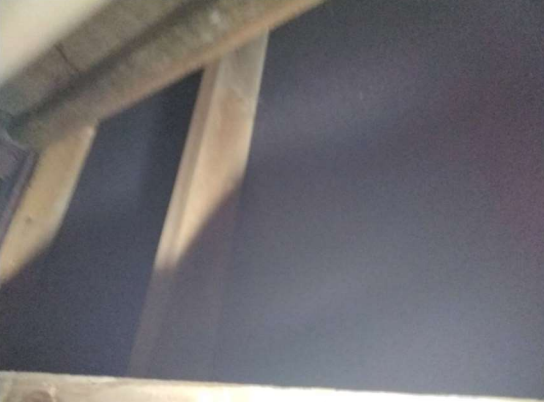
150	As KX001621	Ceiling void wall lining	Block B Ground Floor Kitchen (Room 109)	Does not contain asbestos.

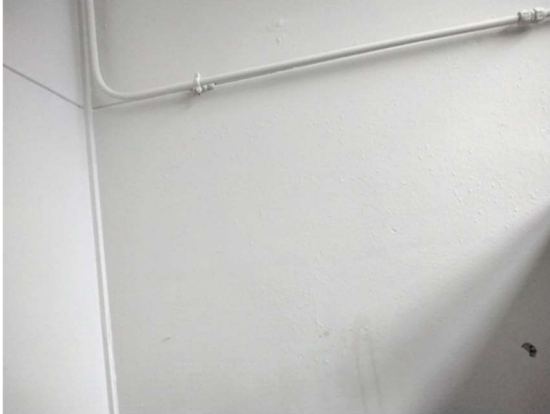
163	As KX001625	Wall coating fire flex paint	Block B Ground Floor Toilets (Room 129)	Does not contain asbestos.

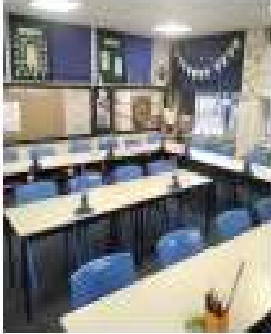
178	CF010792	Floor tile below screed	Ground Floor Classroom (Room 008)	Low Risk
Photo 1: Wide Angle		Photo 2: Close-up

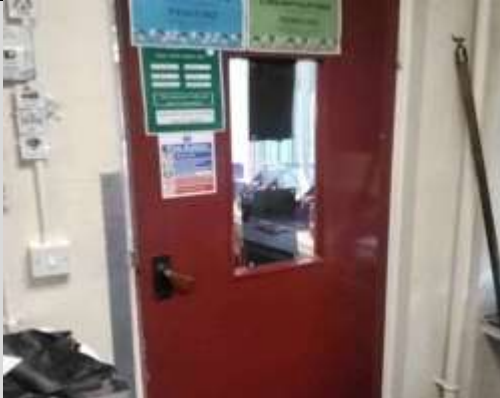
179	CF010791	Mastic to beading within door	Ground Floor Classroom (Room 008)	No Risk

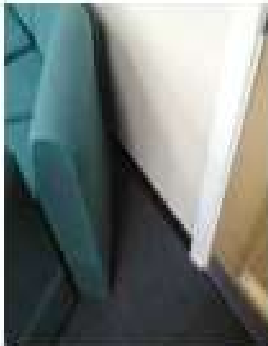
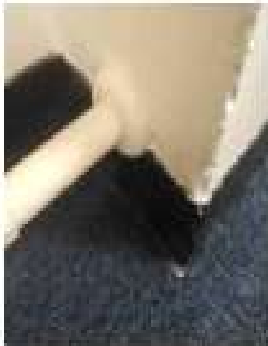
180	CF010789	Floor tile	Ground Floor Staff Room (Room 041)	Low Risk
Photo 1: Wide Angle		Photo 2: Close-up

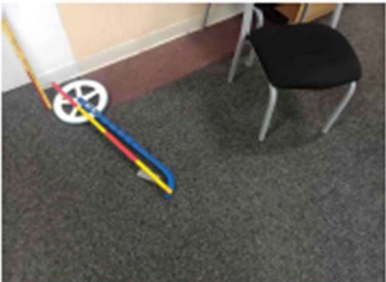
182	TL001053	Floor – covering beneath screed	Ground floor Office rm 2 (Heads Office) (G/001)	Low Risk
Photo 1: Wide Angle		Photo 2: Close-up

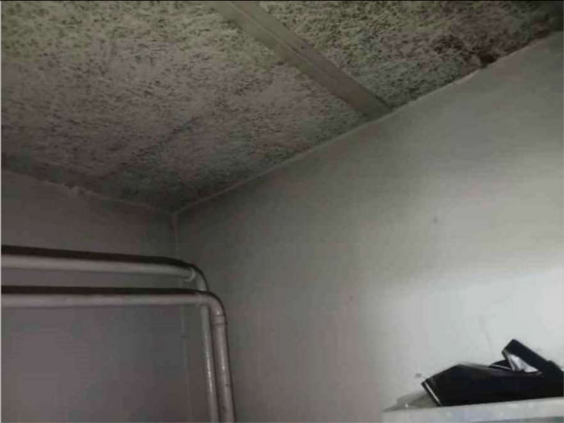
196	As TL001361	Ceiling - Coating	Store room G/008	No Risk

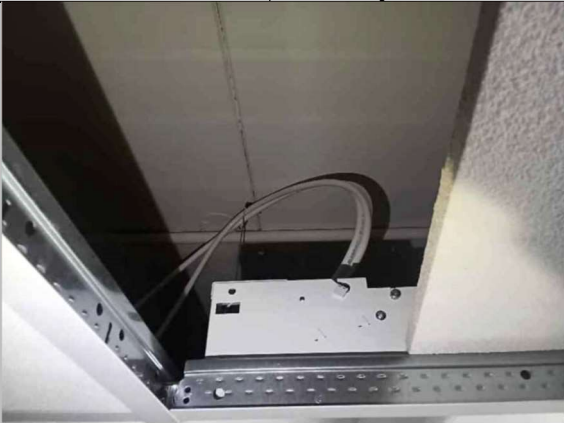
197	As TL001362	Ceiling Cladding	Classroom Mrs Collins, year 1 G/009	No Risk

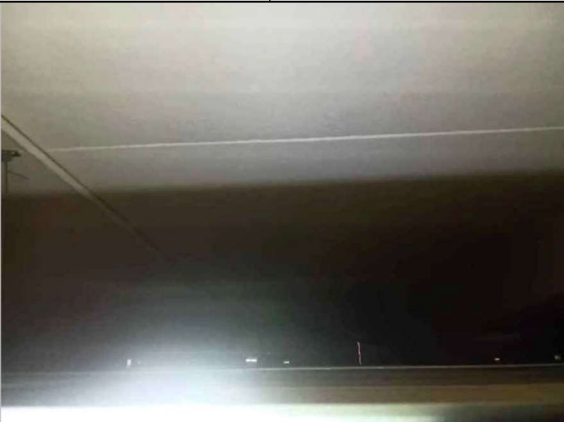
198	As TL001362	Ceiling Cladding	Classroom Year 2, owls G/010	No Risk

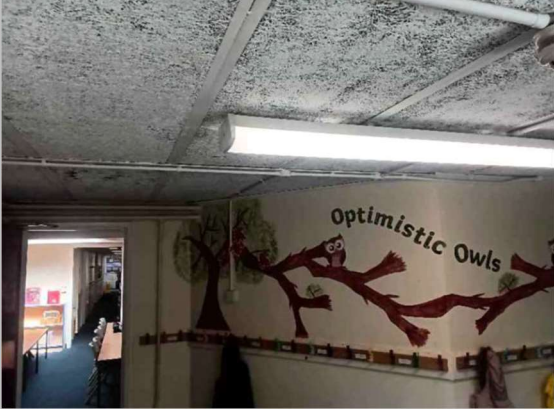
199	As TL001361	Ceiling - Coating	Classroom G/011	No Risk
NO PHOTOGRAPH PROVIDED				
200	TL001364	Ceiling Cladding	Cloakroom G/012	No Risk

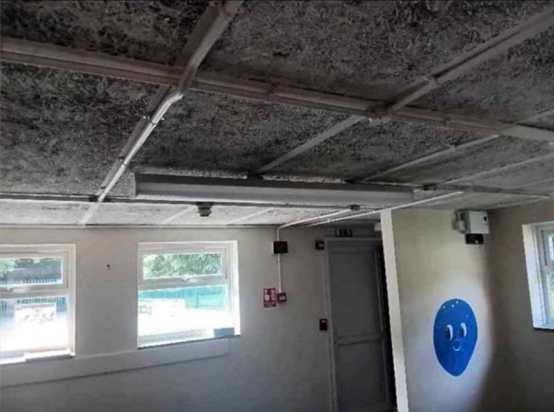
201	As TL001364	Ceiling Cladding	Classroom Seaside Room G/013	No Risk
