ASBESTOS SURVEY REPORT FOR ROSSMERE ACADEMY, CATCOTE ROAD, HARTLEPOOL, TS25 3JL.

Asbestos Register for

Rossmere Academy, Hartlepool

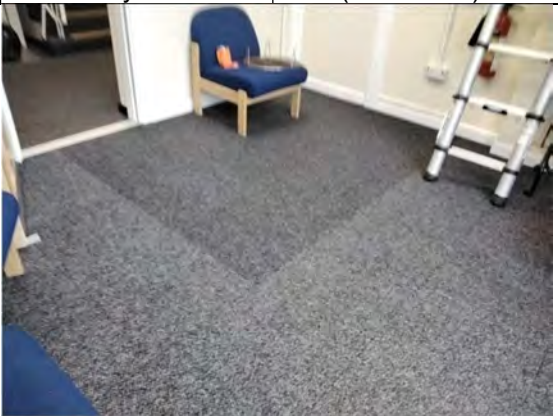
1	KX001572	Floor screed under lino and modern screed layer	Block A Ground Floor Reception Entrance Hall (Room 001)	Does not contain asbestos.

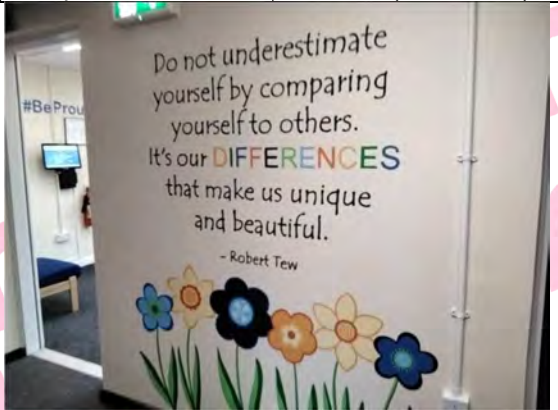
2	KX001573	Wall Coating fire flex paint	Block A Ground Floor Corridor (Room 014)	Does not contain asbestos.

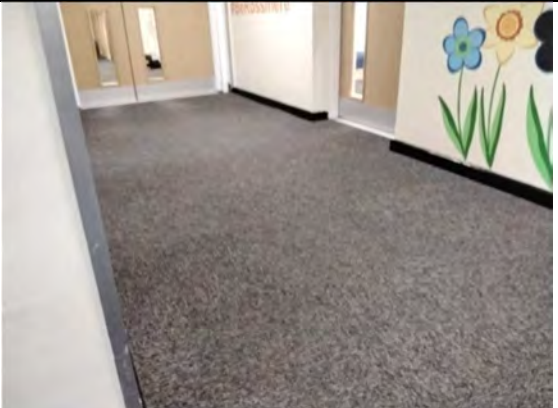
3	As KX001572	Floor screed under carpet and modern screed layer	Block A Ground Floor Corridor (Room 014)	Does not contain asbestos.

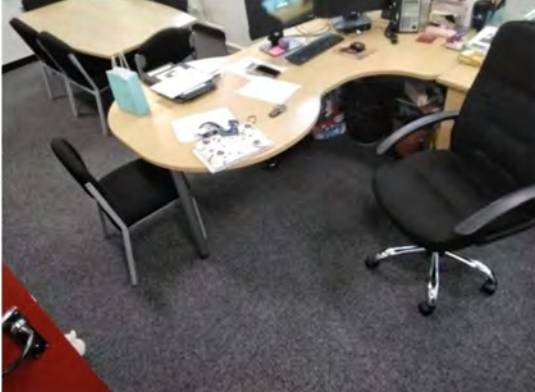
4	As KX001572	Floor screed under carpet and modern screed layer	Block A Ground Floor Office (Room 002)	Does not contain asbestos.

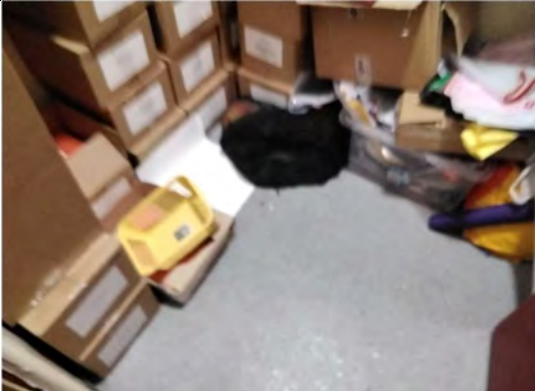
6	As KX001572	Floor screed under lino and modern screed layer	Block A Ground Floor Cupboard Store (Room 003a)	Does not contain asbestos.

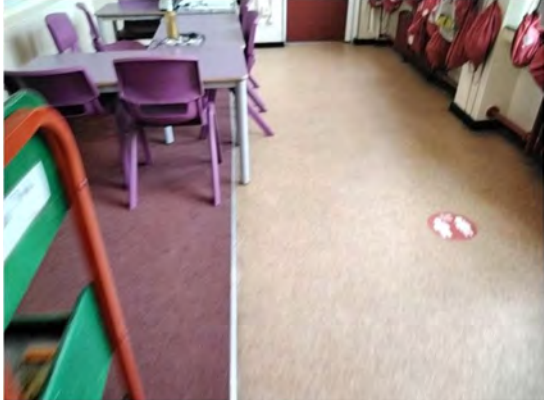
10	As KX001572	Floor screed under carpet and modern screed layer	Block A Ground Floor Hallway Passageway (Room 007)	Does not contain asbestos.

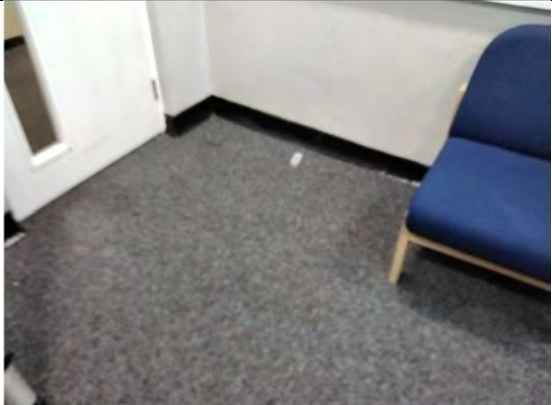
15	As KX001572	Floor screed under lino and modern screed layer	Block A Ground Floor Office (Room 010)	Does not contain asbestos.

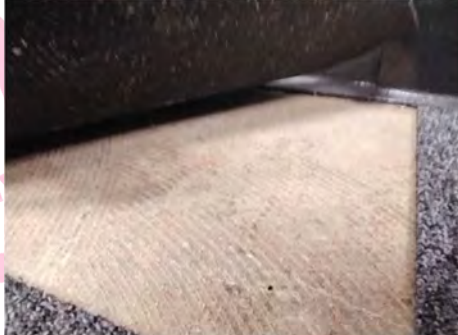
20	KX001581	Floor adhesive residue under carpet and screed	Block A Ground Floor Hallway/Passageway (Room 020)	Contains asbestos - Any change in appearance should be recorded and passed to Property Services.

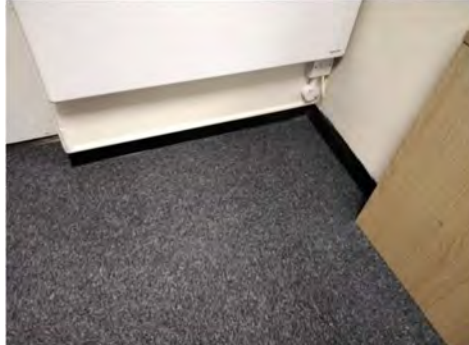
21	As KX001580	Wall Skirting	Block A Ground Floor Reception (Room 020 b & c)	Contains asbestos - Any change in appearance should be recorded and passed to Property Services.

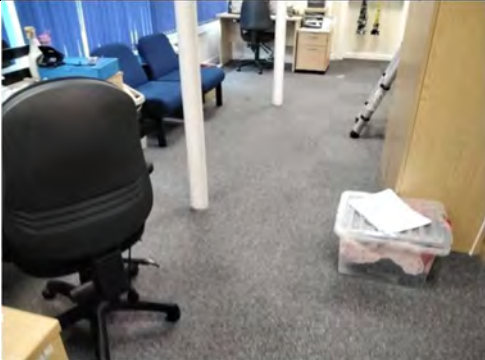
22	As KX001581	Floor adhesive residue under carpet and screed	Block A Ground Floor Reception (Room 020 b & c)	Contains asbestos - Any change in appearance should be recorded and passed to Property Services.

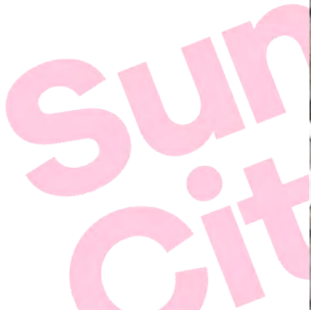
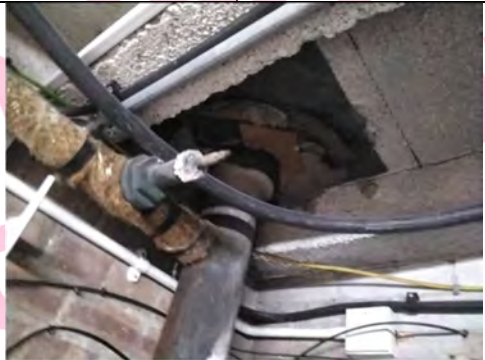
23	KX001582	Ceiling packing to stench pipe penetration	Block A Ground Floor Switch Room (Room 016)	Contains asbestos - Any change in appearance should be recorded and passed to Property Services.

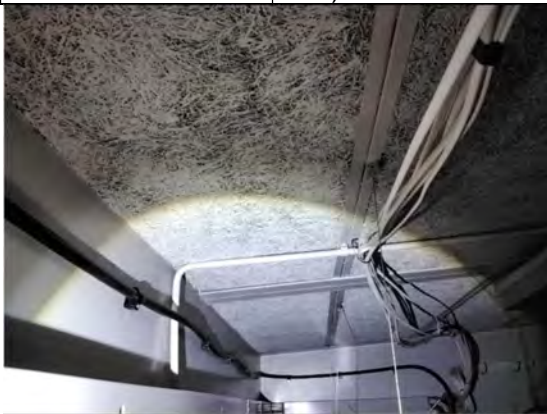
25	KX001584	Ceiling void above ceiling	Block A Ground Floor Store Room (Room 039)	Does not contain asbestos.

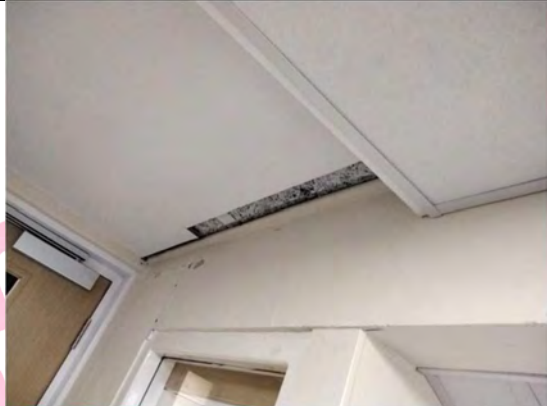
26	As KX001584	Ceiling void above ceiling	Block A Ground Floor Corridor (Room 036)	Does not contain asbestos.

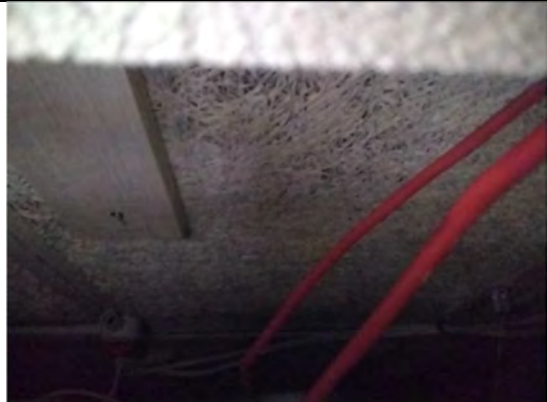
27	As KX001584	Ceiling void above ceiling	Block A Ground Floor Classroom (Room 021)	Does not contain asbestos.

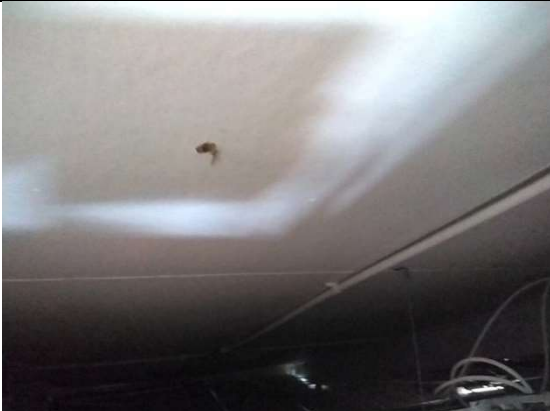
42	KX001589	Ceiling void ceiling above	Block A Ground Floor Classroom (Room 029)	Does not contain asbestos.

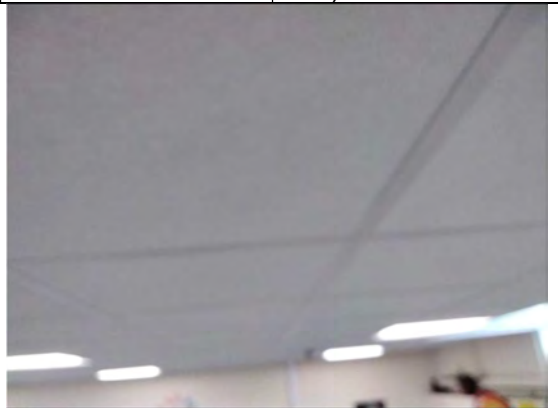
49	As KX001589	Ceiling void ceiling above	Block A Ground Floor Classroom (Room 034)	Does not contain asbestos.

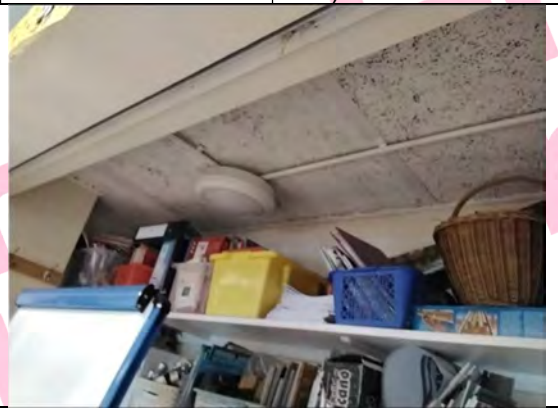
50	As KX001584	Ceiling void above ceiling	Block A Ground Floor Classroom (Room 034)	Does not contain asbestos.

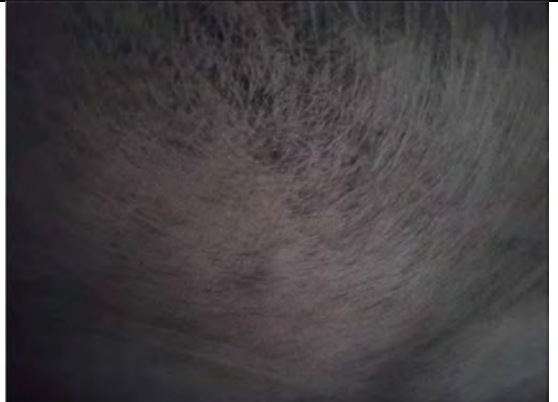
51	As KX001584	Ceiling void above ceiling	Block A Ground Floor Corridor (Room 041a)	Does not contain asbestos.

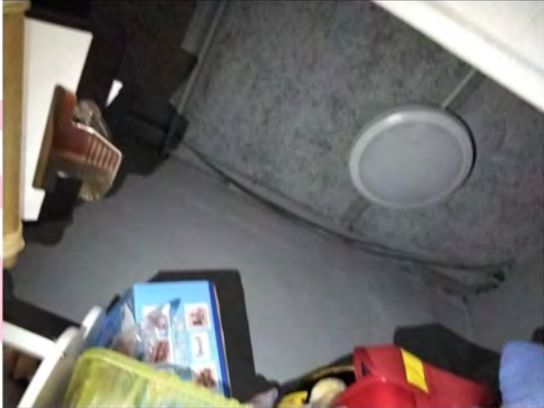
59	As KX001591	Ceiling void ceiling above	Block A Ground Floor Cupboard (Room 057)	Does not contain asbestos.

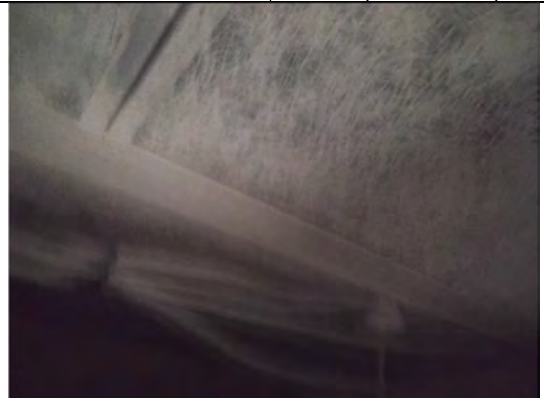
63	As KX001591	Ceiling void ceiling above	Block A Ground Floor Office (Room 059)	Does not contain asbestos.

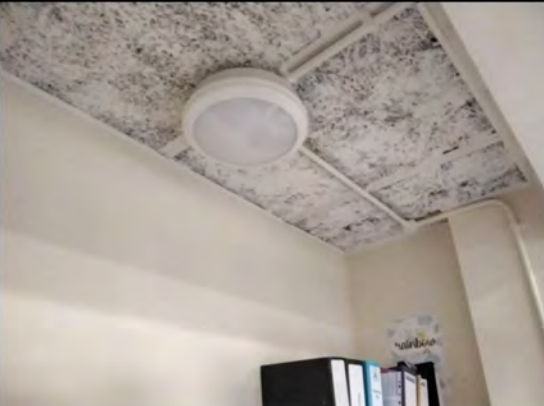
75	As KX001591	Ceiling alcove	Block A Ground Floor Classroom (Room 065)	Does not contain asbestos.

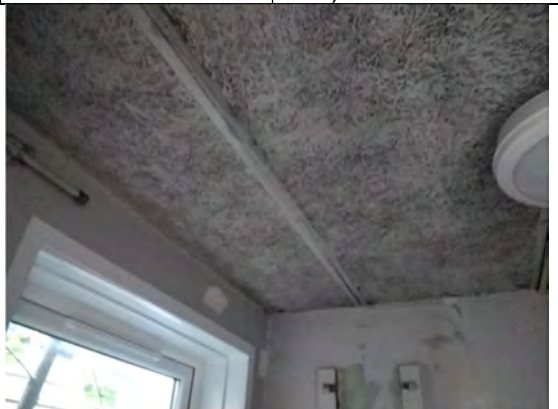
82	As KX001591	Ceiling void ceiling above	Block A Ground Floor Cupboard (Room 070)	Does not contain asbestos.

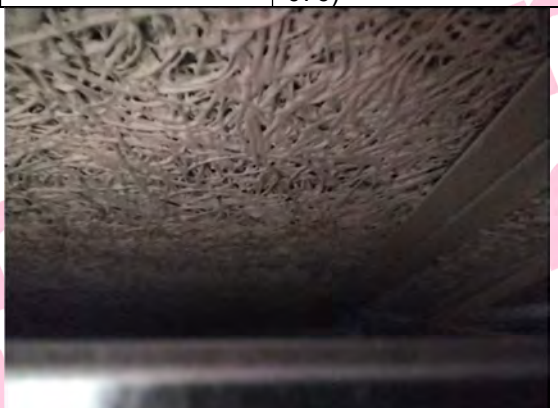
83	As KX001591	Ceiling	Block A Ground Floor Classroom (Room 076)	Does not contain asbestos.

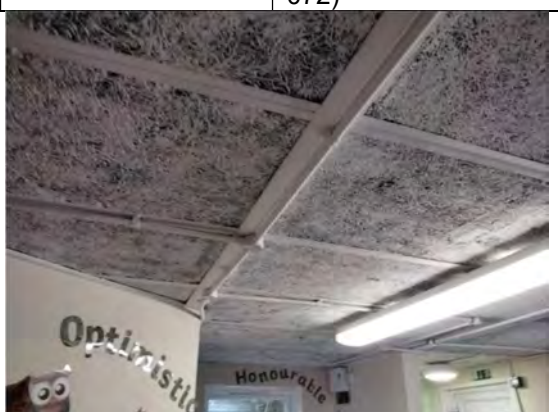
84	As KX001591	Ceiling	Block A Ground Floor Cloakroom (Room 072)	Does not contain asbestos.

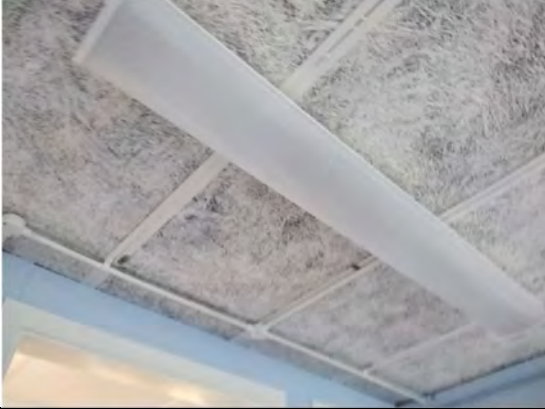
91	As KX001591	Ceiling	Block A Ground Floor Classroom (Room 078b)	Does not contain asbestos.

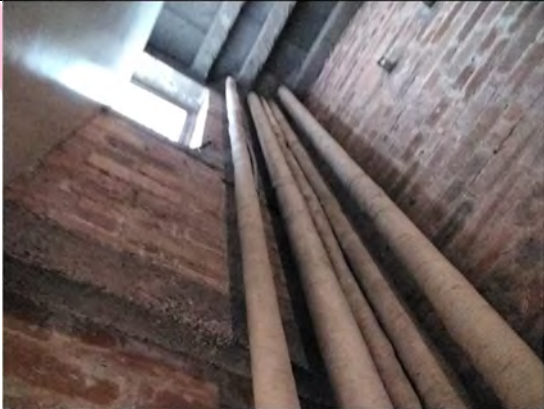
116	KX001583	Electric services cabling/braiding insulation x2	Block A First Floor Storage (Room 018)	Does not contain asbestos.
<p>No Photographic Evidence</p>				
117	As KX001585	Pipework insulation string binding to fibreglass	Block A First Floor Storage (Room 018)	Contains asbestos - Any change in appearance should be recorded and passed to Property Services.

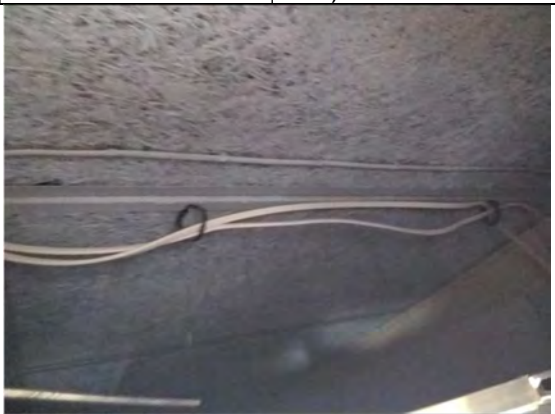
121	As KX001591	Ceiling void ceiling above	Block A First Floor Cloakroom (Room 105)	Does not contain asbestos.

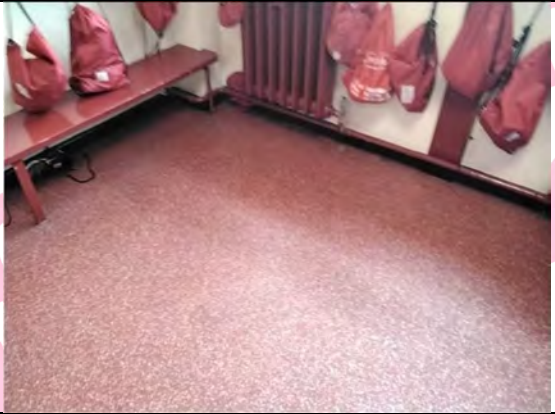
122	KX001604	Floor screed under modern lino and screed	Block A First Floor Cloakroom (Room 105)	Does not contain asbestos.

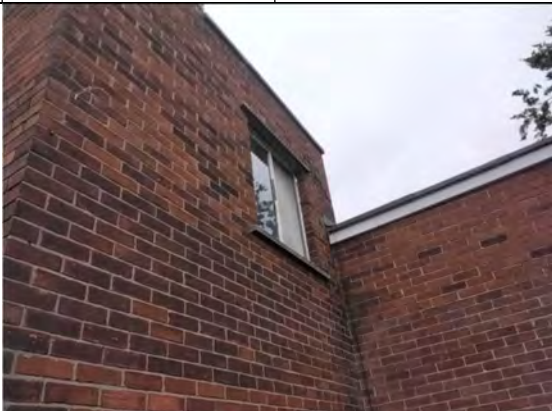
141	KX001609	Window putty seal second floor store window	Block A External	Does not contain asbestos.

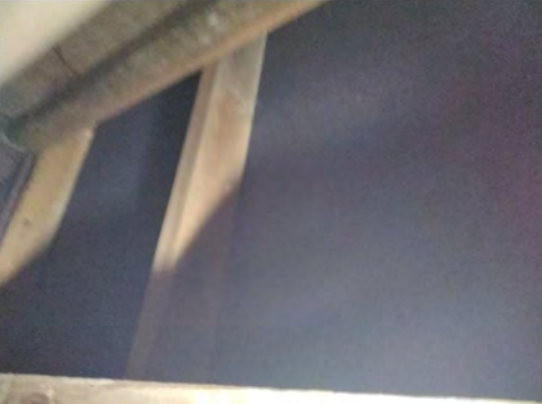
150	As KX001621	Ceiling void wall lining	Block B Ground Floor Kitchen (Room 109)	Does not contain asbestos.

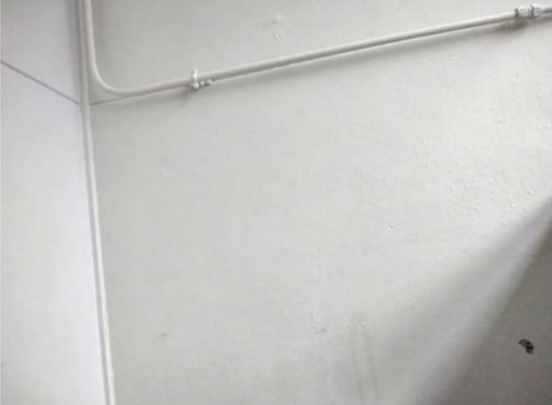
163	As KX001625	Wall coating fire flex paint	Block B Ground Floor Toilets (Room 129)	Does not contain asbestos.

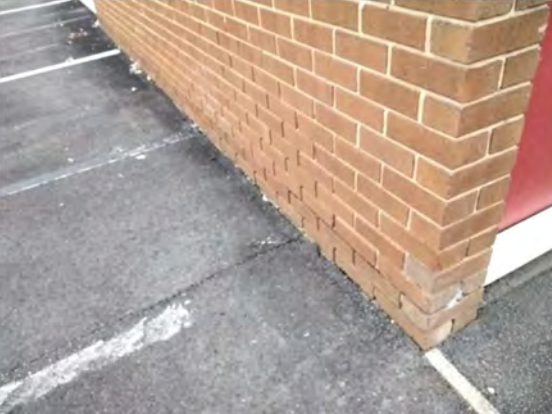
165	KX001614	Damp proof course	Block B External	Does not contain asbestos.

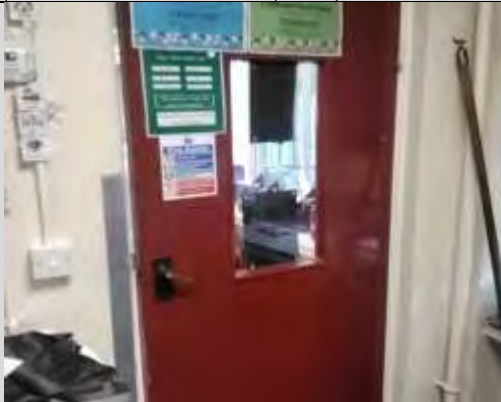
179	CF010791	Mastic to beading within door	Ground Floor Classroom (Room 008)	No Risk

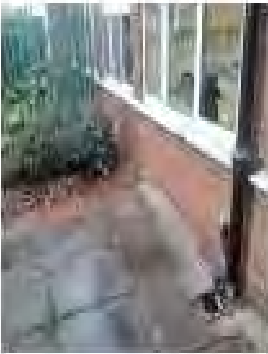
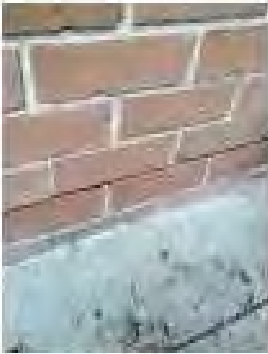
181	CF010794	Damp proof course	External to staff room (E/001)	Low Risk
Photo 1: Wide Angle		Photo 2: Close-up

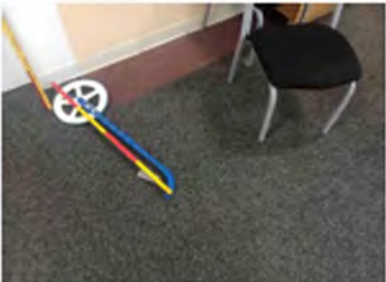
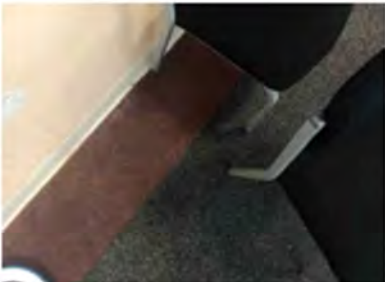
182	TL001053	Floor – covering beneath screed	Ground floor Office rm 2 (Heads Office) (G/001)	Low Risk
Photo 1: Wide Angle		Photo 2: Close-up

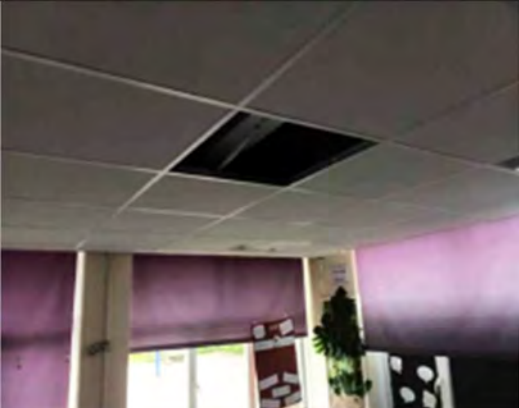
183	TL001254	Ceiling Cladding	Classroom Iguanas (G/001)	No Risk

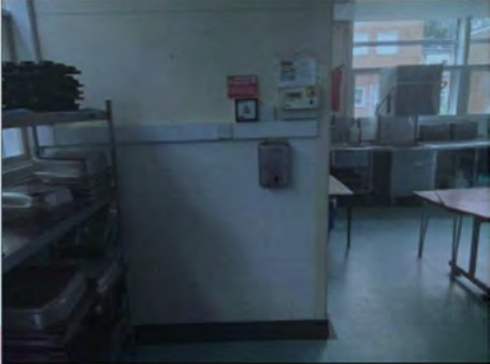
187	EU004472	Fixed fibreboard ceiling tiles	Dining Room (Survey J081624)	No Risk
NO PHOTOGRAPH PROVIDED				
188	Presumed	Old Electrical equipment to wall	Kitchen (Survey J081624)	Low Risk

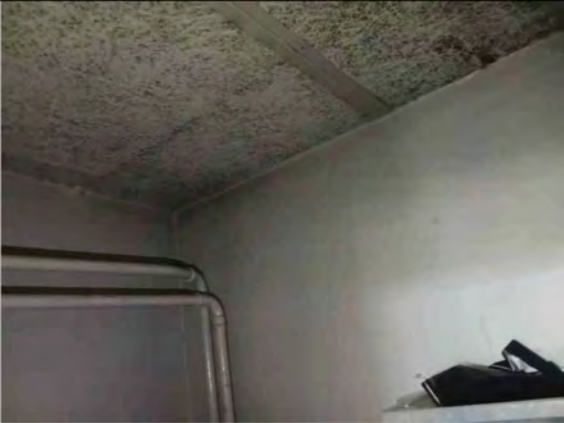
196	As TL001361	Ceiling - Coating	Store room G/008	No Risk

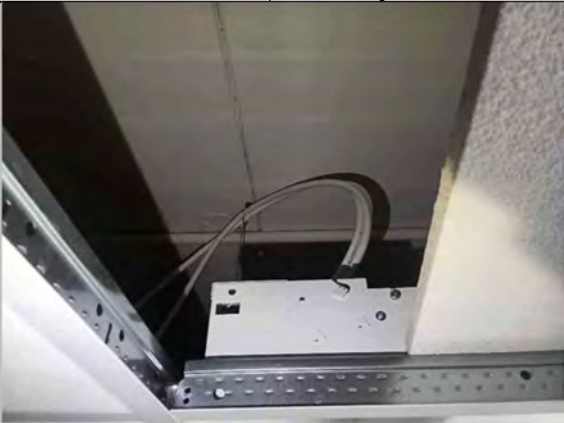
197	As TL001362	Ceiling Cladding	Classroom Mrs Collins, year 1 G/009	No Risk

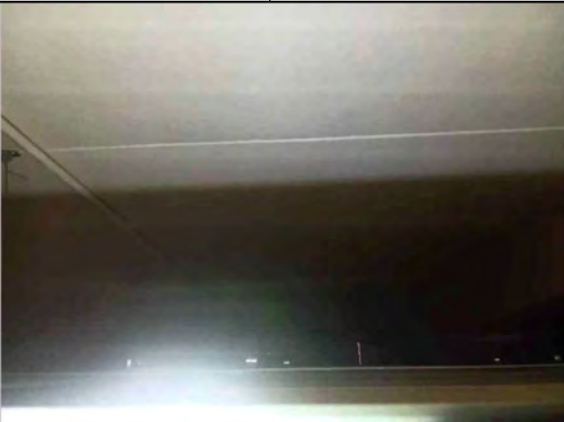
198	As TL001362	Ceiling Cladding	Classroom Year 2, owls G/010	No Risk

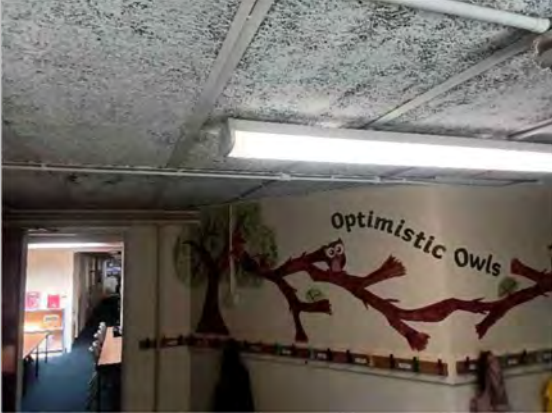
199	As TL001361	Ceiling - Coating	Classroom G/011	No Risk
<h1>NO PHOTOGRAPH PROVIDED</h1>				
200	TL001364	Ceiling Cladding	Cloakroom G/012	No Risk

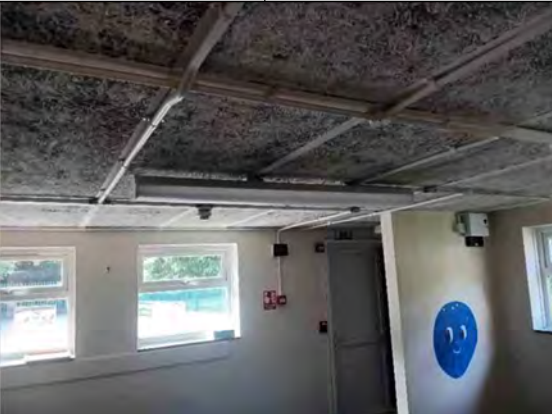
201	As TL001364	Ceiling Cladding	Classroom Seaside Room G/013	No Risk
