ASBESTOS SURVEY REPORT FOR THORNTREE ACADEMY, BIRKHAL ROAD, MIDDLESBOROUGH, TS3 9JW.

Asbestos Register for Thorntree Academy, Middlesbrough

Date: 09 May 2025

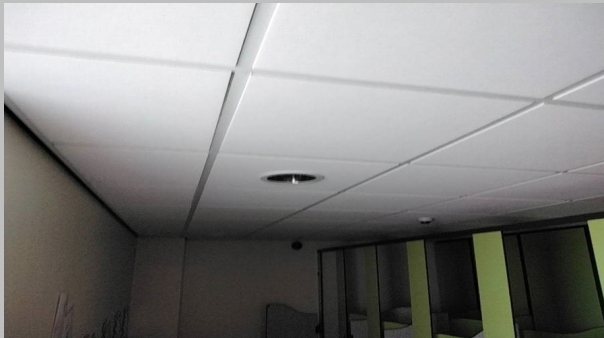
101	As KX001635	Ceiling void ceiling above	Main Building Female Toilets (Room 092)	No Risk
