ASBESTOS SURVEY REPORT FOR THORNTREE ACADEMY, BIRKHALL ROAD, MIDDLESBOROUGH, TS3 9JW.

## **Asbestos Register for Thorntree Academy, Middlesbrough**

**Date: 23 July 2025**

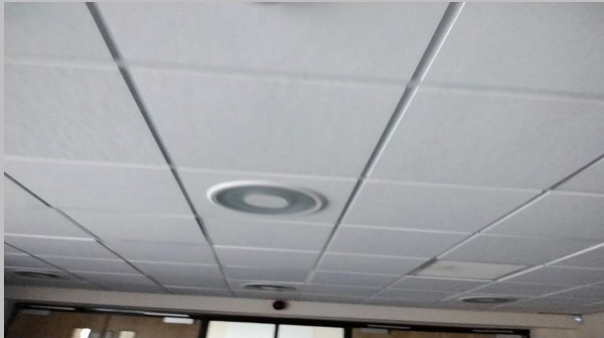
10	KX001635	Ceiling void ceiling above	Main Building Reception/Entrance (Room 001)	No Risk

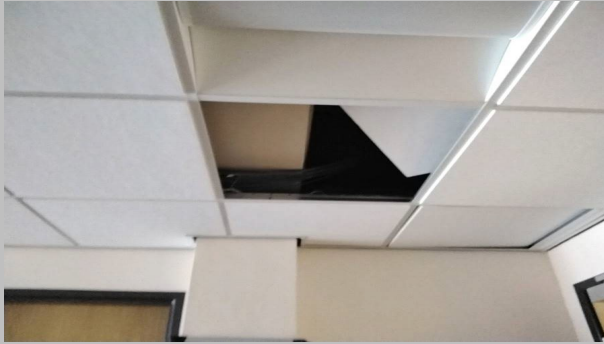
13	As KX001635	Ceiling void ceiling above	Main Building Reception (Room 007)	No Risk

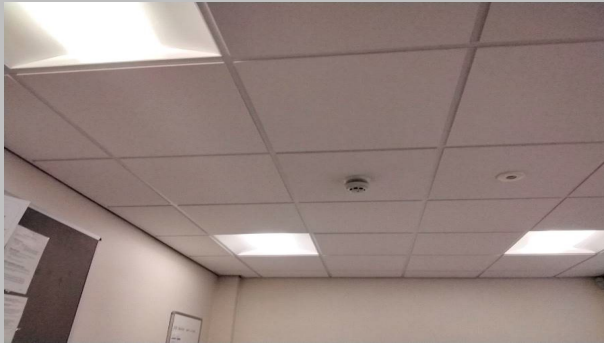
15	As KX001635	Ceiling void ceiling above	Main Building Office (Room 008)	No Risk

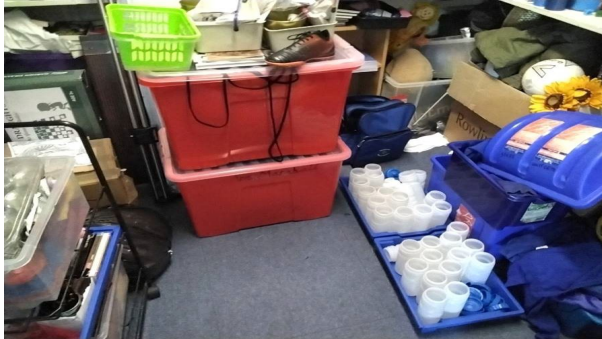
43	Presumed	Floor duct pipe insulation binding to fibreglass pipe insulation within floor duct under concrete slab (identified in previous report)	Main Building Storeroom (Room 024)	12 monthly

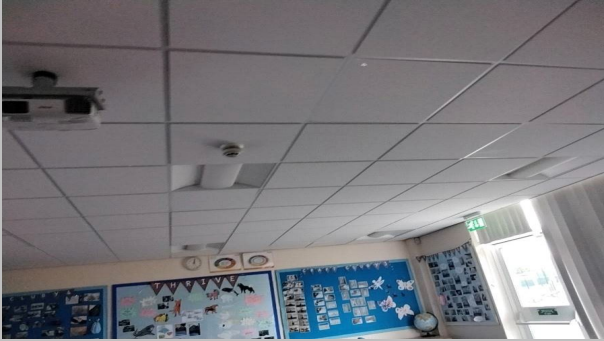
52	As KX001635	Ceiling void ceiling above	Main Building Classroom (Room 030)	No Risk

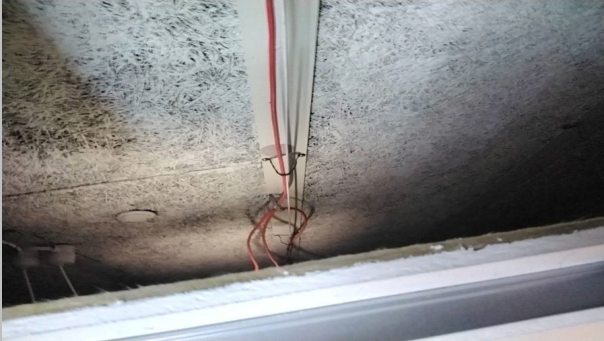
53	As KX001635	Ceiling void ceiling above	Main Building Hallway/passageway (Room 031)	No Risk

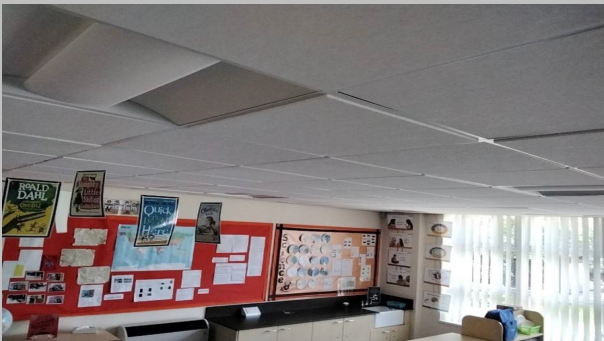
54	As KX001635	Ceiling void ceiling above	Main Building Classroom (Room 032)	No Risk

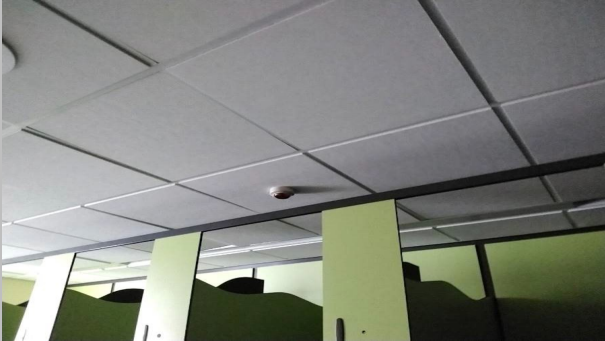
61	As KX001635	Ceiling void ceiling above	Main Building Female Toilets (Room 050)	No Risk

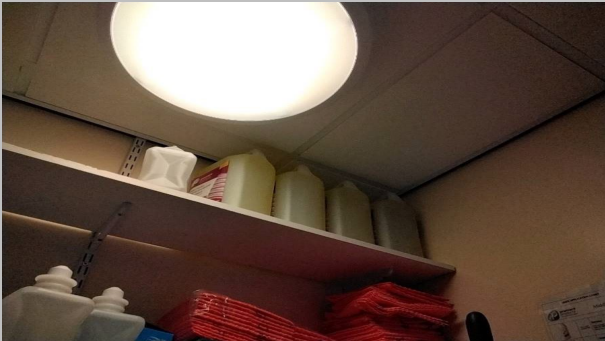
62	As KX001635	Ceiling void ceiling above	Main Building Cupboard (Room 050a)	No Risk

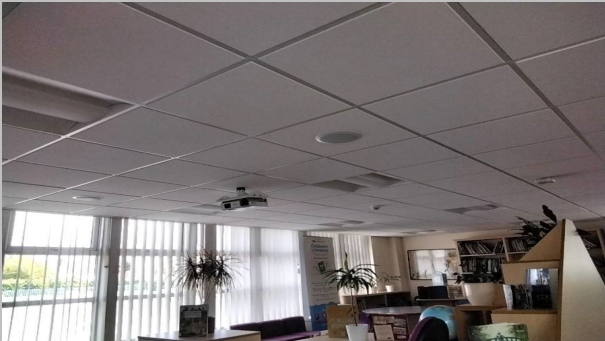
63	As KX001635	Ceiling void ceiling above	Main Building Library (Room 051)	No Risk

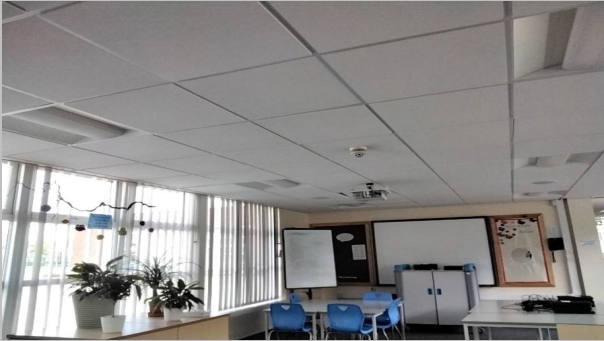
65	As KX001635	Ceiling void ceiling above	Main Building Hallway/Passageway (Room 052)	No Risk

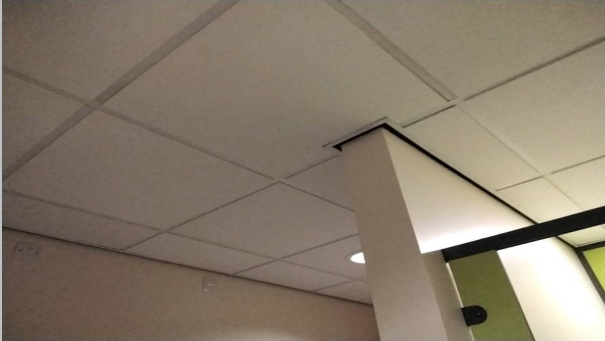
70	As KX001635	Ceiling void ceiling above	Main Building Female Toilets (Room 055)	No Risk

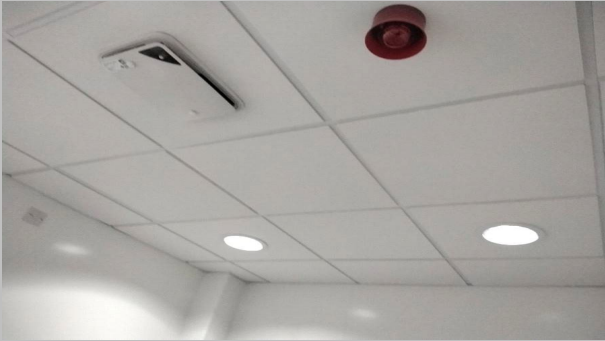
71	As KX001635	Ceiling void ceiling above	Main Building Toilets (Room 056)	No Risk

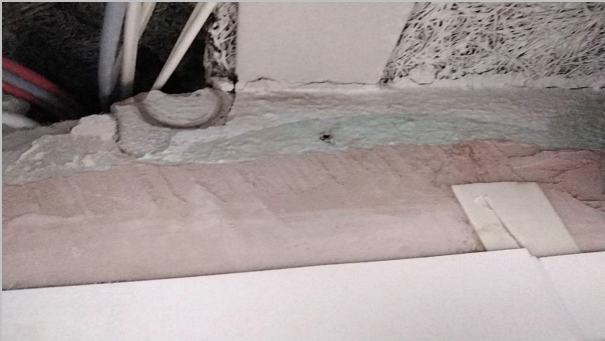
72	KX001641	Wall coating skimmed cladding visible in ceiling void	Main Building Toilets (Room 056)	No Risk

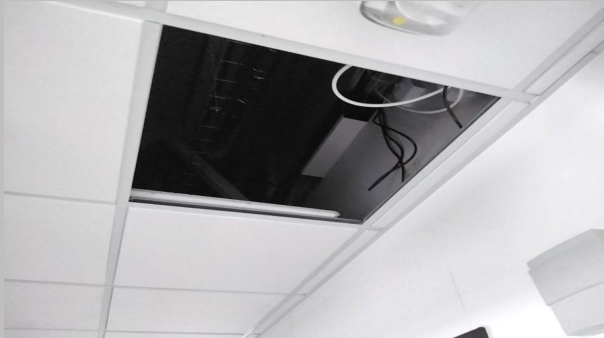
73	As KX001641	Wall coating skimmed cladding visible in ceiling void	Main Building Kitchen (Room 038)	No Risk

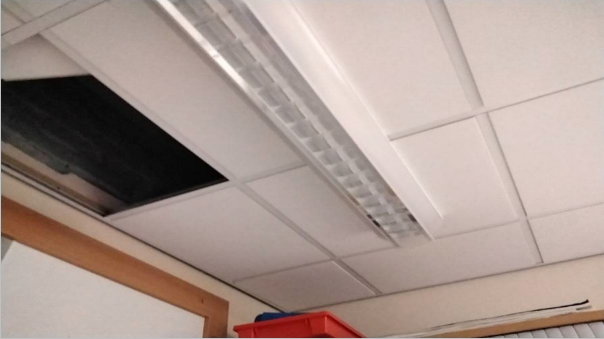
83	As KX001645	Ceiling void ceiling above	Main Building Office (Room 060)	No Risk

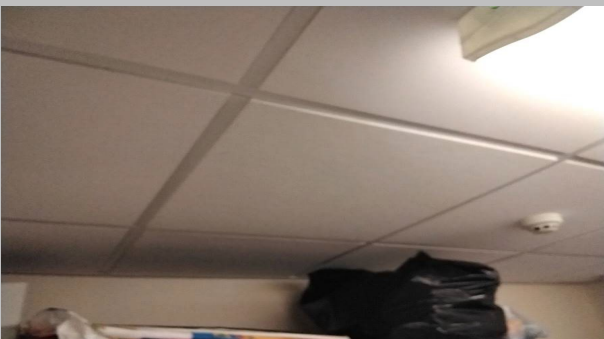
84	As KX001645	Ceiling void ceiling above	Main Building Cupboard Store (Room 062)	No Risk

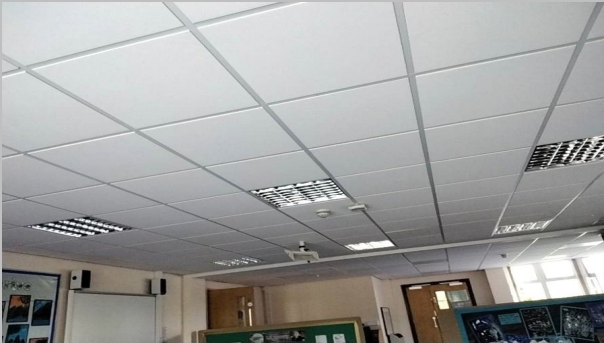
95	As KX001645	Ceiling void ceiling above	Main Building Classroom (Room 073)	No Risk

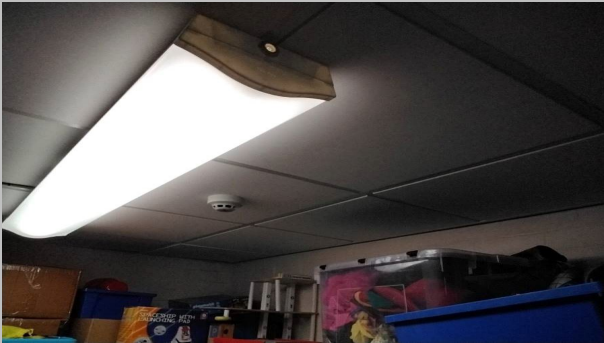
96	As KX001645	Ceiling void ceiling above	Main Building Store Room (Room 075)	No Risk

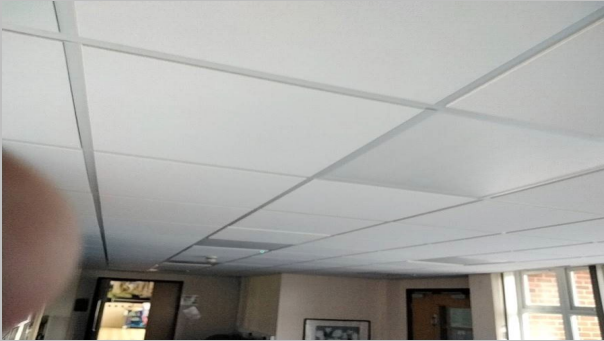
100	As KX001645	Ceiling void ceiling above	Main Building Corridor (Room 070)	No Risk

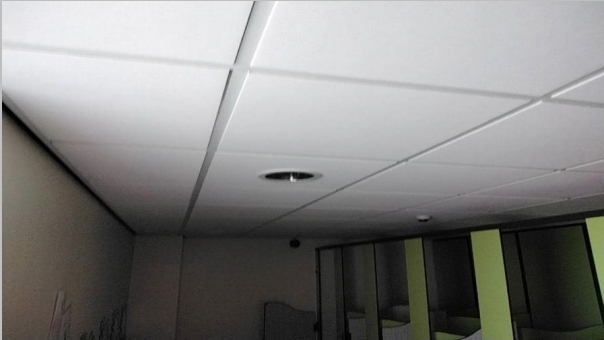
101	As KX001635	Ceiling void ceiling above	Main Building Female Toilets (Room 092)	No Risk

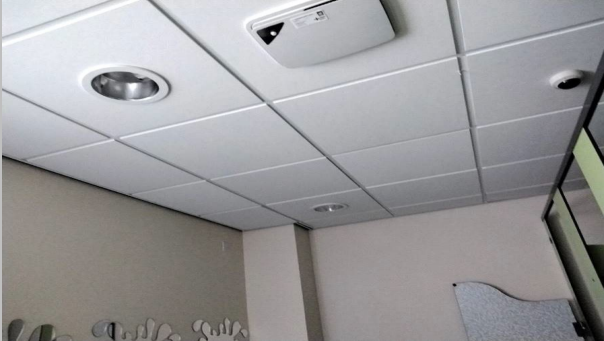
109	As KX001635	Ceiling void ceiling above	Main Building Female Toilets (Room 097)	No Risk

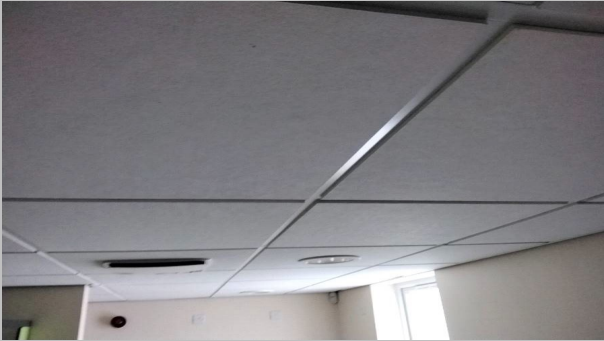
110	As KX001635	Ceiling void ceiling above	Main Building Male Toilets (Room 097a)	No Risk

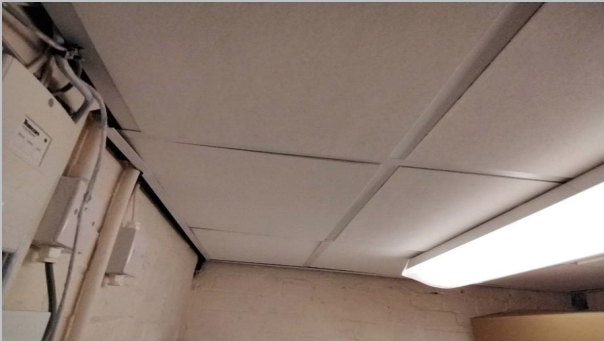
111	As KX001645	Ceiling void ceiling above	Main Building Caretakers Room (Room 077)	No Risk

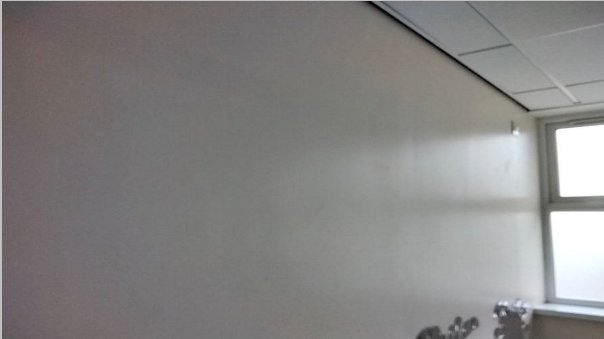
115	As KX001667	Wall Coating	Main Building Toilets (Room 080)	No Risk

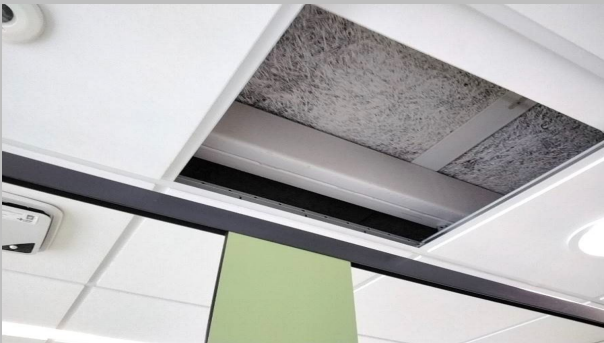
116	As KX001645	Ceiling void ceiling above	Main Building Toilets (Room 080)	No Risk

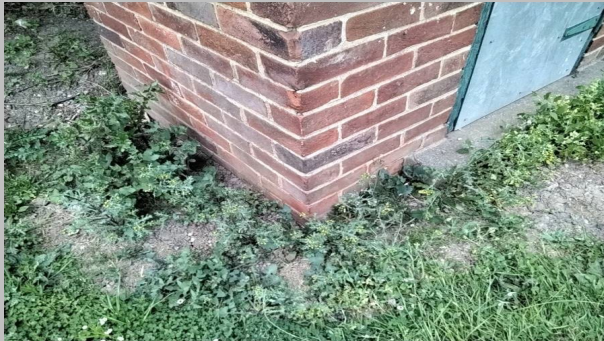
125	KX001666	Damp proof course including packing to roof	External Meter Cupboard (Room 03)	No Risk
