ASBESTOS SURVEY REPORT FOR FULWEL JUNIOR SCHOOL, SEA ROAD, SUNDERLAND, SR6 9EE.

Asbestos Register for

Fulwell Junior School, Sea Road, Sunderland, SR6 9EE

Date: 04 March 2026

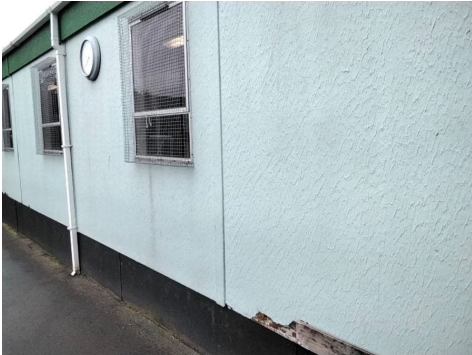
Item 58 Ref: CF006519

The wall coating
(External/E001) does not
contain asbestos.

Demolished in refurb 2024

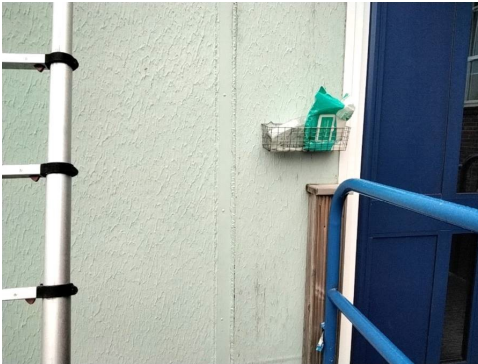
Item 59 Ref: CF006520

The wall panel
(External/E001) does not
contain asbestos.

Demolished in refurb 2024

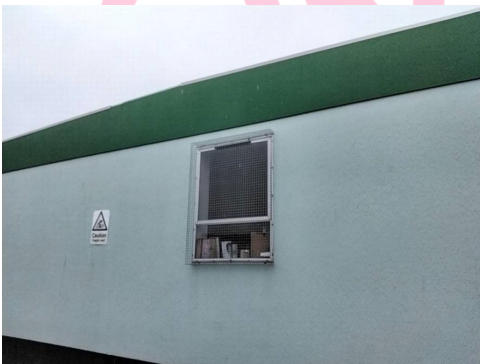
Item 60 Ref: CF006526

The window putty
(External/E001) does not
contain asbestos.

Demolished in refurb 2024

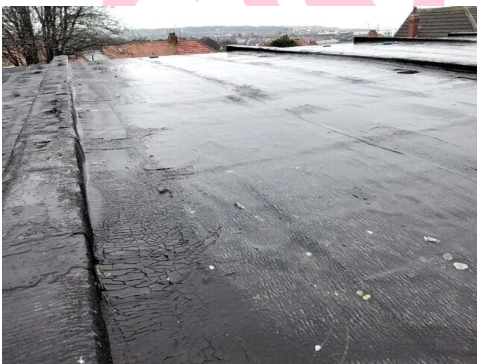
Item 63 Ref: CF006525

The roof felt below modern plastic covering (External/E002) does not contain asbestos.

Demolished in refurb 2024

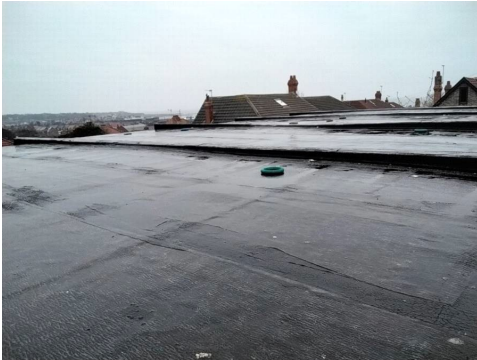
Item 64 Ref: CF006522

The roof jointing compound (External/E002) does not contain asbestos.

Demolished in refurb 2024

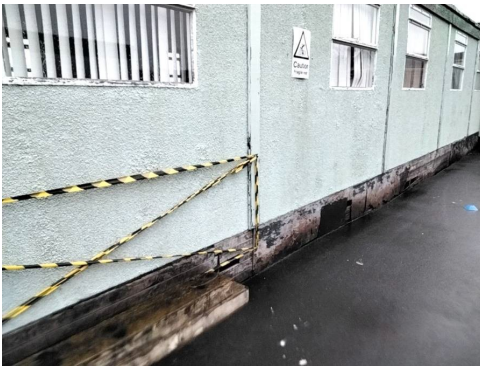
Item 65 Ref: CF006523

The wall coating (External/E002) does not contain asbestos.

Demolished in refurb 2024

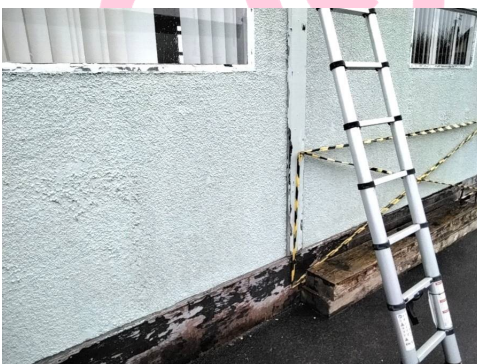
Item 66 Ref: CF006524

The wall panel (External/E002) does not contain asbestos.

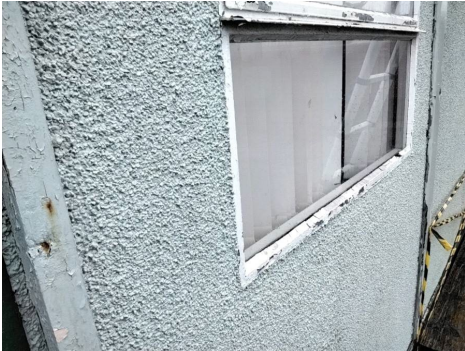
Item 67 Ref: CF006526

The window putty (External/E002) does not contain asbestos.

Demolished in refurb 2024

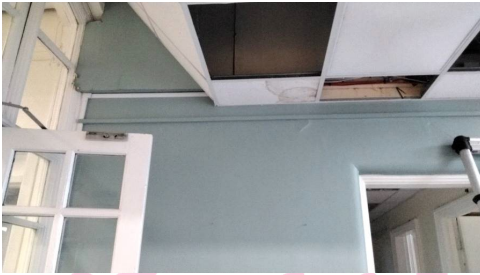
Item 68 Ref: NO000600

The Wall coating fire flex paint (Reception/Entrance Hall G/001) does not contain asbestos.

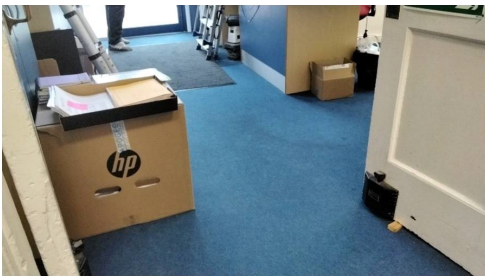
Item 69 Ref: NO000601

The Floor (Reception/Entrance Hall G/001) does not contain asbestos.

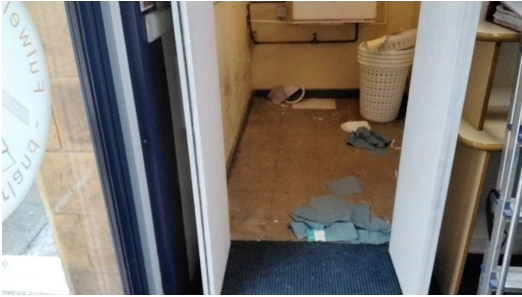
Item 70 Ref: NO000602

The Floor tile (Cupboard G/002) does not contain asbestos.

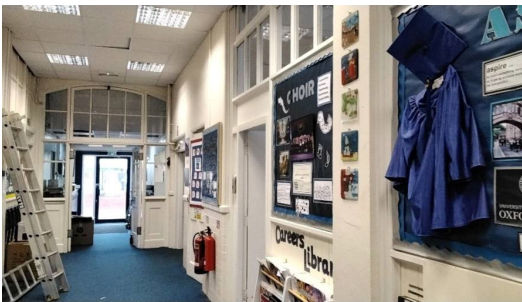
Item 71 Ref: As NO000600

The Wall coating fire flex paint (Corridor G/003) does not contain asbestos.

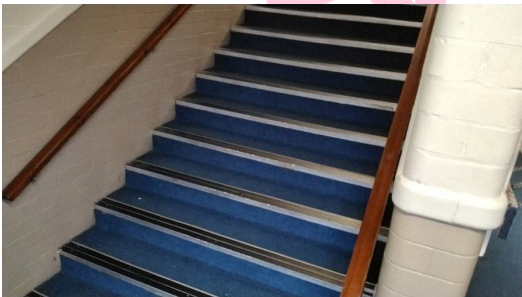
Item 72 Ref: NO000603

The Floor nosing to stairs (Corridor including stairs to Mezzanine G/004) does not contain asbestos.

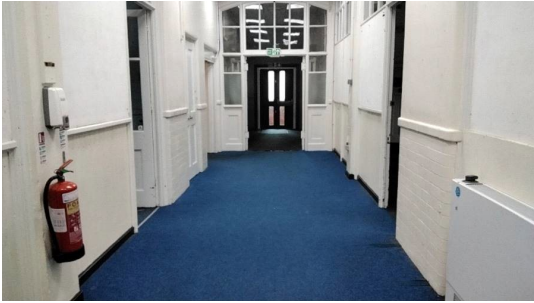
Item 73 Ref: As NO000600

The Wall coating fire flex paint (Corridor G/010) does not contain asbestos.

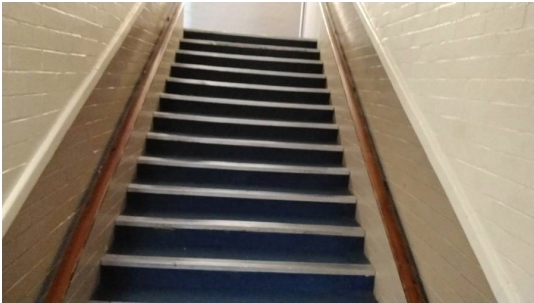
Item 74 Ref: As NO000603

The Floor nosing to stairs (Corridor including stairs to Mezzanine G/013) does not contain asbestos.

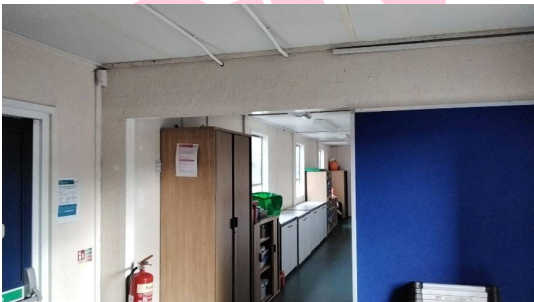
Item 75 Ref: NO000604

The Wall coating (Entrance Hall G/014) does not contain asbestos.

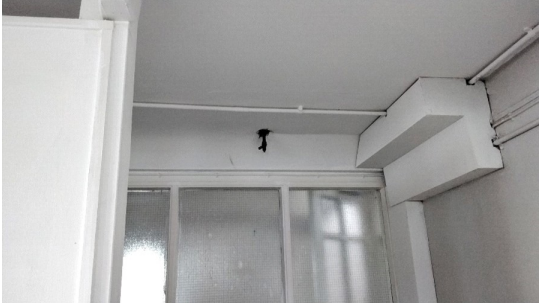
Item 76 Ref: NO000605

The Debris/Residue in pipe penetration (Female Toilets G/020) does not contain asbestos.

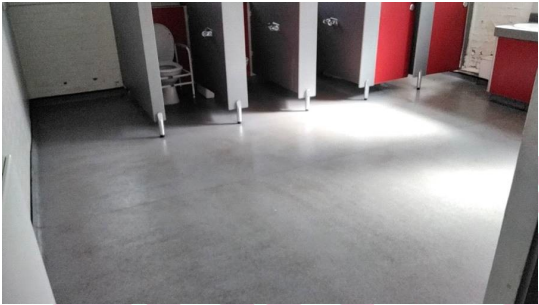
Item 77 Ref: As NO000601

The Floor adhesive remnants (Female Toilets G/020) do not contain asbestos.

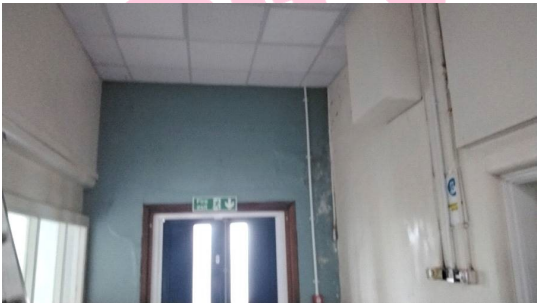
Item 78 Ref: As NO000600

The Wall coating fire flex paint (Entrance Hall/Foyer/Lobby G/021) does not contain asbestos.

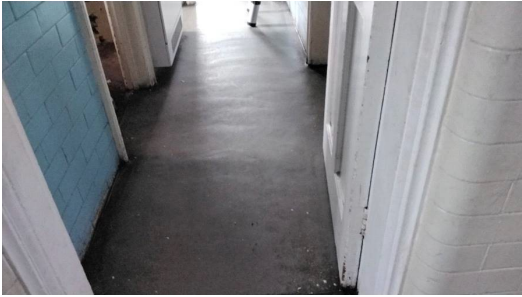
Item 79 Ref: As NO000601

The Floor beneath lino (Corridor G/022) does not contain asbestos.

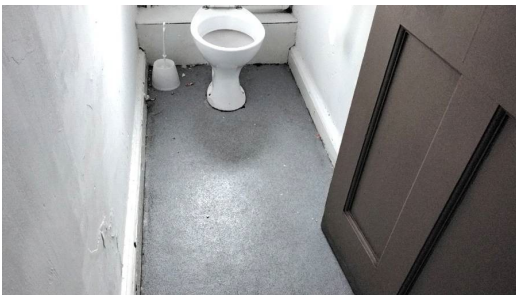
Item 80 Ref: As NO000601

The Floor beneath lino (Toilets G/024) does not contain asbestos.

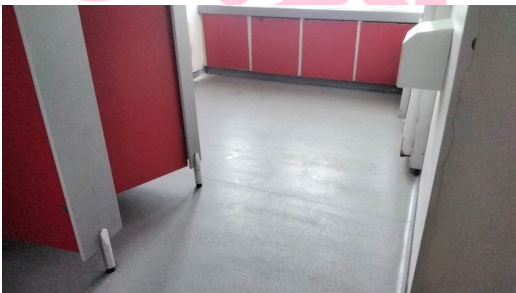
Item 81 Ref: As NO000601

The Floor beneath lino (Toilets G/025) does not contain asbestos.

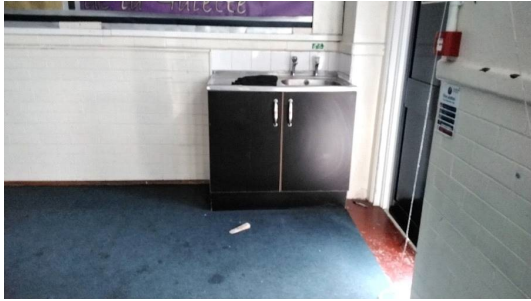
Item 82 Ref: NO000597

The Pipework to sink waste pipe (Classroom G/026) does not contain asbestos.

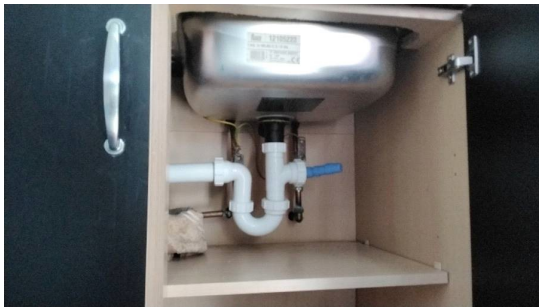
Item 83 Ref: NO000598

The Under sink mat (Classroom G/026) does not contain asbestos.

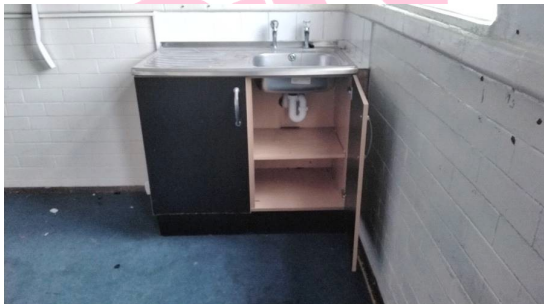
Item 84 Ref: As NO000597

The Pipework to sink waste pipe (Classroom G/027) does not contain asbestos.

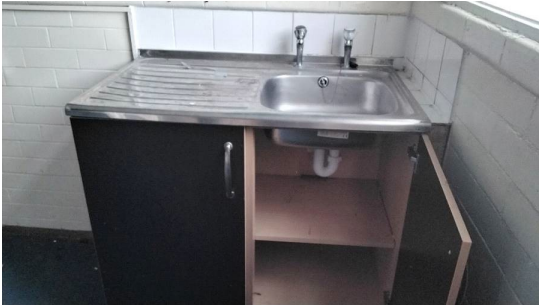
Item 85 Ref: As NO000598

The Under sink mat (Classroom G/027) does not contain asbestos.

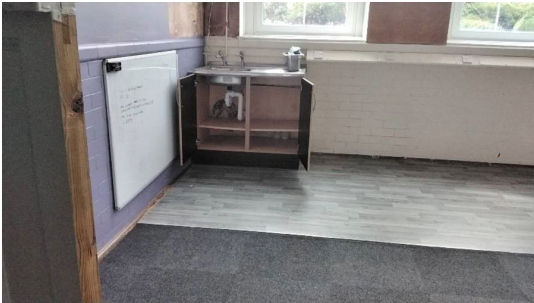
Item 86 Ref: As NO000597

The Pipework to sink waste pipe (Classroom G/028) does not contain asbestos.

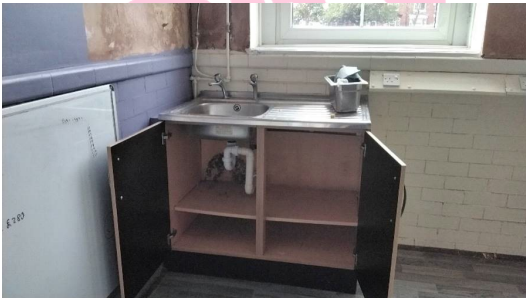
Item 87 Ref: As NO000598

The Under sink mat (Classroom G/028) does not contain asbestos.

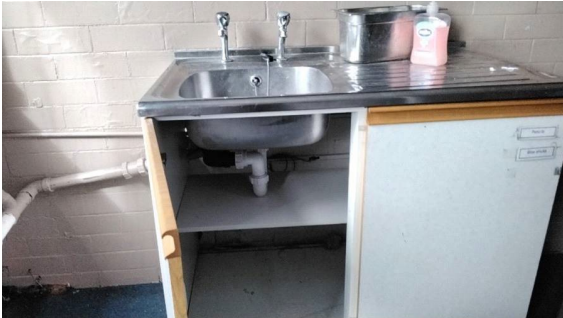
Item 88 Ref: As NO000598

The Under sink mat (Classroom G/029) does not contain asbestos.

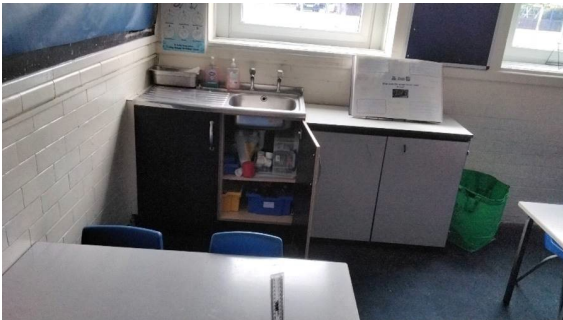
Item 89 Ref: As NO000597

The Pipework to sink waste pipe (Classroom G/030) does not contain asbestos.

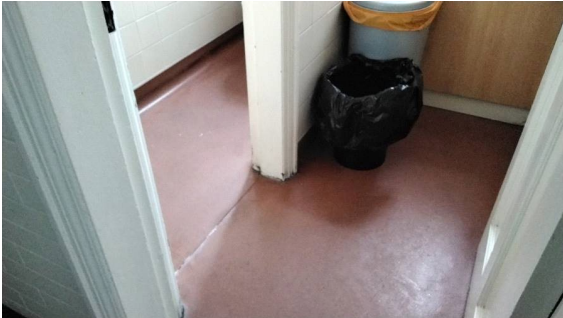
Item 91 Ref: As NO000601

The Floor beneath lino (Toilets G/033) does not contain asbestos.

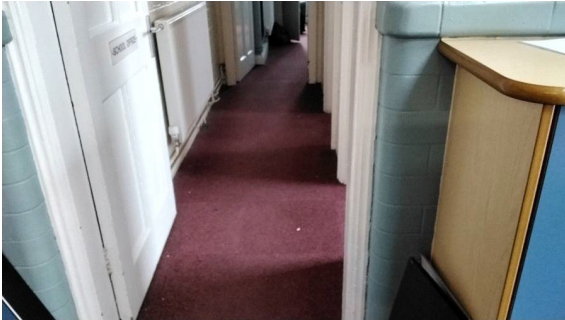
Item 94 Ref: As NO000601

The Floor (Corridor G/035) does not contain asbestos.

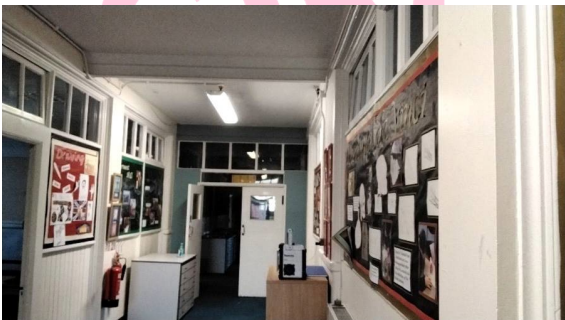
Item 96 Ref: As NO000596

The Wall coating (Corridor 1/002) does not contain asbestos.

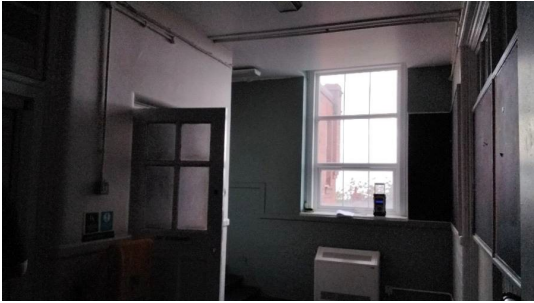
Item 97 Ref: As NO000596

The Wall coating (Corridor 1/007) does not contain asbestos.

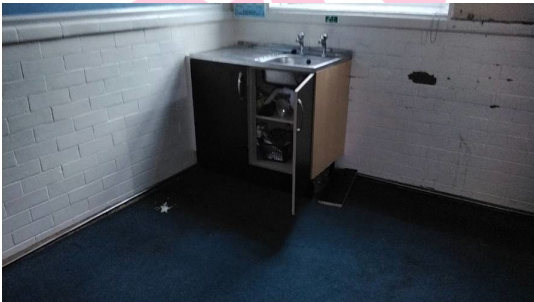
Item 99 Ref: NO000597

The Pipework to sink water pipe (Classroom 1/013) does not contain asbestos.

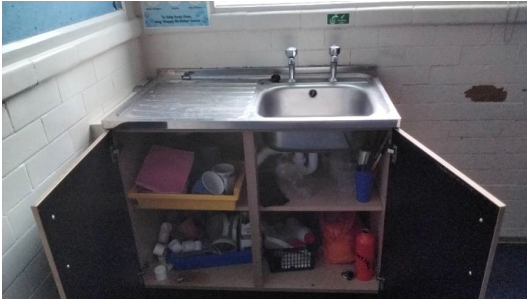
Item 100 Ref: NO000598

The Under sink mat
(Classroom 1/013) does not
contain asbestos.

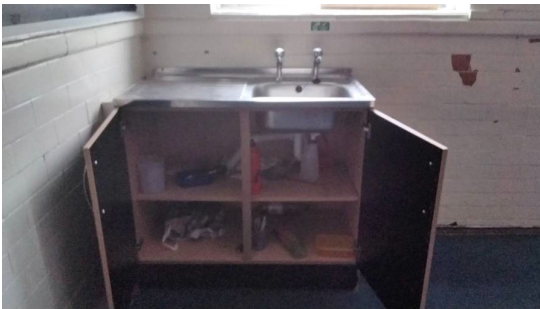
Item 101 Ref: As NO000598

The Under sink mat
(Classroom 1/014) does not
contain asbestos.

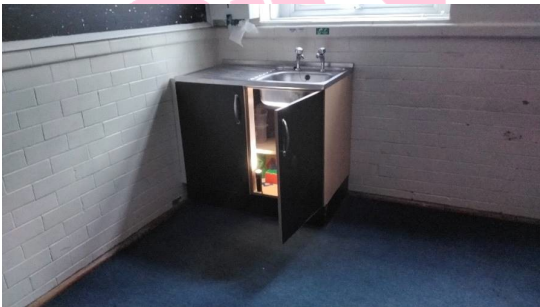
Item 102 Ref: As NO000598

The Under sink mat
(Classroom 1/015) does not
contain asbestos.

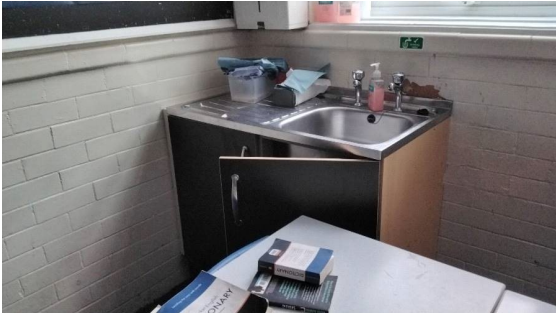
Item 103 Ref: As NO000598

The Under sink mat (Classroom 1/016) does not contain asbestos.

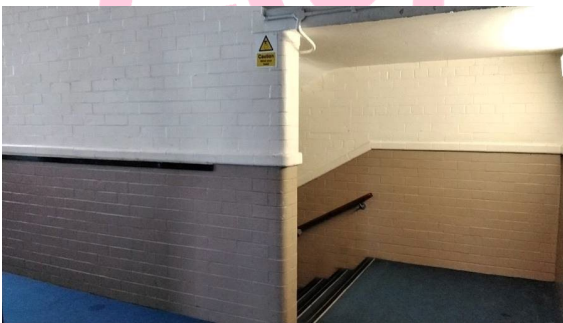
Item 108 Ref: As NO000600

The Wall coating fire flex paint (Landing MZ/001) does not contain asbestos.

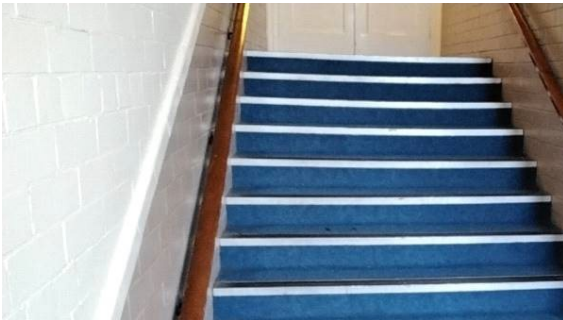
Item 110 Ref: As NO000603

The Floor nosing to stairs (Landing MZ/001) does not contain asbestos.

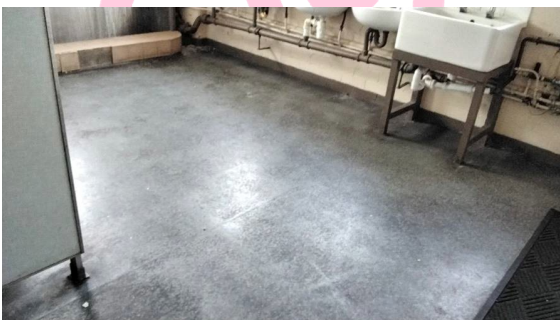
Item 111 Ref: As NO000601

The Floor (Male Toilets MZ/002) does not contain asbestos.

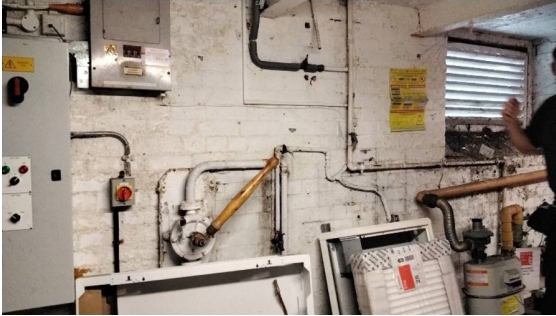
Item 115 Ref: NO000592

The Debris/Residue to wall at pipe penetration area (Boiler Room Z1/001) does not contain asbestos.

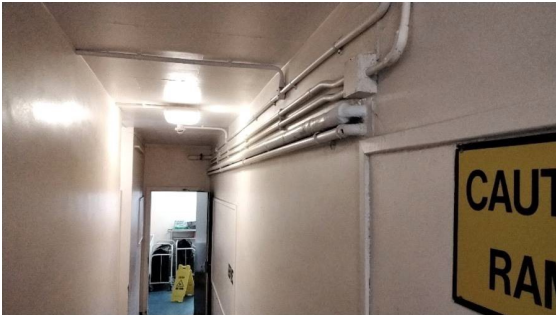
Item 116 Ref: Presumed

The Pipework insulation (Entrance Hall/Foyer/Lobby G/001) is presumed to contain asbestos.

Any change in its appearance should be recorded and passed to Property Services.

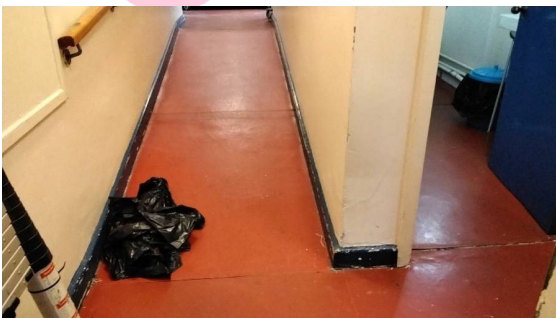
Item 117 Ref: NO000582

The Floor covering adhesive residue (Entrance Hall/Foyer/Lobby G/001) contains asbestos.

Any change in its appearance should be recorded and passed to Property Services.

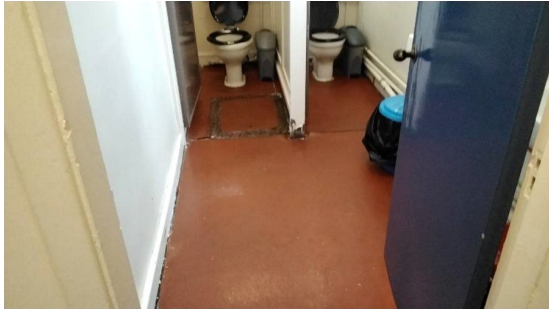
Item 118 Ref: As NO000582

The Floor covering adhesive residue (Toilets G/002) contains asbestos.

Any change in its appearance should be recorded and passed to Property Services.

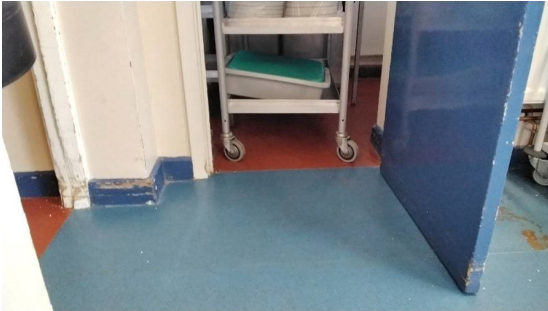
Item 121 Ref: As NO000582

The Floor covering adhesive residue (Store Room G/005) contains asbestos.

Any change in its appearance should be recorded and passed to Property Services.

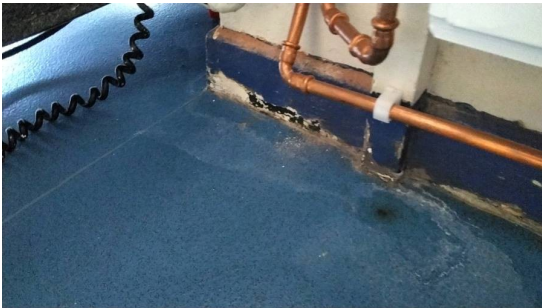
Item 122 Ref: As NO000582

The Floor covering adhesive residue (Kitchen G/006) contains asbestos.

Any change in its appearance should be recorded and passed to Property Services.

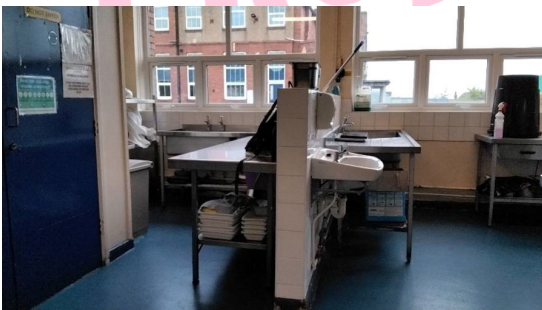
Item 123 Ref: NO000583

The Under sink mat (Kitchen G/006) does not contain asbestos.

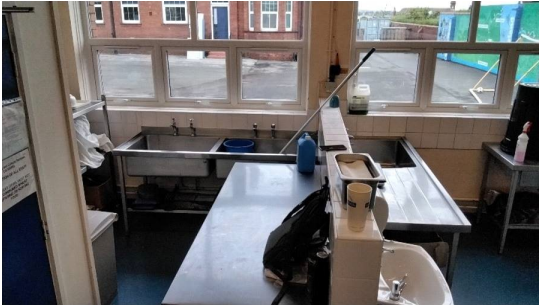
Item 124 Ref: NO000584

The Pipework sink waste x 3 sinks (Kitchen G/006) contains asbestos.

Any change in its appearance should be recorded and passed to Property Services.

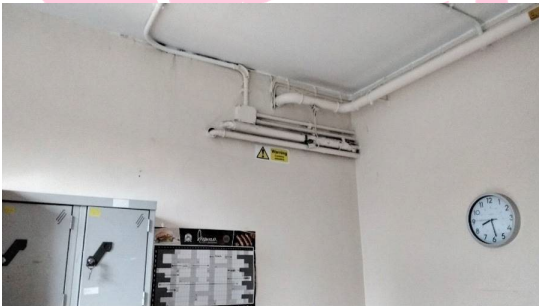
Item 126 Ref: Presumed

The Pipework insulation (Office G/007) Is presumed to contain asbestos.

Any change in its appearance should be recorded and passed to Property Services.

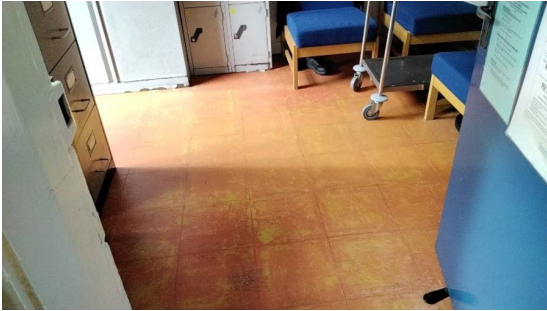
Item 127 Ref: As NO000585

The Floor tile red (Office G/007) contains asbestos.

Any change in its appearance should be recorded and passed to Property Services.

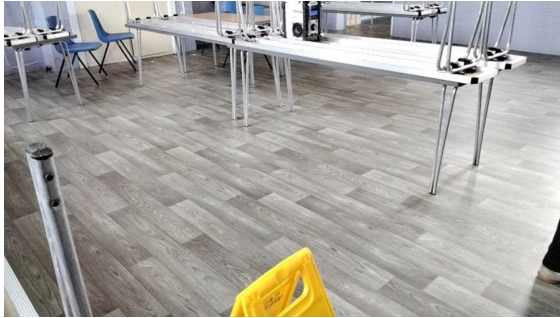
Item 130 Ref: NO000586

The Floor adhesive parquet blocks (Dining hall/area G/009) does not contain asbestos.

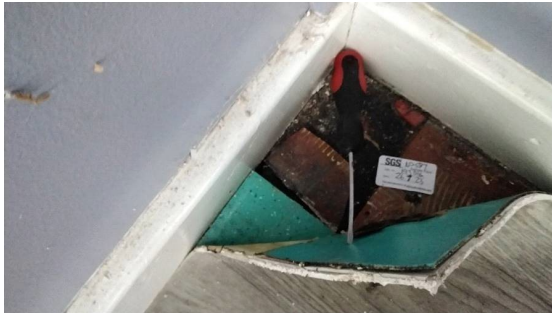
Item 131 Ref: NO000587

The Floor tile red thicker/older type (Corridor G/010) contains asbestos.

Any change in its appearance should be recorded and passed to Property Services.

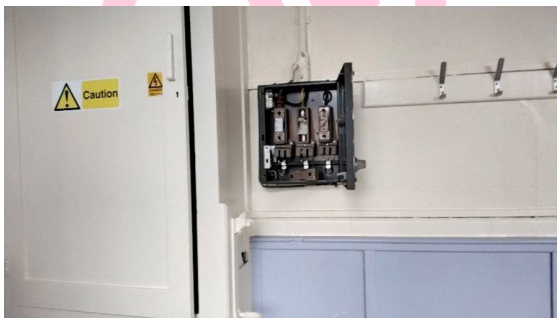
Item 132 Ref: NO000588

The Electrical Services Fuses/Flashguards (Corridor G/010) contains asbestos.

Any change in its appearance should be recorded and passed to Property Services.

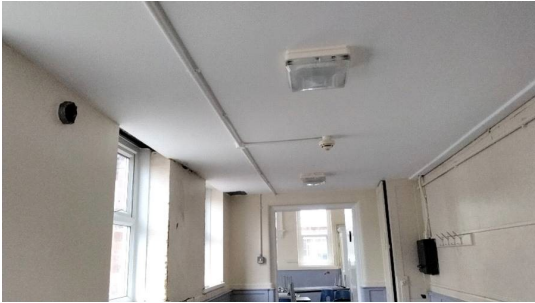
Item 133 Ref: NO000589

The Ceiling inspected within (Corridor G/010) does not contain asbestos.

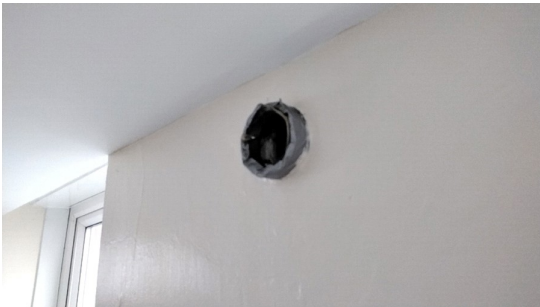
Item 134 Ref: NO000590

The Flue Pipe (Corridor G/010) contains asbestos.
Any change in its appearance should be recorded and passed to Property Services.

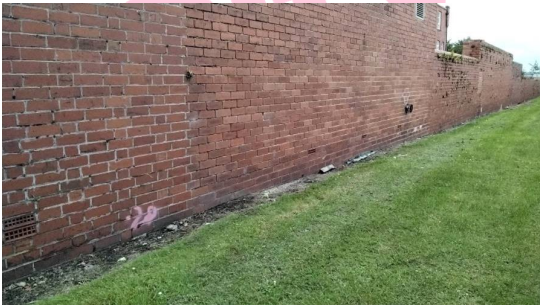
Item 135 Ref: NO000591

The Damp proof course (External E/001) does not contain asbestos.

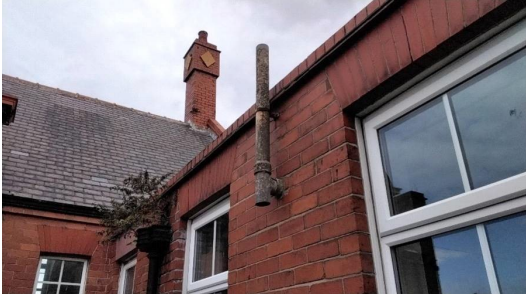
Item 136 Ref: As NO000590

The Flue Pipe (External E/001) contains asbestos.

Any change in its appearance should be recorded and passed to Property Services.
