ASBESTOS SURVEY REPORT FOR ST HELEN'S PRIMARY SCHOOL,  
DURHAM ST, HARTLEPOOL, TS24 0HR

**St Helen's Primary School, Durham St,  
Hartlepool, TS24 0HR**

**UPRN: - J149186**

**Date: 18 June 2026**

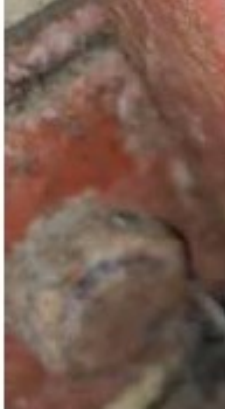
48	As RT000607	String - to pipework - Within ceiling void	KS2 Building - 25, 016 Store, G/25	Low Risk – To be checked on a 6 monthly basis

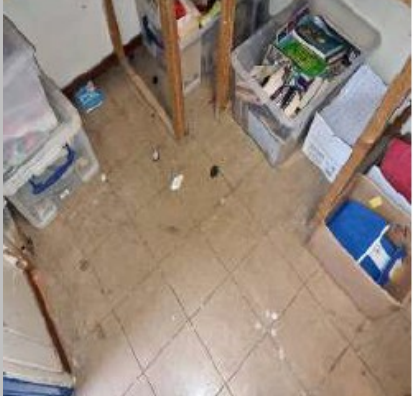
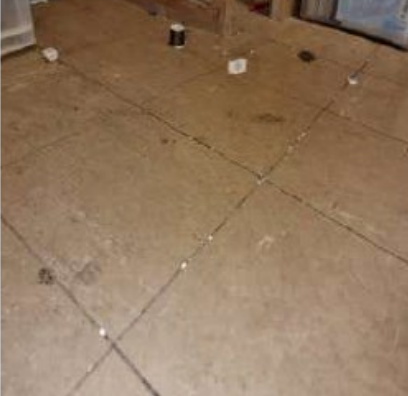
66	As RT000612	Beige vinyl tiles and adhesive - to floor	KS2 Building - 031 Store G/36	No Risk

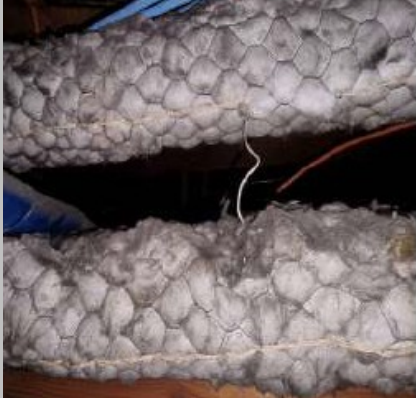
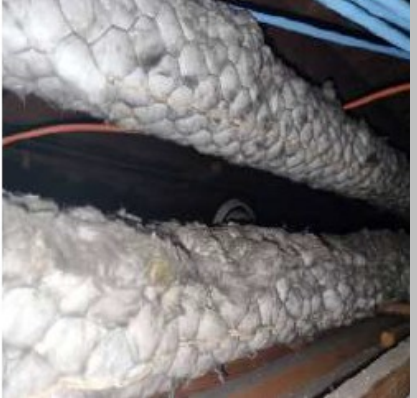
103	RT000619	String - to pipework	KS1 Building - 001 Entrance Lobby G/01	No Risk

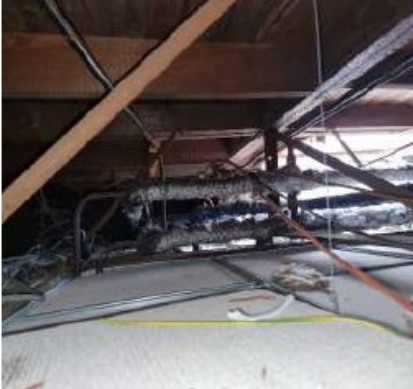
117	As RT000619	String - to pipework	KS1 Building - 020 Store G/21	No Risk

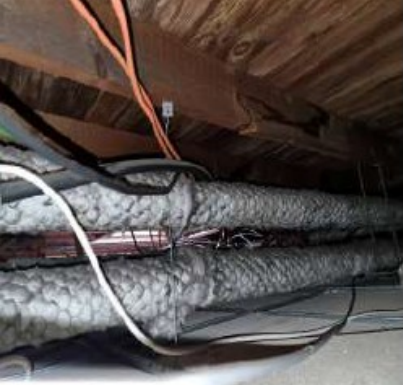
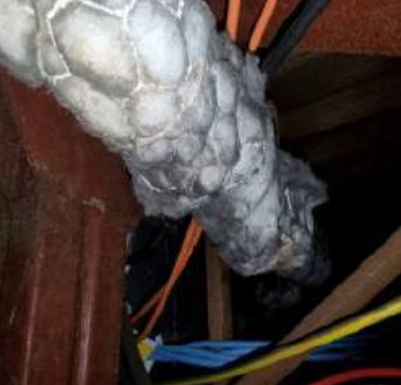
144	As RT000624	String - to pipework	KS1 Building - 011 Circulation G/44	No Risk

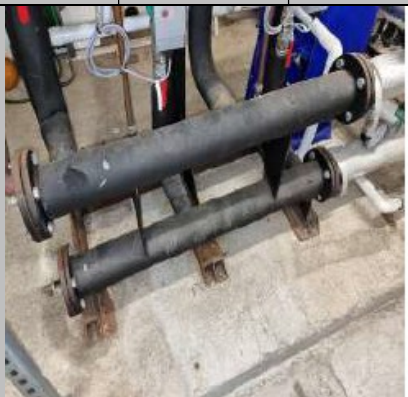
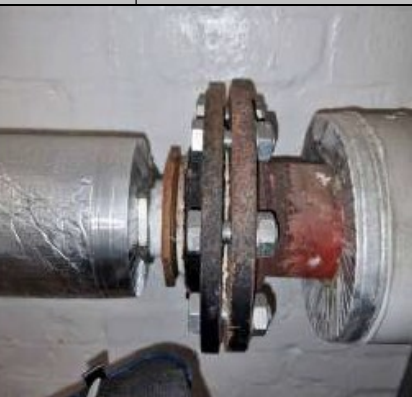
153	RT000634	Gaskets - to pipework	KS1 Building - 044 KS1 Boiler Room G/47	No Risk
